**47A and 47B Huntington Drive:
final report (HNZPTA authority 2020/076)**

**report to
Austin Management Ltd
and
Heritage New Zealand Pouhere Taonga**

Matthew Campbell and Ella Ussher

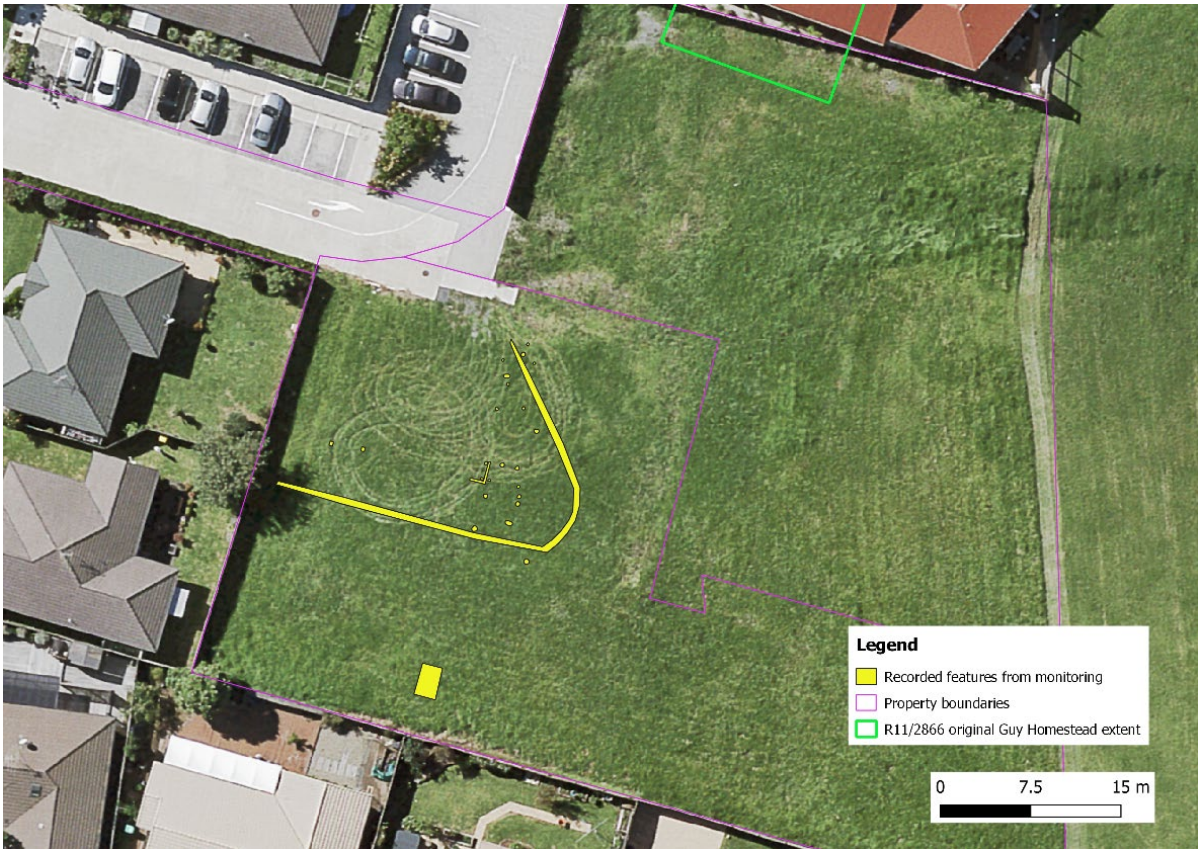
Figure 2. Map of properties at 47A and 47B Huntington Drive showing location of post-1900 features observed during monitoring of topsoil stripping over the entire area of the two properties.

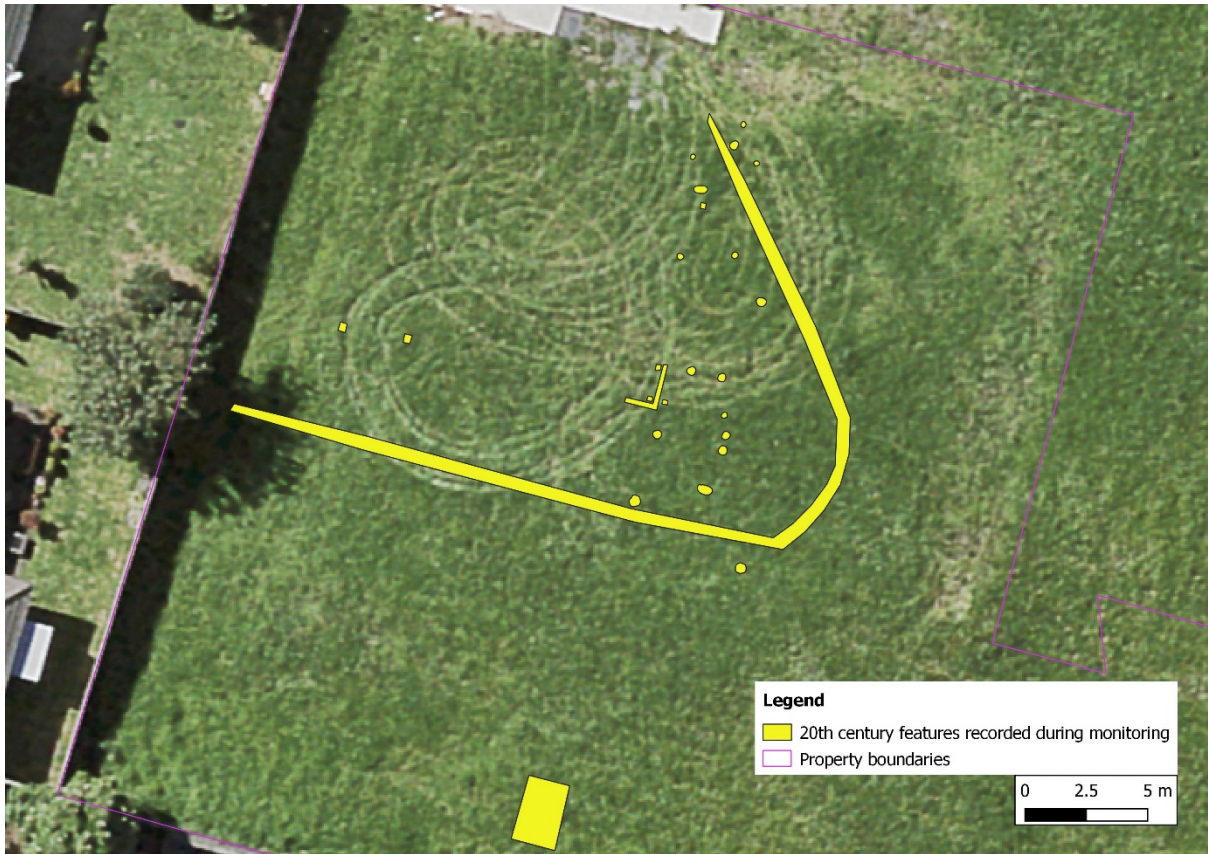
Figure 3. Detail of 47A Huntington Drive and the recorded post-1900 features observed during monitoring.

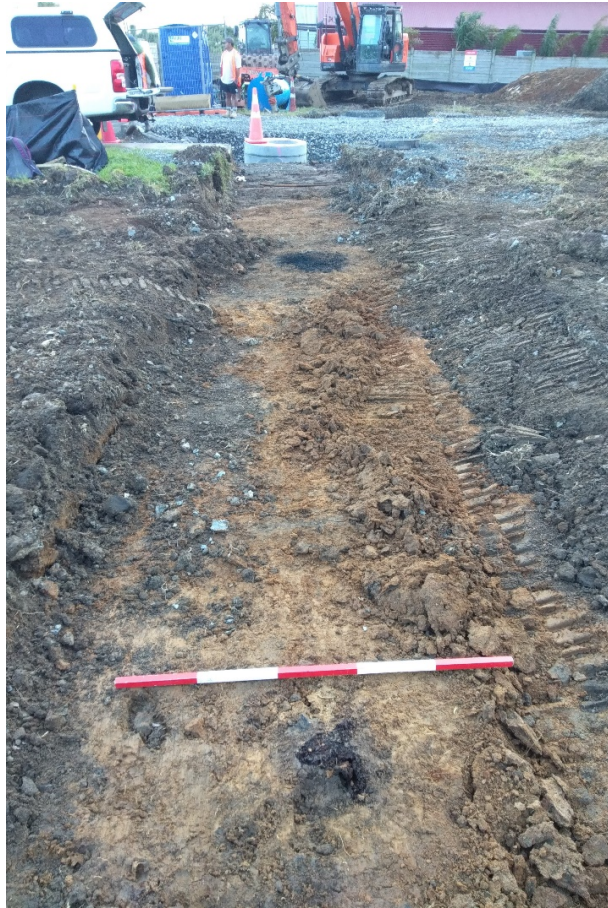
Figure 4. Area stripped to clay for wastewater drain for Units 7-22, showing post-holes below demolition layer.

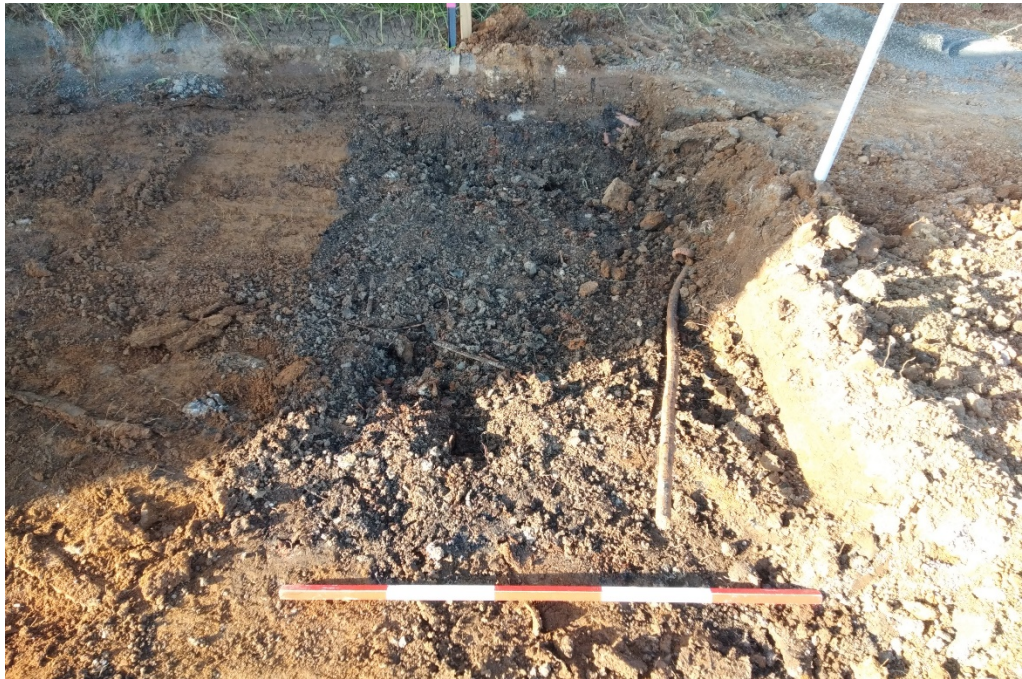
rubbish pit, 1.5m wide x 2m long and 600mm deep (Figure 5). The pit was filled with material from the demolition of the farm sheds that were once located here and are visible in aerial photographs from 1943 to 1988. This material consisted of aged asbestos, wood, corroded metal, rubber pipes, stock tags and other farming items. The presence of asbestos suggest that the sheds were built during the 1930s or 1940s. North of this pit but within the same building platform were at least 16 post-holes (several with intact posts) (Figure 7) and the base of a small concrete structure cut into the unmodified clay. The only remaining portions of this structure were the bases of two walls, one extending east 1.4m and the other north 1.8m and cut 100mm into the unmodified clay (Figure 6). It is likely that the remainder of the structure was demolished when the farm buildings were levelled between 1988 and 1995. The fill of one post-hole in this area had a bottle inside which was stamped with a 1921 date on it, indicating that the post was removed and the hole back-filled after this date (Figure 8).

Figure 5. Pit in south of building platform for Units 15-22 containing demolition material from farm buildings

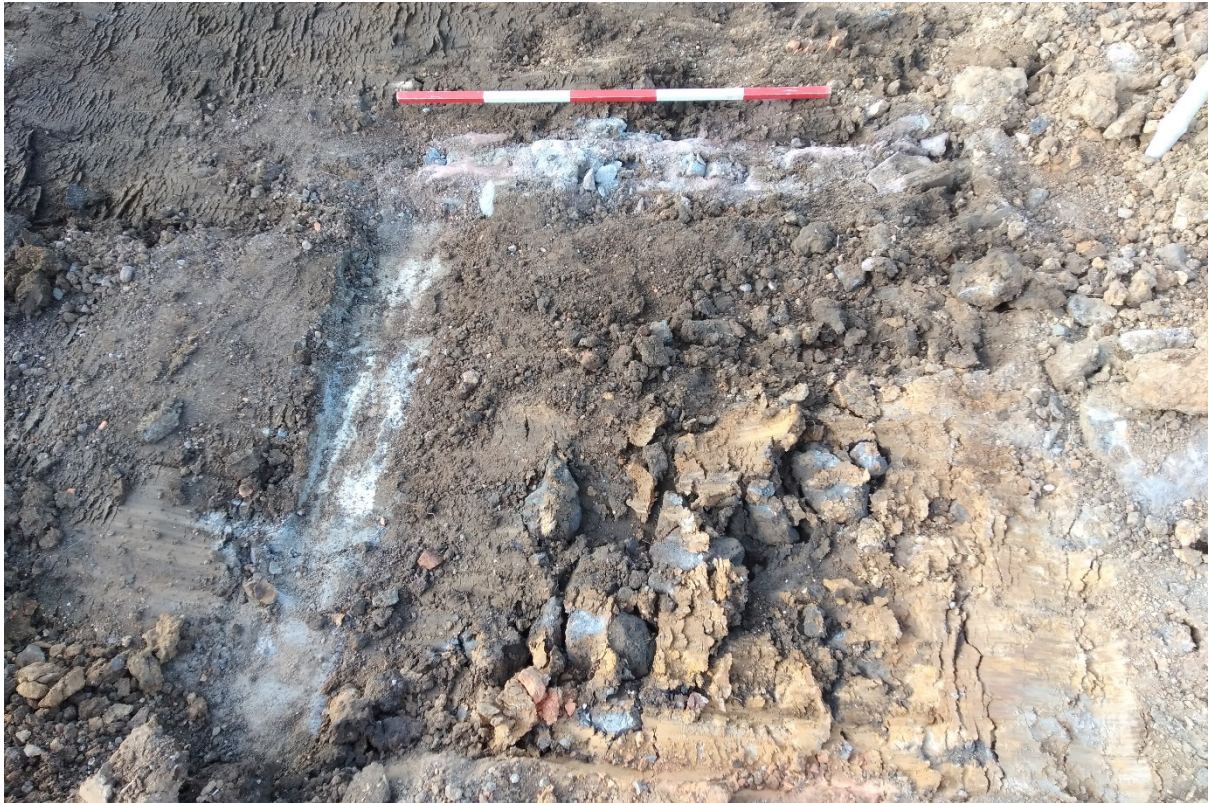
Figure 6. Structure recorded in building platform for Units 15-22, most likely levelled during demolition of farm buildings

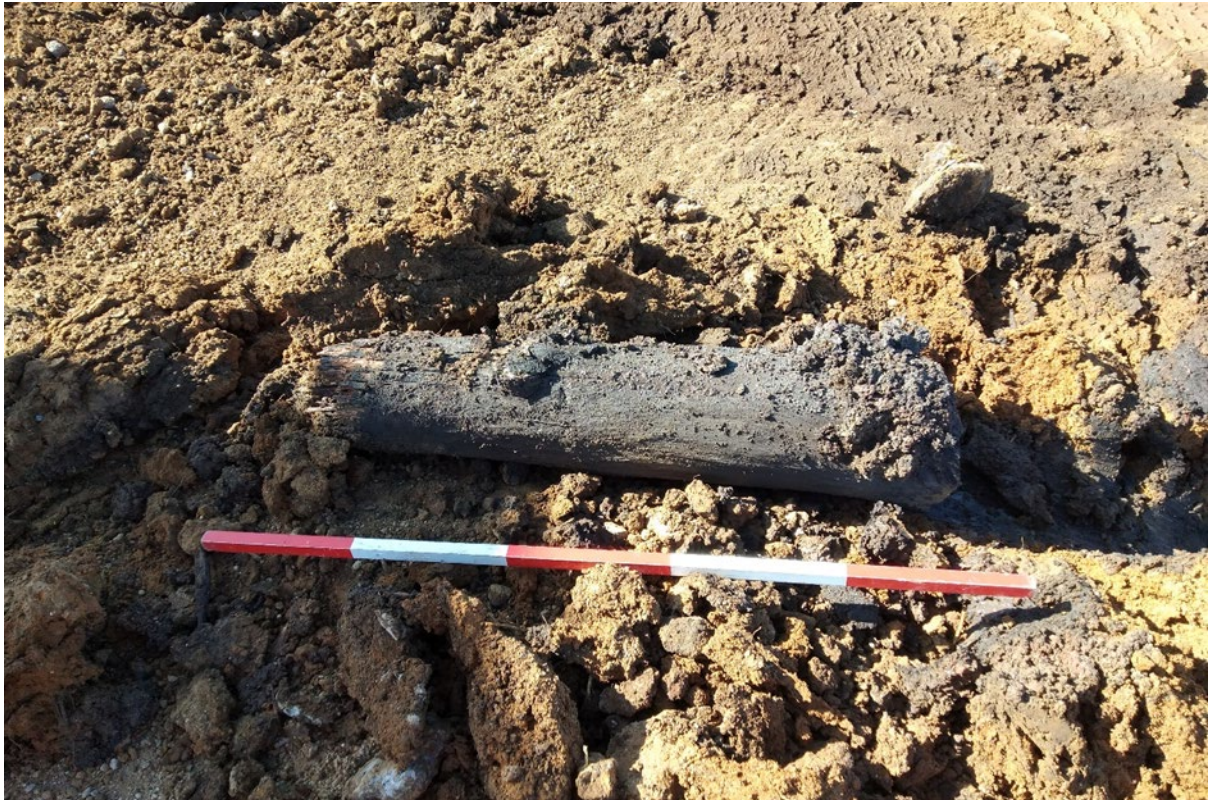
Figure 7. Intact post removed from post-hole in building platform for Units 15-22

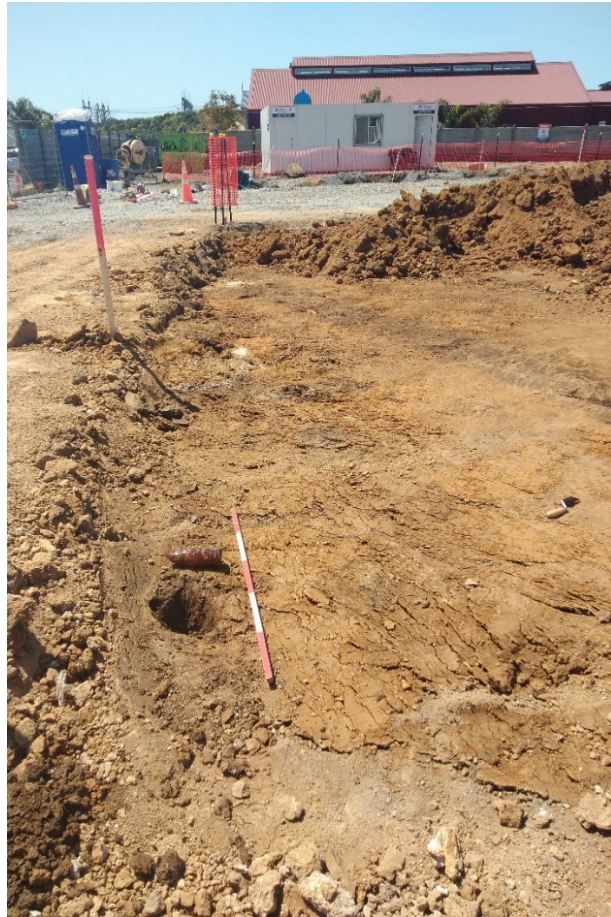
Figure 8. 1921 bottle excavated from fill of post-hole and drain feature in building platform for Units 15-22

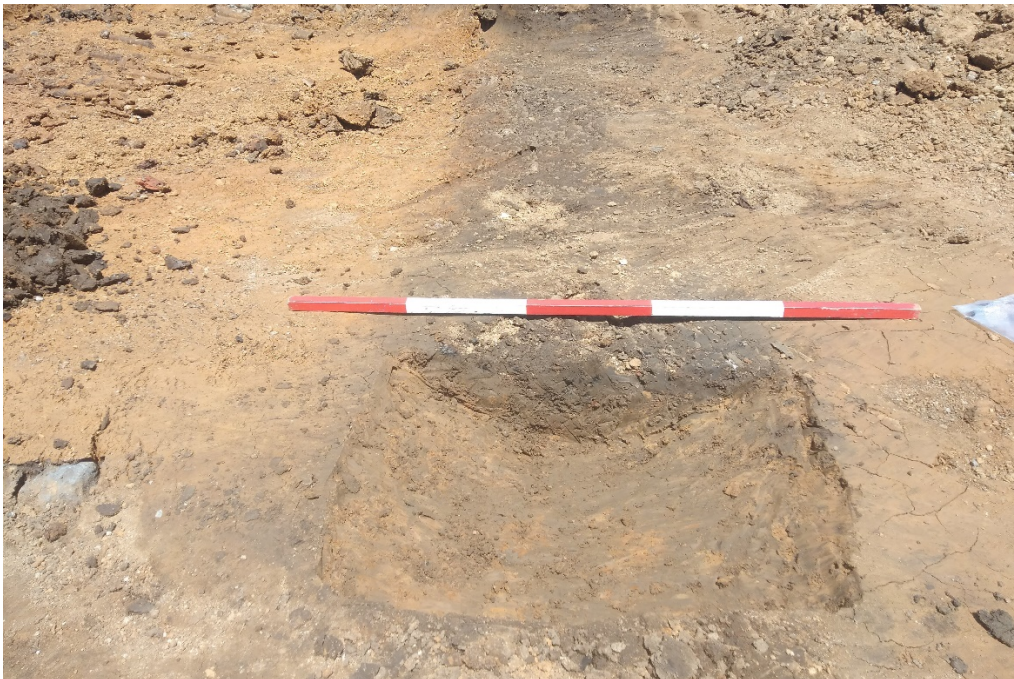
This drain feature was later found to extend in an east-west direction through the building platform for Units 15 to 22, before turning north towards the new driveway. This area was stripped between 30 October and 5 November 2019, and the remaining features were recorded by Ella Ussher. In the southern end of the building platform was a large square

Figure 9. Cut and fill within drain feature for farm buildings that extended east to west across the building platform for Units 7-22 then turned north towards the new driveway
