JOHN MARTIN'S HOUSE, OMAPERE

REPORT TO
THE DEPARTMENT OF CONSERVATION,
WHANGAREI AREA OFFICE

Date: 13 July 2009

Reference: 2009/22

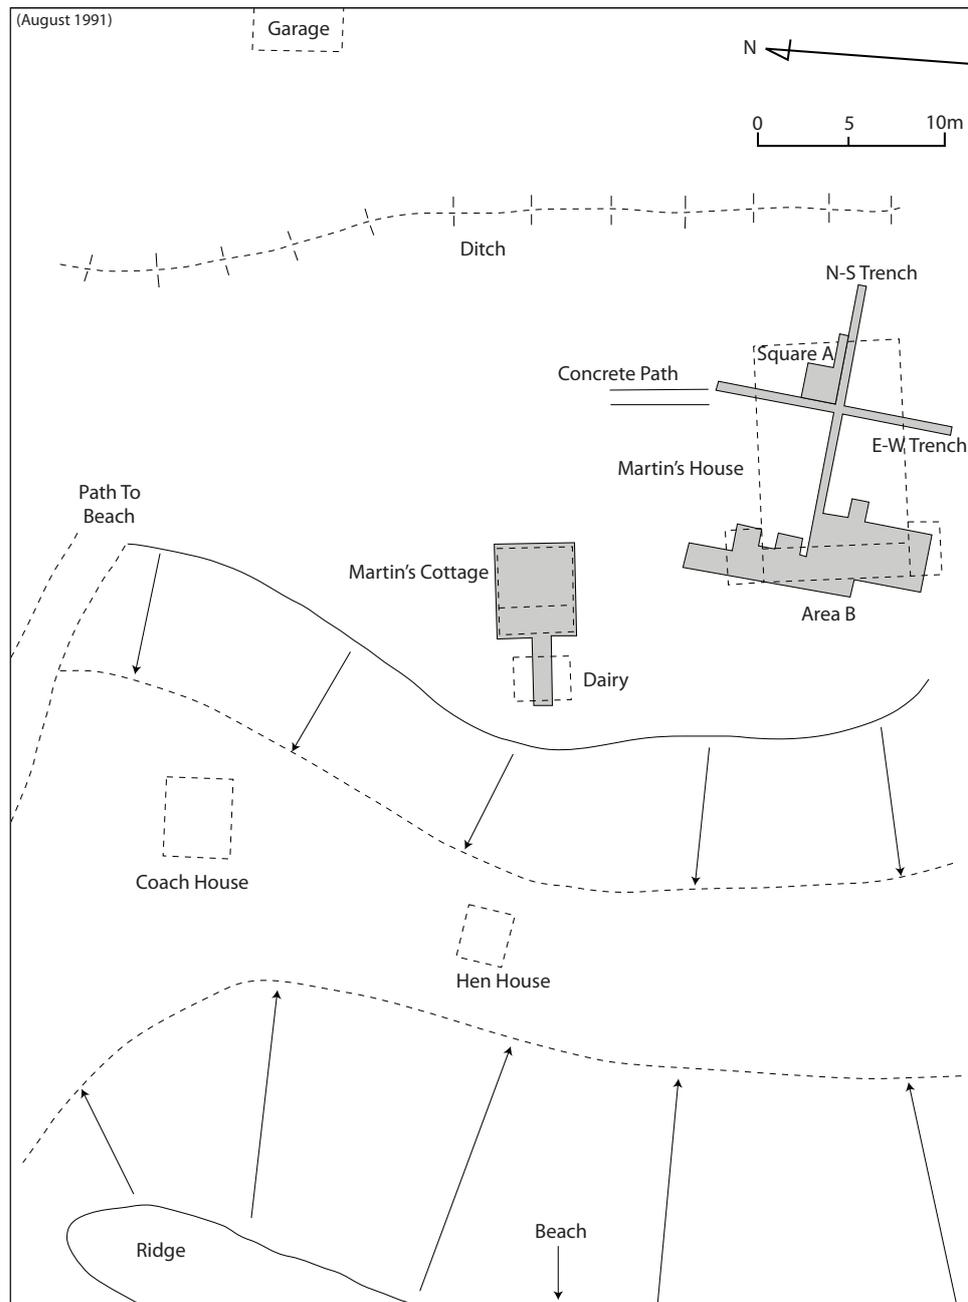
3. Site plan, showing the location of buildings and the three excavated areas (adapted from Slocombe 1991).

The archaeological investigation took place over a two week period from 26 August to 7 September 1991 and was focused on the areas lately occupied by the historic buildings. Three areas were selected for excavation: Martin’s House, Martin’s Cottage, and Square A (Figure 3). The research objectives were:

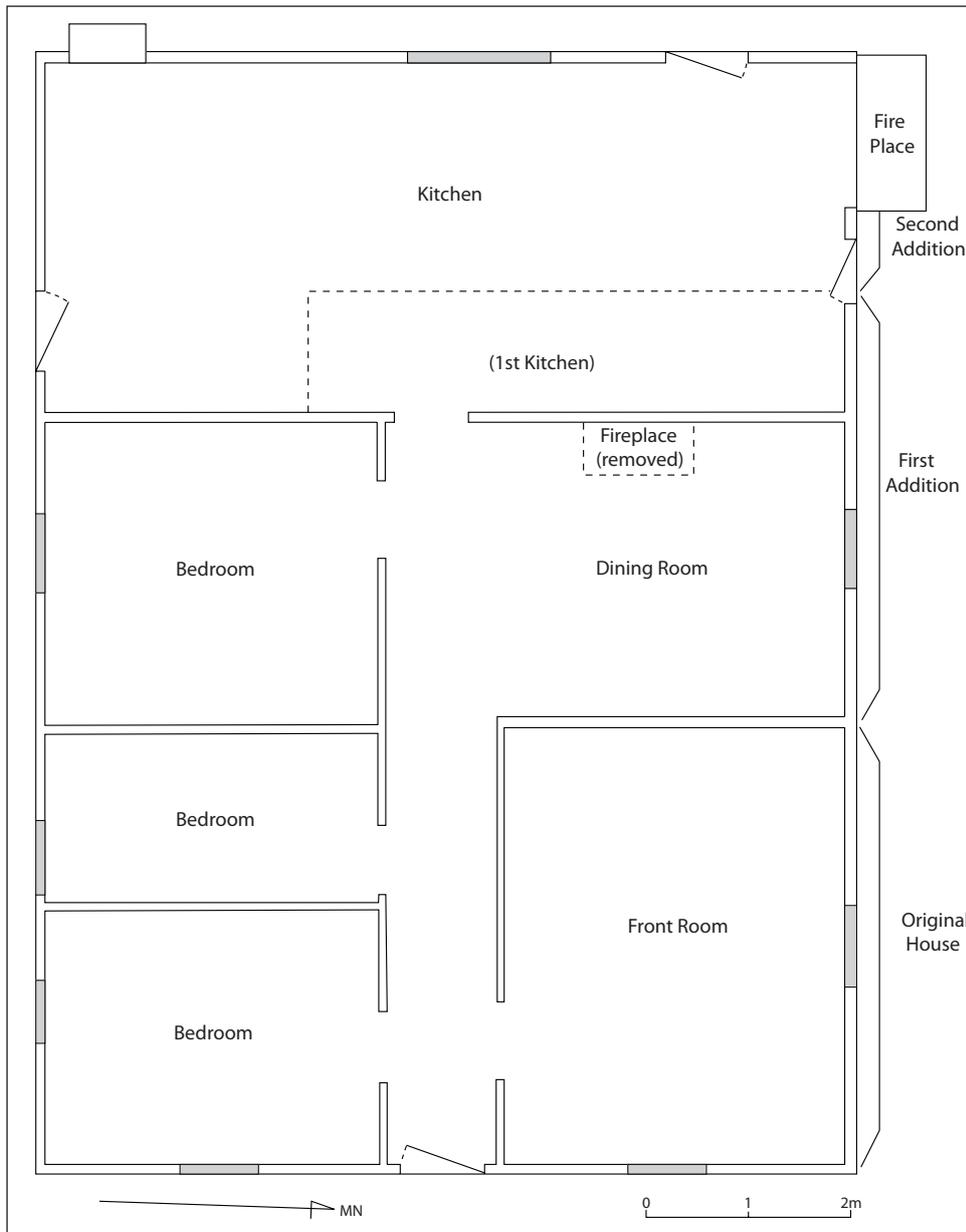
4. Plan of Martin's House showing possible stages of construction (from Grouden 1992: 56, after Spring-Rice 1991).

Until just prior to the investigation the site had consisted of three main buildings: a house, a smaller cottage and a hut referred to as the “dairy.” A garage was also located towards the road, but is not likely to have had any historical significance. These buildings had recently been removed at the time of excavation. There appears to be some confusion over which of the two main buildings was the original cottage built around 1832, with one scenario being that it had been on the site of the house and had become incorporated into this structure with additions added over the years, or that the smaller cottage by the dairy could have been the first dwelling. In any case the original construction of both the house and cottage probably date prior to 1850. A proposed sequence of construction for the house is outlined in Figure 4.

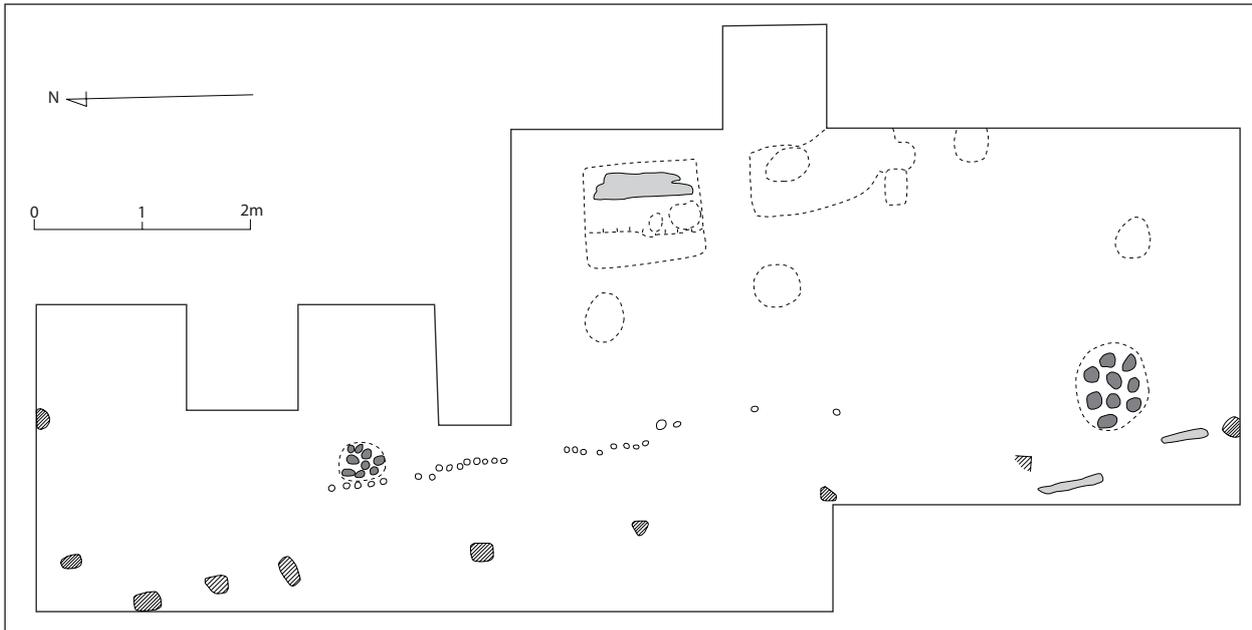
5. Plan of Area B (Martin's House) showing layout of house posts/piles and possible pre-European features (adapted from Grouden 1992: Figure 31).

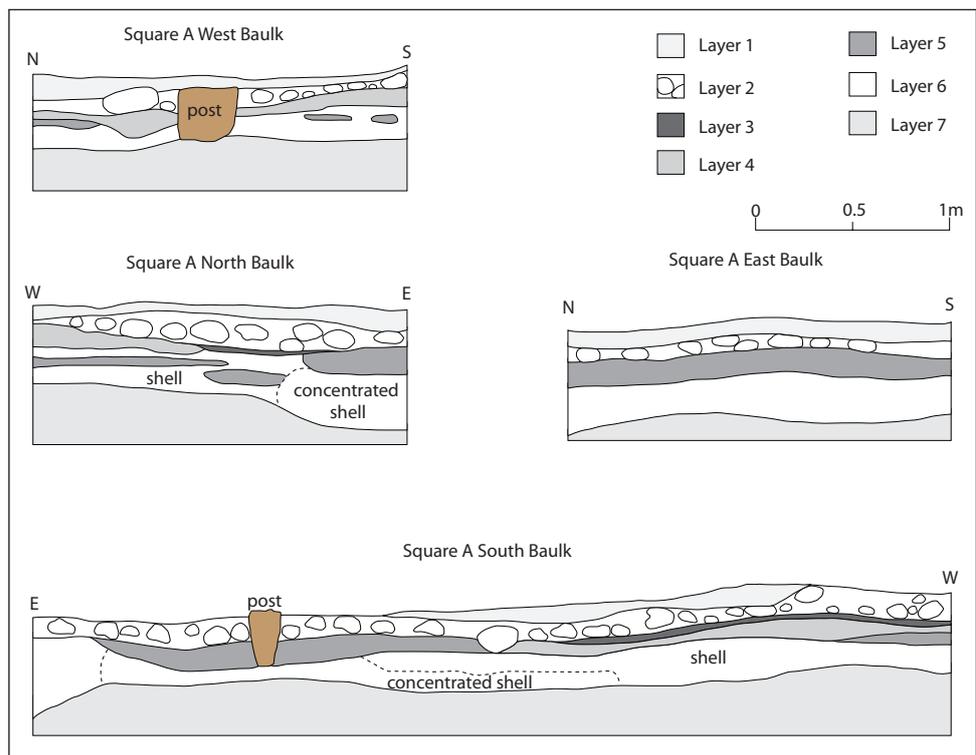
6. Square A profiles (from Grouden 1992: Figure 28).

Square A was a 2 x 2 m unit excavated under what had supposedly been one of the oldest parts of the house. This unit was excavated by stratigraphic layer with the identification of seven layers (Figure 6). Grouden (1992: Figure 29) provides a description of the various layers:

- 1) compacted sandy brown soil with shell, charcoal and ash inclusions
- 2) stoney layer
- 3) brown, silty, sandy soil with shell concentrated at base
- 4) orange, gravelly, sandy soil
- 5) clay

- 6) a) brown/black, sandy soil with charcoal and shell inclusions
- b) black, sandy soil with charcoal inclusions and concentrated shell
- 7) yellow/grey natural clay.

profile drawings of Square A (Figure 6) Smith interpreted that Layer 6 possibly predates house construction “because it is clearly below the base of the post in the south baulk and is cut through by that in the west baulk” (Smith 1995). Most of the faunal and other material was concentrated in Layer 6 with 63% (by weight) of glass and clay pipe fragments, 68% (by number) of ceramics, buttons and stone artefacts, and 84% (by weight) of bone coming from this layer (Grouden 1992: Figure 30). The faunal remains from Layer 6 were dominated by pig and cattle, along with some fish, sheep, dog and chicken bones (Smith 1995). This sample from

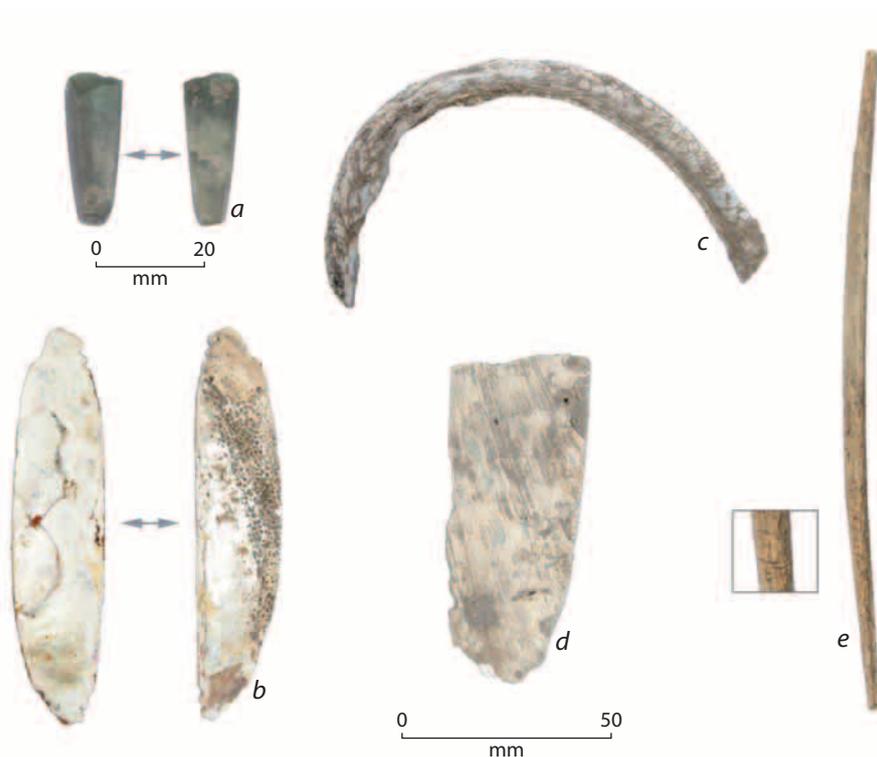
7. Maori artefacts:
a, greenstone chisel;
b, paua shell lure; c,
section of paua shell
rim from which a blank
has been cut from; d,
a broken or unfinished
paua shell lure; e, a
piece of modified bone
with cut marks.

line. That these artefacts were being manufactured on site is indicated by a section of paua shell rim from which a blank has been cut, found in unit D19. A small greenstone chisel, with maximum dimensions of 21 x 8 x 5 mm, was found in the top 2 cm of Feature 11. One other artefact showing Maori influence is a piece of modified bone from Square A, Layer 4.

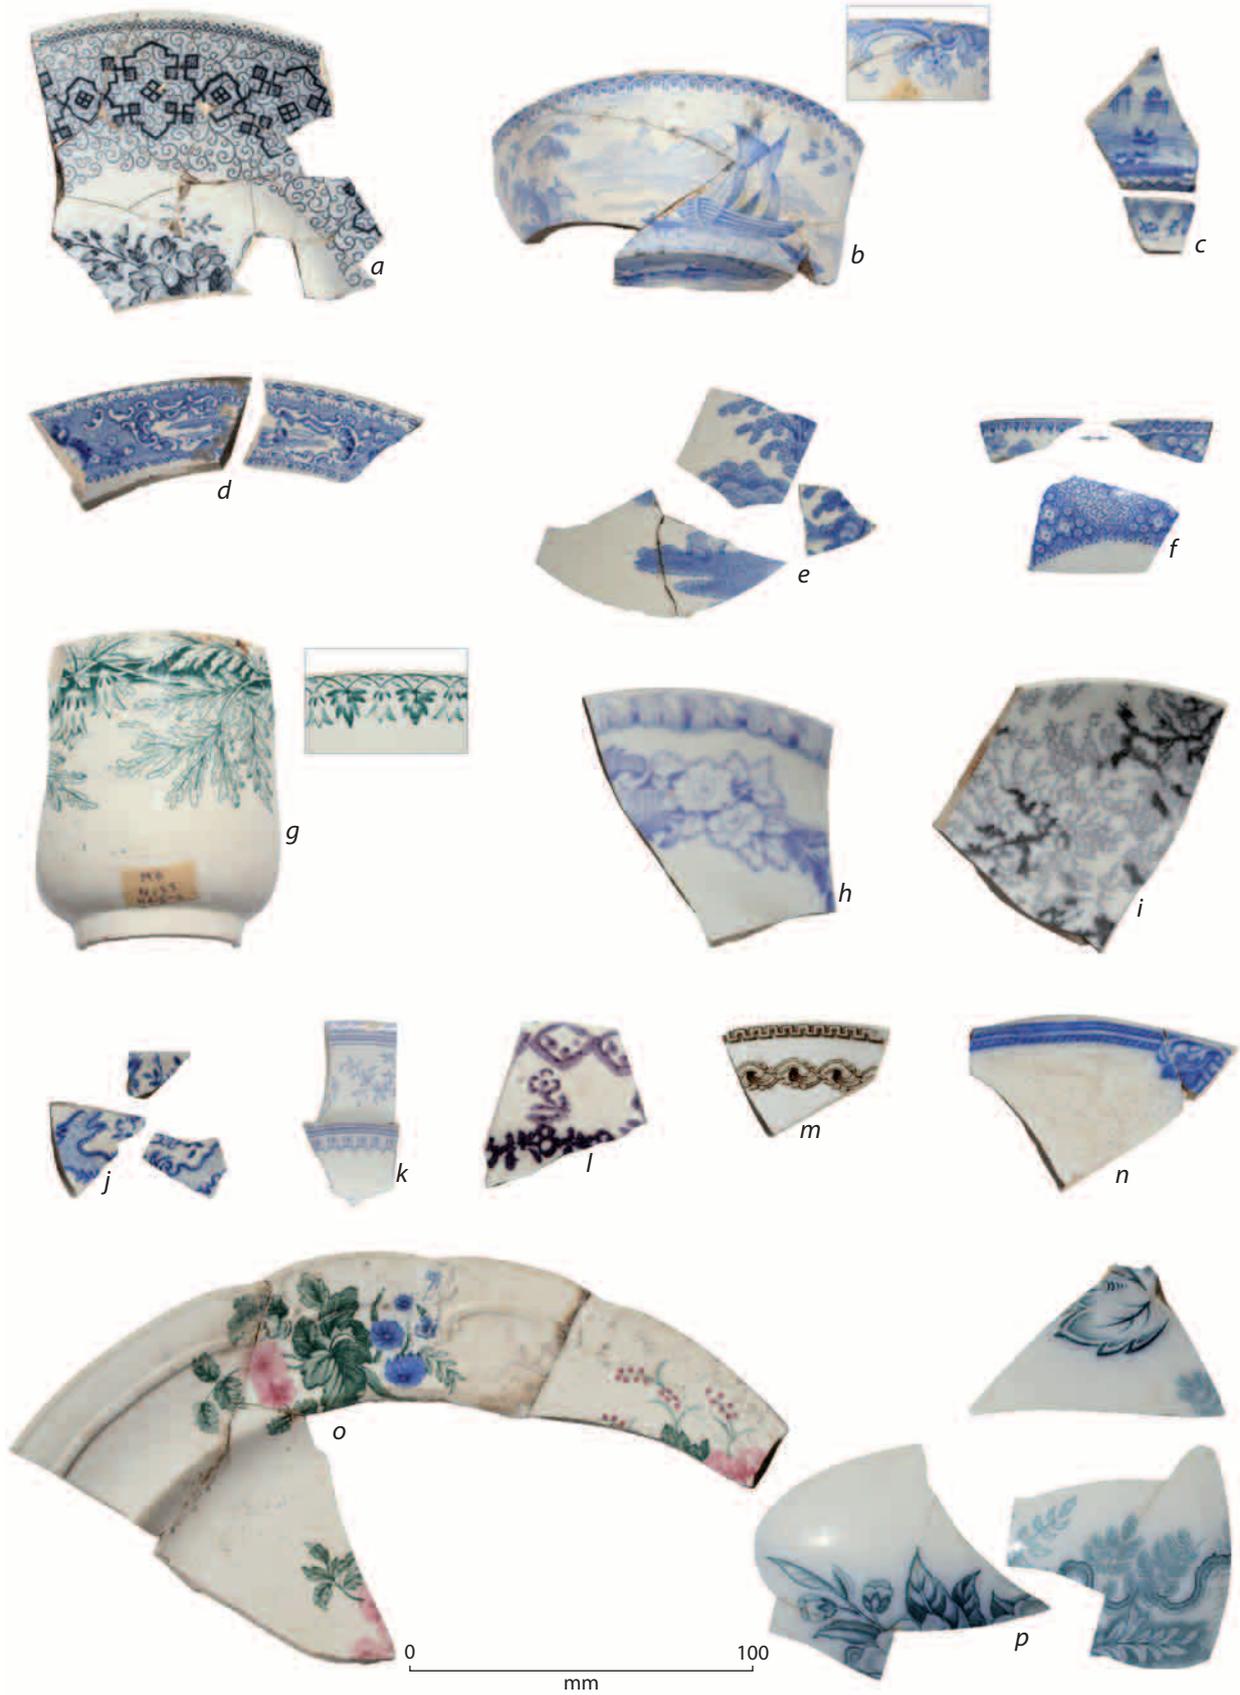
8 (opposite). Unidentified ceramic patterns: a, black transfer printed saucer, Square A; b, blue transfer printed cup, Martin's House; c, blue transfer printed plate, Square A; d, blue transfer printed chamberpot, Martin's House; e, blue transfer printed chamberpot, Martin's House; f, blue transfer printed cup/bowl (rim Martin's House, body Square A); g, green transfer printed cup, Martin's House; h, purple transfer printed saucer, Martin's House; i, black transfer printed saucer, Square A (pattern previously recorded from the Scott Farmstead, Mangere, as SH 001 and was marked by manufacturer Cooper and Lockett, dating to the 1860s: CFG Heritage, report in preparation); j, blue transfer printed saucer, Square A (pattern previously recorded from the Bamber House site, Wanganui, as UCOL 135: CFG Heritage report in preparation); k, purple transfer printed plate, Martin's House; l, under-glaze handpainted plate rim in purple, Martin's House; m, brown transfer printed saucer, Martin's House (pattern previously recorded from the Wellington Inner City Bypass project, site AS26, as WICB 117: CFG Heritage report in preparation); n, blue transfer printed plate, Square A; o, green transfer printed plate with under-glaze hand colouring and relief moulded rim, Martin's House or Cottage; p, green transfer printed mixing bowl or chamberpot, Martin's House.
