**ARI-HAM TOWERS B 0100 AND A 0051:  
ARCHAEOLOGICAL INVESTIGATION OF  
PART OF SITE T15/296  
(HNZPTA AUTHORITY 2016/910)**

**REPORT TO  
HERITAGE NEW ZEALAND POUHERE TAONGA  
AND  
TRANSPOWER NEW ZEALAND LTD**

Date: 18 August 2016

Reference: 15-0693

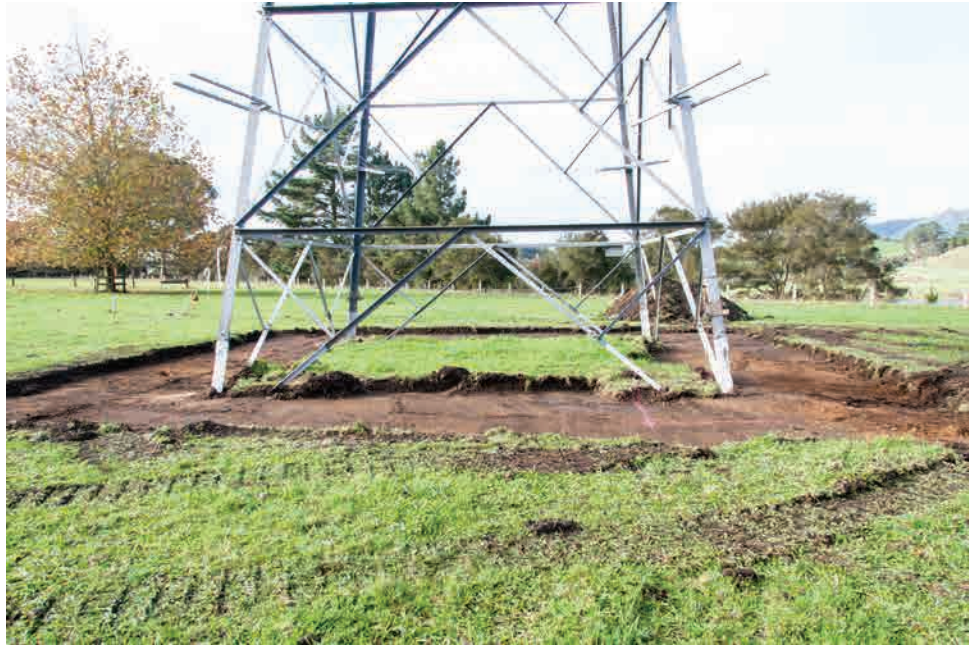
3. Tower A 0051 showing the format of excavation with a single trench surrounding the tower and footing cuts about to commence, facing south east.

Archaeological monitoring of the site undertaken by Danielle Trilford of CFG Heritage from 30 May–7 June 2016. Each tower had four footings which were originally installed in the mid to late 20th century. The maintenance works involved stripping of the soil with a 3 and 8 tonne digger under archaeological supervision. Around each footing the works would create a 3500 mm square by 1000–2100 mm deep hole for foundation and maintenance works before reinstating the holes. Additional to the holes, a 2000 mm wide and 300–400 mm deep trench between

each pole footing was excavated (Figure 3). Excavation of the hole was halted while investigation and recording of any archaeological features was carried out. Spatial information was recorded using a hand held GPS with an accuracy of  $\pm 5$  m. All spatial information was uploaded to the project GIS. Standard archaeological method for all excavation and recording was employed.

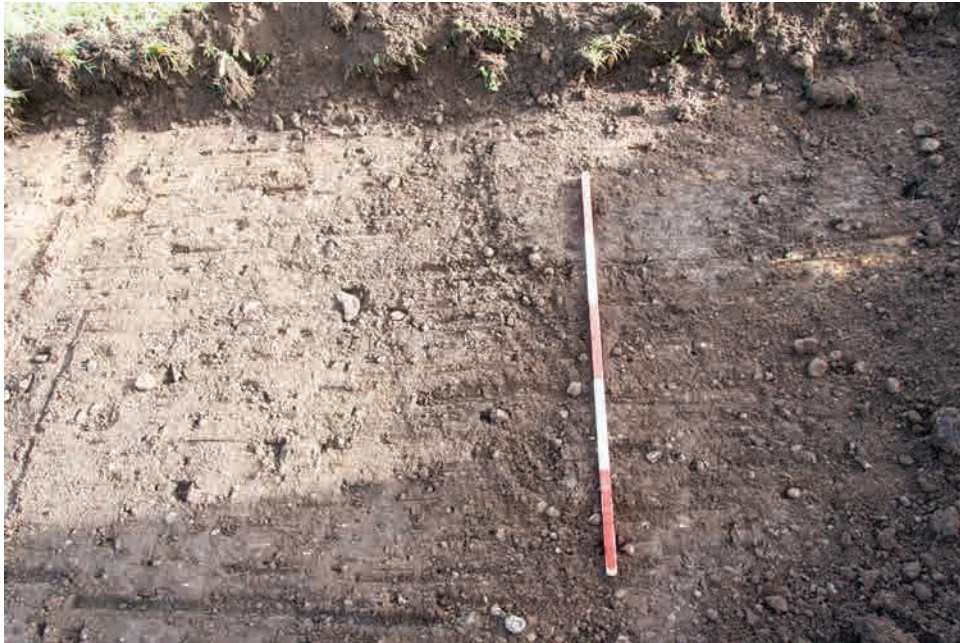
4. Tamahere soil in the form of a sheet mulch below the topsoil. Scale = 1 m.

The subsurface stratigraphy exposed by earthworks at both towers was the same: a shallow organic topsoil; the Tamahere soil in the form of a sheet mulch of alluvial sands and gravels (Figure 4); and in places a charcoal stain probably resulting from vegetation clearance prior to garden establishment. This sat on top of a moderately firm yellow-ochre natural loam.

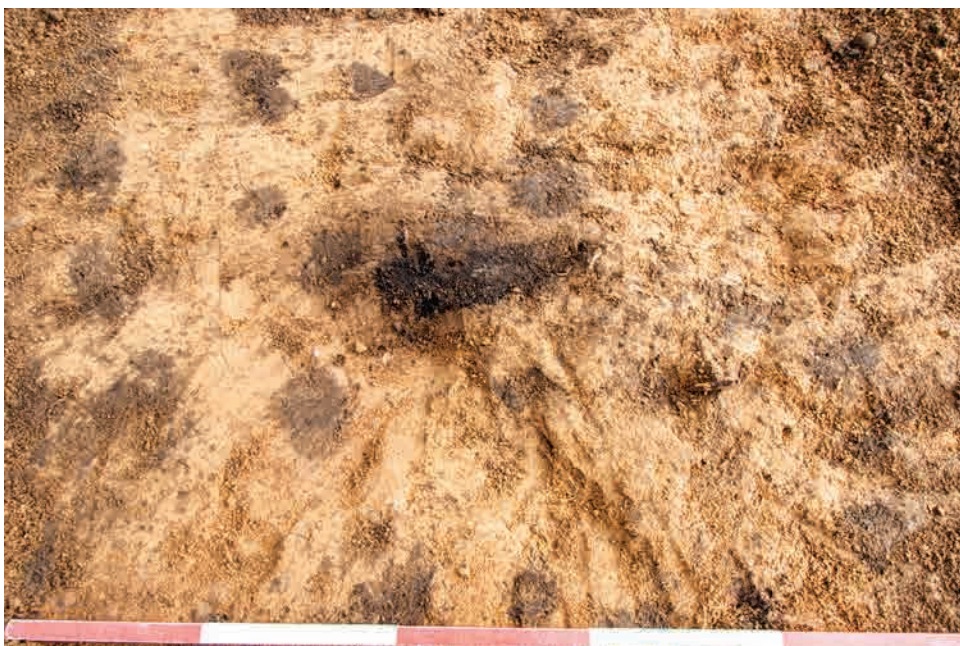
5. Planting hollows at Tower A 0051 holes, facing south towards the river. Scale = 1 m.

In the east part of the Tower A 0051 excavations brown loamy circular features between 80–120 mm in diameter cut into the yellow loamy base provided further evidence of gardening (Figure 5). These cuts are the bases of hollows dug by pre-European Maori gardeners who usually cut these holes into the modified ground and then filled them with coarse pumice and sand mixed with a brown loam. These planting hollows have been interpreted as the bases of mounds (puke) (Gumbley et al 2003) but, while this seems reasonable, actual mounds have not been found during archaeological excavation and not all planting hollows may have had mounds over them. The hollows found ran in a series of tidy rows perpendicular to the river. The clear arrangement and absence of clustering, intercutting or irregularly placement, provide preliminary evidence that could suggest these were used for a single season. Only a very small portion of the site has been exposed and the hollows were only found in part of that, so this interpretation cannot be confirmed without further investigation.
