# **Central Interceptor settlement monitoring point (SMP) installation: final report (HNZPTA authority 2021/692)**

**report to  
Heritage New Zealand Pouhere Taonga  
and  
Ghella Abergeldie JV**

Date: 28 August 2021

Reference: 21-1224

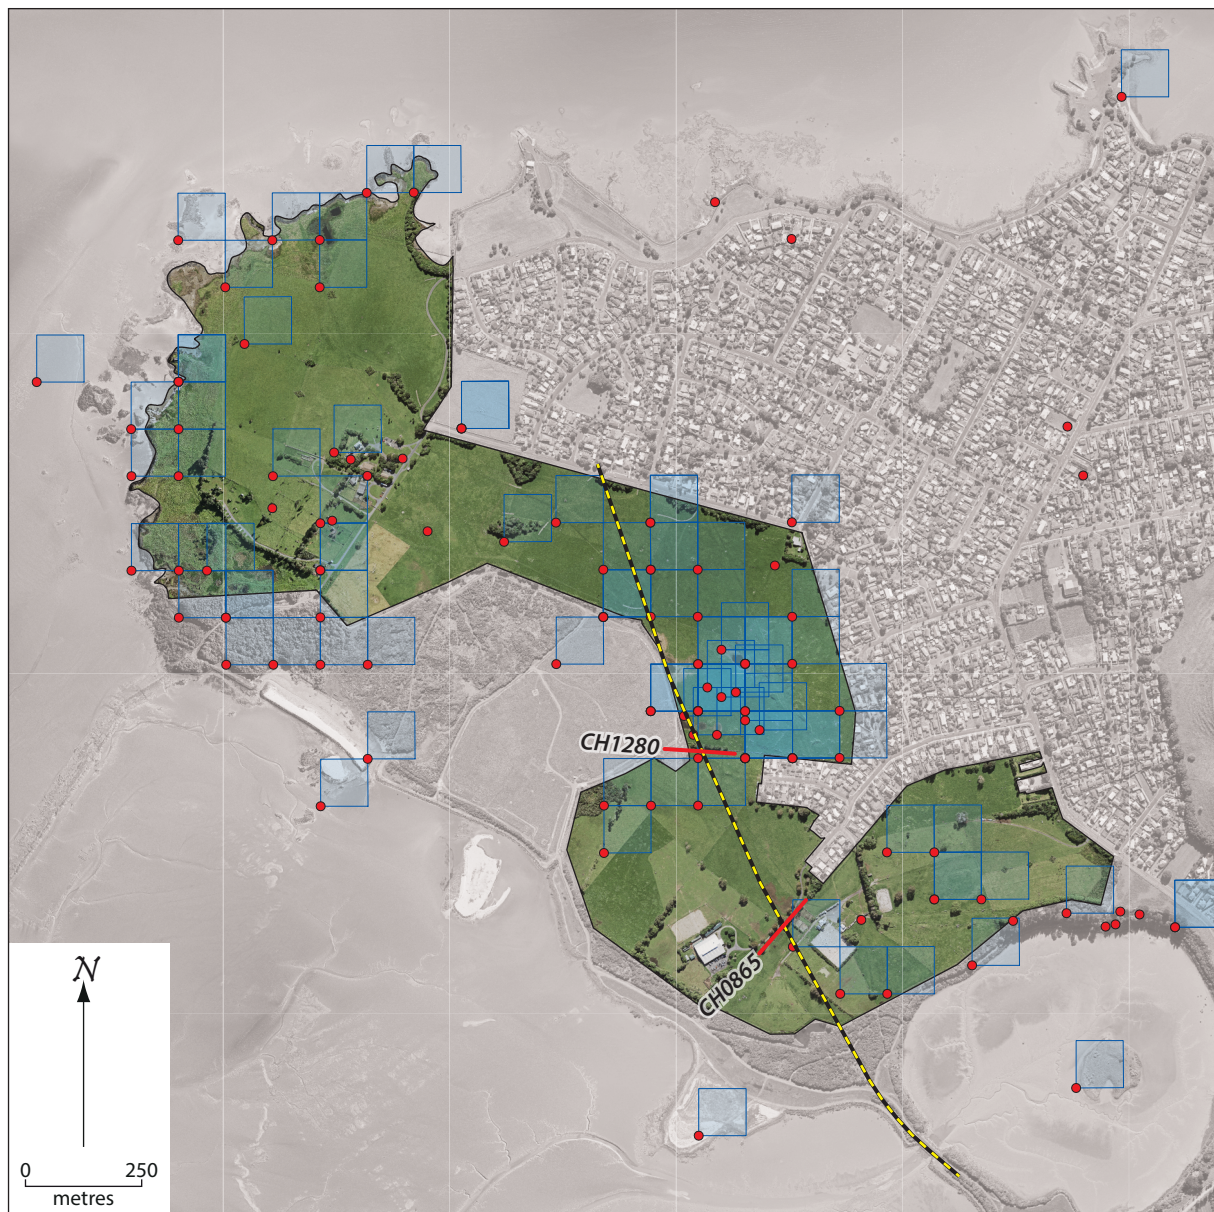
Figure 2. Overview of the Central Interceptor route and SMP array locations in Ambury Regional Park, showing recorded archaeological sites.

Works took place on 14 July 2021 and were monitored by Hayley Glover of CFG Heritage Ltd. Works consisted of markers being installed in a row on the tunnel centreline, then at 2, 5, 10, 25, 50, and 75 m on each side. This was done in two locations (Figure 2), but one of the 75 m markers could not be dug, making the total number of markers installed 25. The locations were assessed by Matthew Campbell of CFG Heritage and chosen with the goal of avoiding any archaeological features (Campbell 2021).

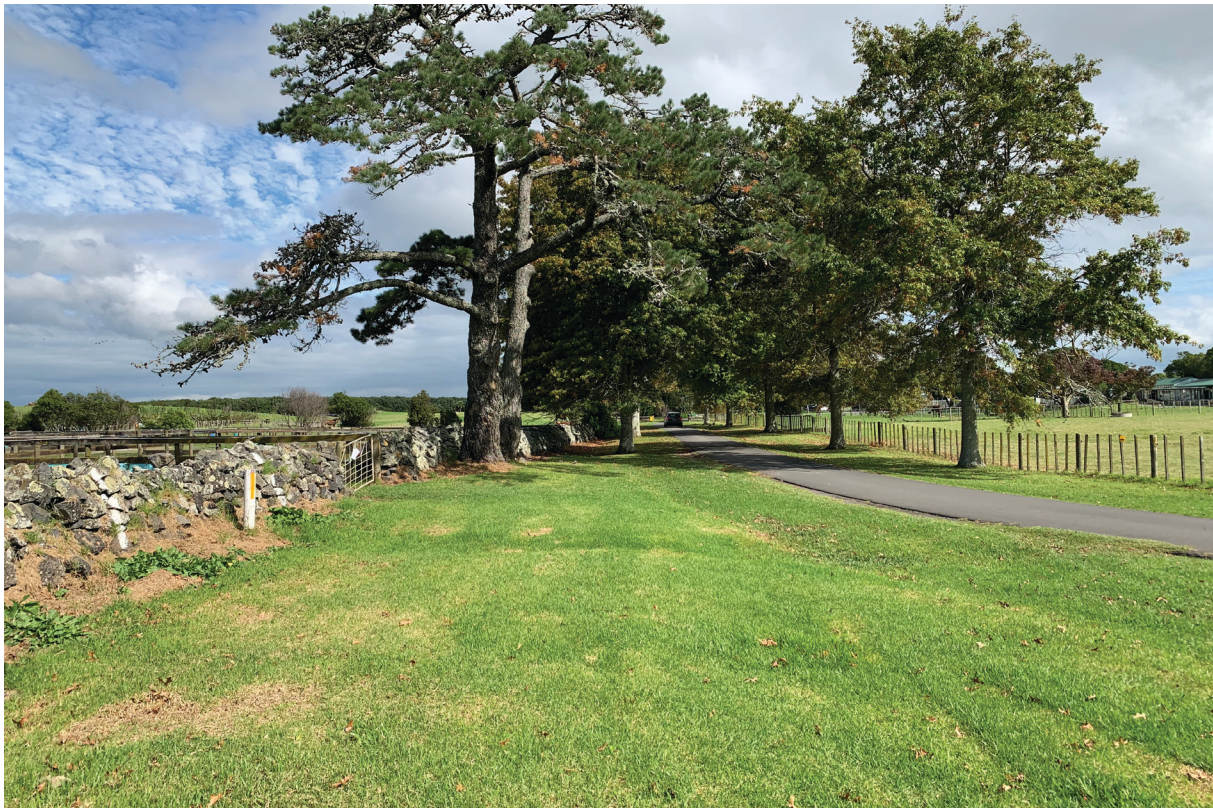
The array location chosen at CH0865 was 5 m north of the stone wall alongside the driveway to the Ambury Park Centre, running parallel to the wall (Figure 3). Probing did not detect any shell along this alignment and the area had been modified by the stone wall and driveway (the wall is not currently recorded as an archaeological site in the SRS).

Figure 3. The tunnel array at CH0865 looking west.

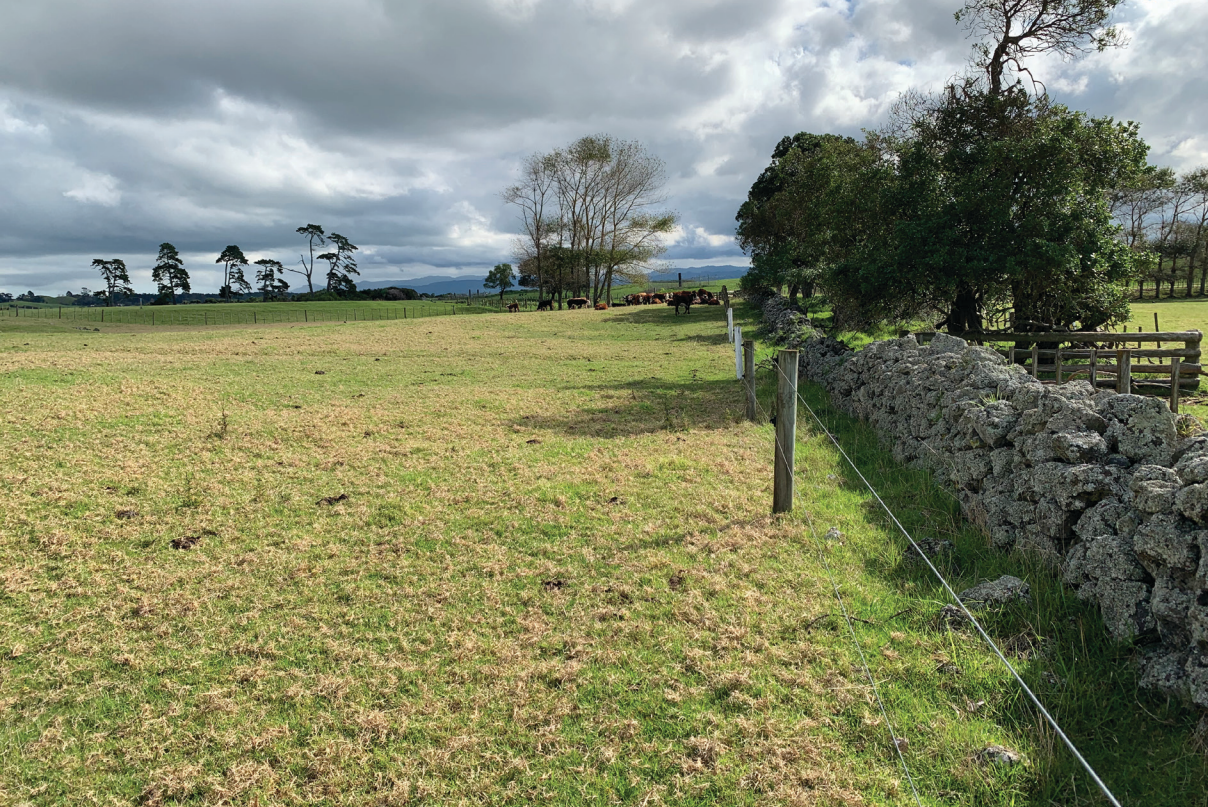
The array location at CH1280 was south of the stone wall to the north of the end of Kiekie Road, 5 m south of the wall at the eastern end of the array and 10 m south of the wall

Figure 4. The tunnel array at CH1280 looking west.

at its western end (Figure 4), continuing 60 m to the west (the wall is not currently recorded as an archaeological site in the SRS). Probing during assessment did not detect any shell along this alignment.

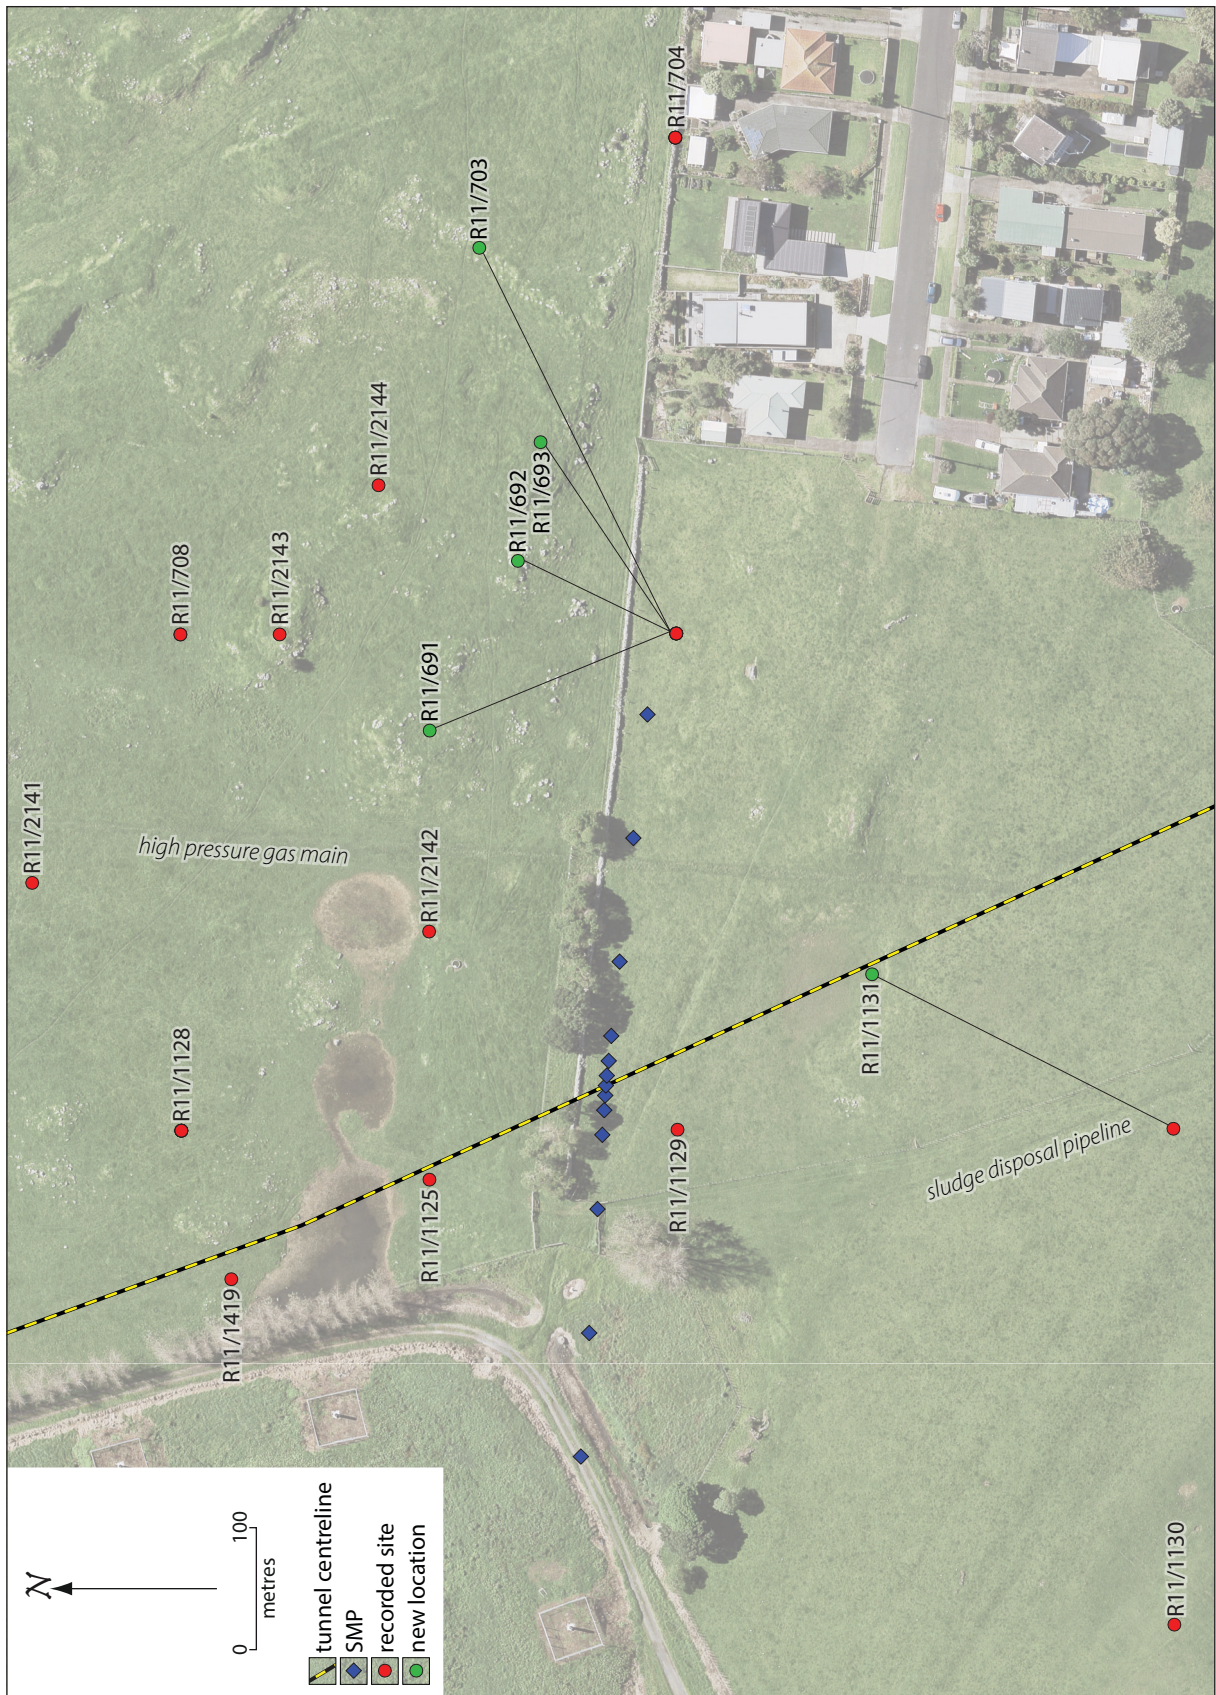
Figure 6. The tunnel array at CH1280 showing the stone wall and sites recorded nearby.

All earthworks associated with the SMP installation were subject to archaeological monitoring. The locations of the markers are shown in Figure 6 and Figure 7.

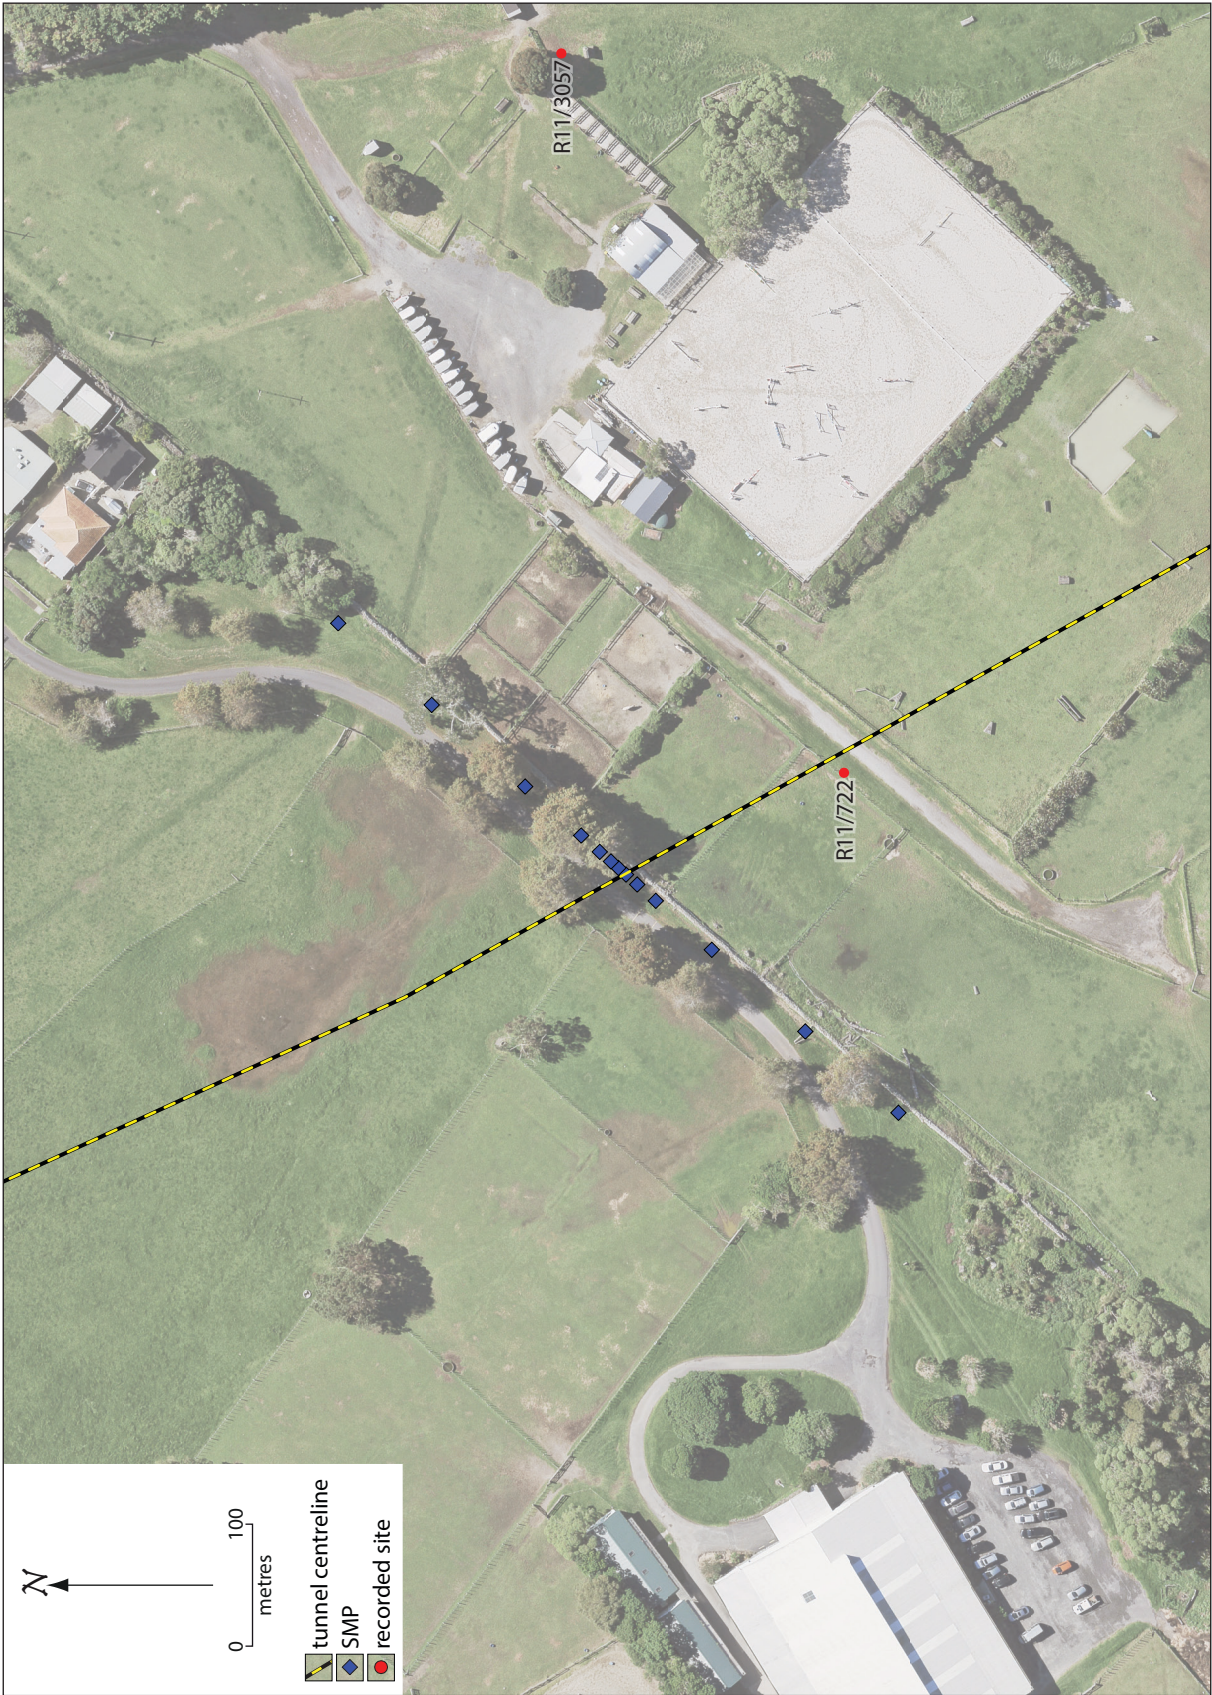
Figure 7. The tunnel array at CH0865 showing the stone wall and sites recorded nearby.

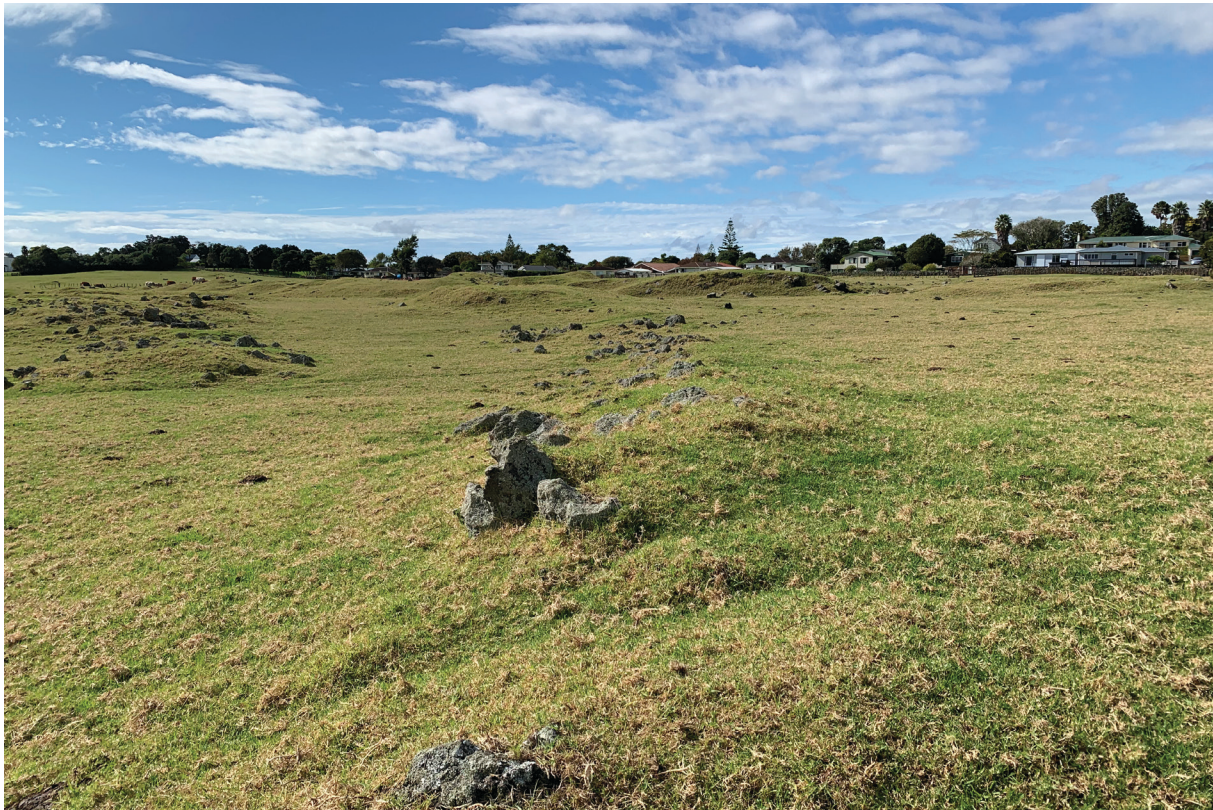
*Figure 8. R11/703, stone row, looking north.*

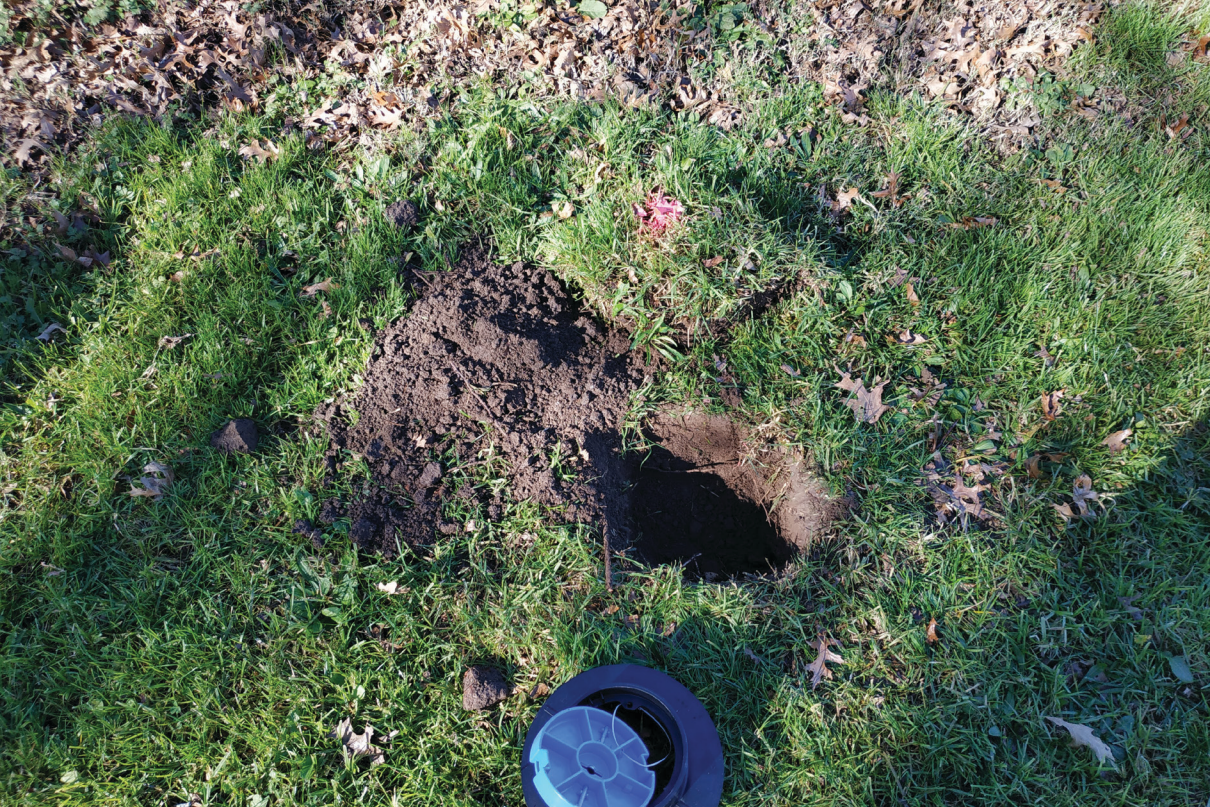
Figure 9. Typical pit dug for installation.

No archaeological features or material were identified during the limited earthworks for the SMP installation (Figure 9 and Figure 10). The two western-most pits at CH1280 had scatters of whole, un-opened tuangi. These shells were not of archaeological origin and were intermixed with modern rubbish like plastic bread tags and medical tape (Figure 11).

To install the markers, a spade width square was dug to no deeper than 300 mm. A short rod was hammered into the exposed ground surface and a section of hard plastic tubing was pressed into the soil to protect the rod. The hole was then filled with soil again and covered with a toby set level with the ground.

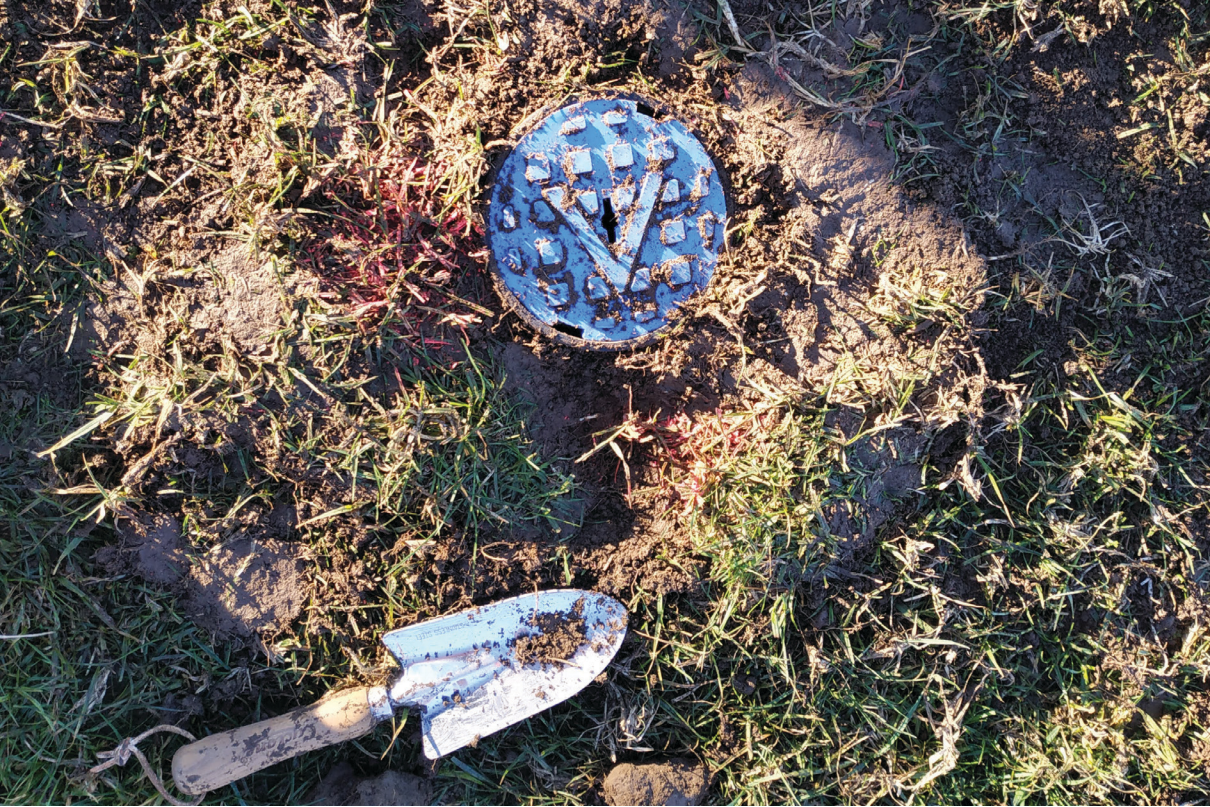
Figure 10. Toby after SMP installed.

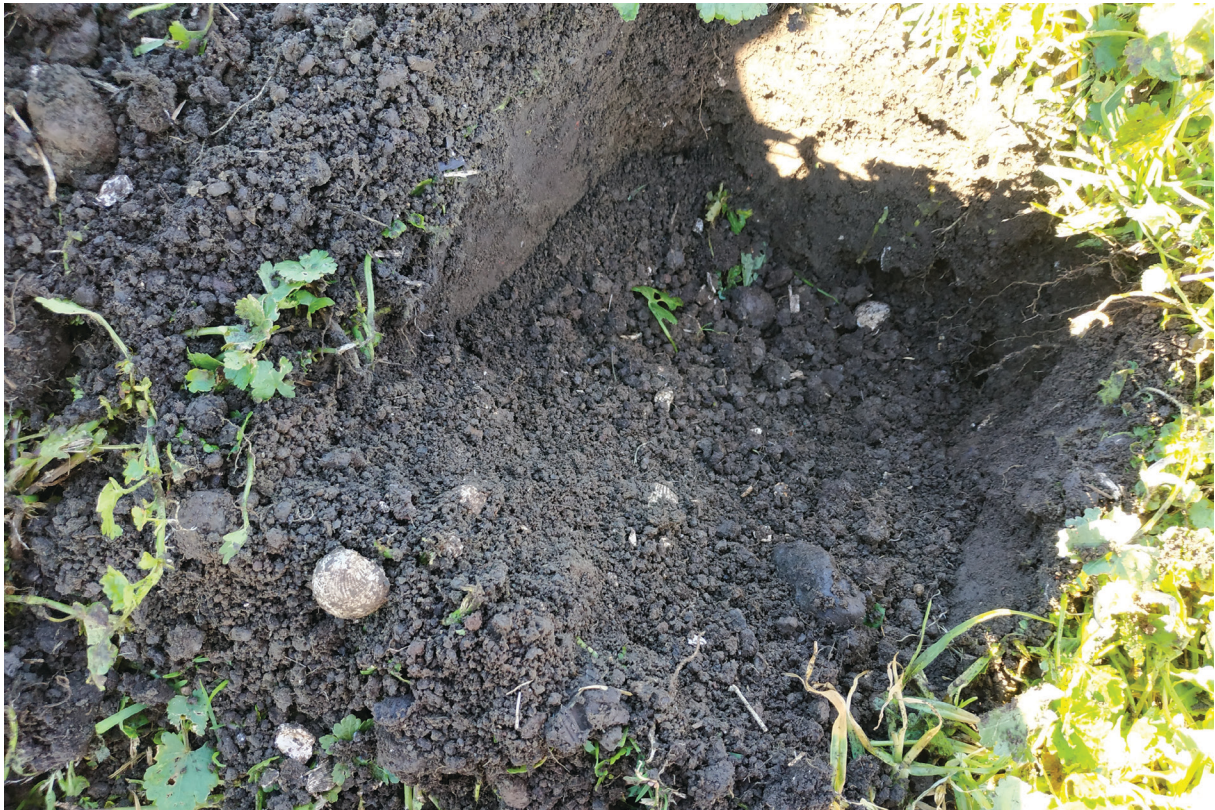
*Figure 11. Shell and plastic fill in western-most pits of CH1280.*
