Kihikihi UFB2 build (HNZPTA authority 2019/446): final report

report to
Heritage New Zealand Pouhere Taonga
and
Ultrafast Fibre

Date: 3 September 2020

Reference: 18-0858

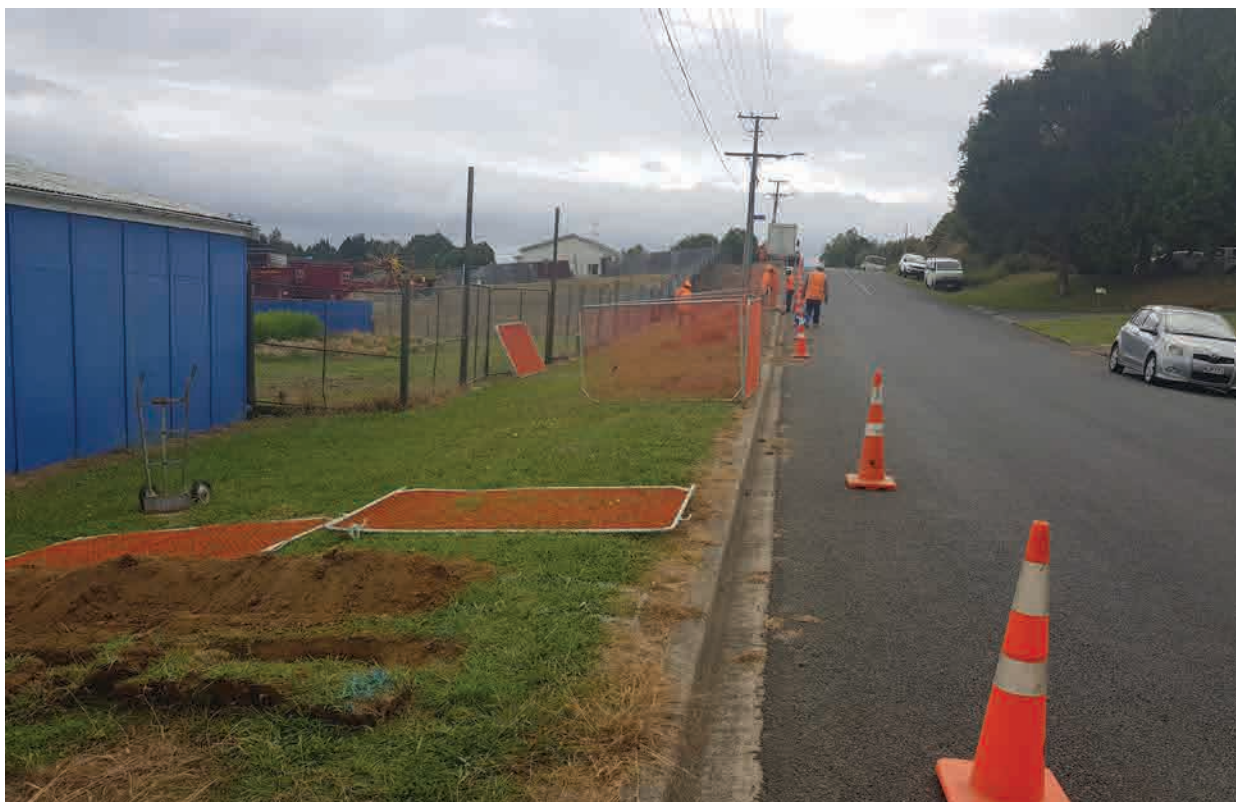
Figure 3. Leslie Street showing lateral potholes to expose existing services prior to a drill shot.

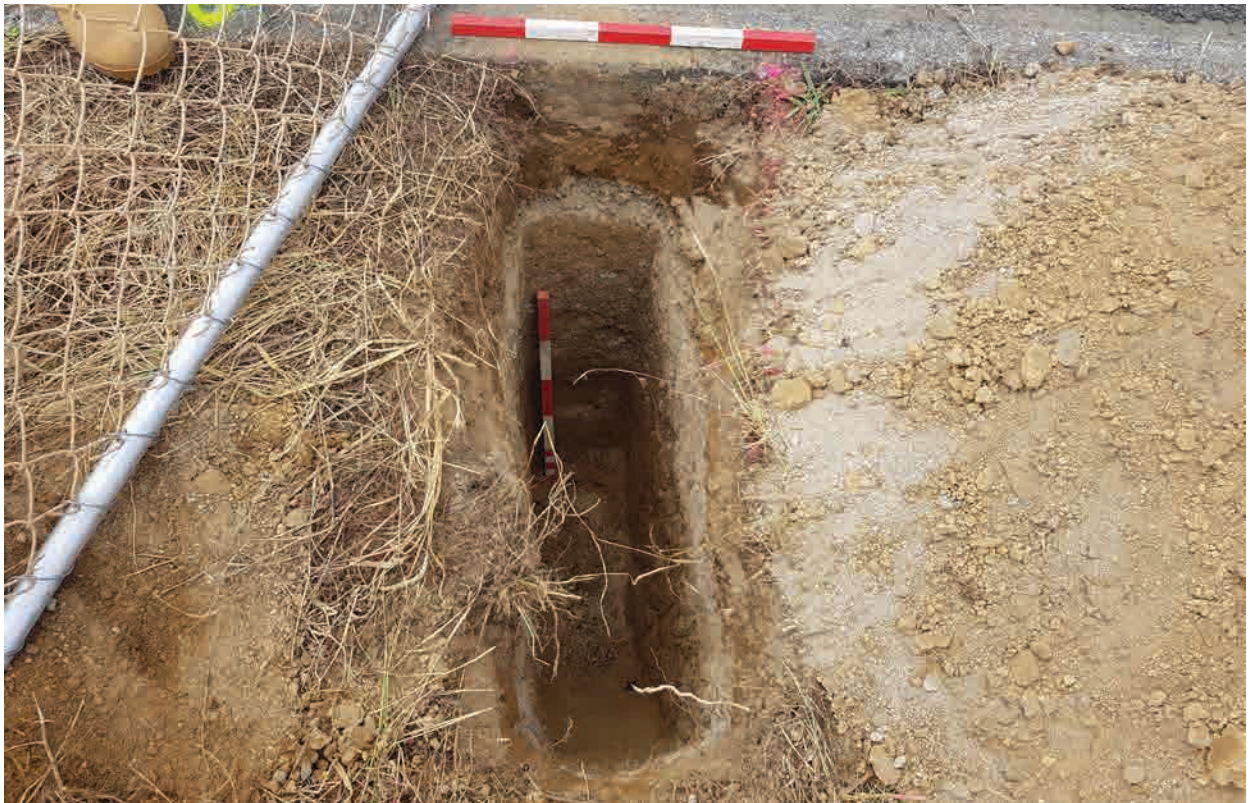
Figure 4. Pothole on Leslie Street showing metal road beneath current street surface. Photo scale = 0.5 m.

The extents along Leslie Street, Havelock Street and Lyon Street around the redoubt were monitored by Arden Cruickshank of CFG Heritage Ltd from 11–13 March 2019. It was noted that within the road cuttings of Lyon and Leslie street the ground surface had been cut down considerably and the visible profile consisted of a sterile allophanic tephric soil, with a built up metaled road surface overlain with a redeposited mix of topsoil and loam. It is likely that this mixed layer on top of the metaled road surface was deposited when the road was sealed in the 1960s.

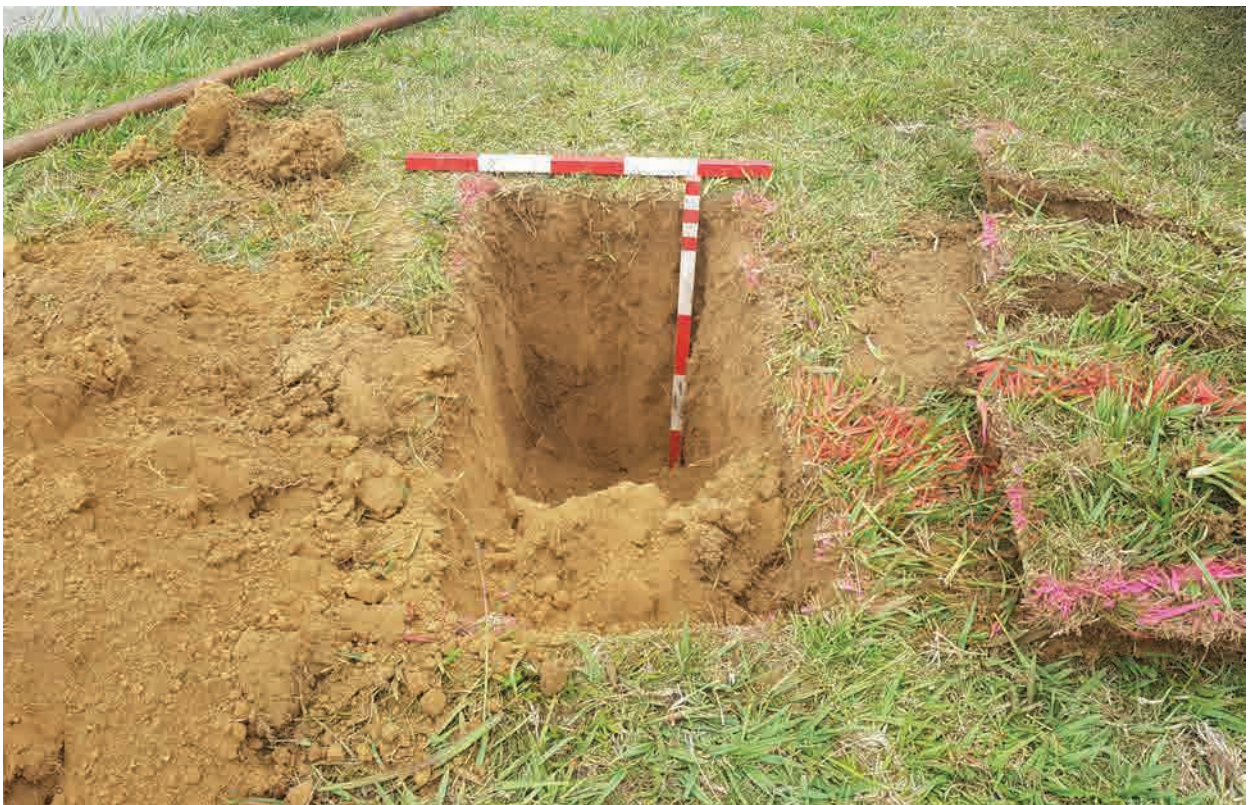
Figure 5. Pothole on top of S15/235 showing thin topsoil onto loam. Photo scales = 0.5 m.

The section of Havelock Street which cuts over the top of Rata-tu hill has also been cut down but does not appear to have had as much modification to the surface as the surrounding streets. This portion of works showed a 20 mm topsoil straight onto the sterile allophanic tephra.

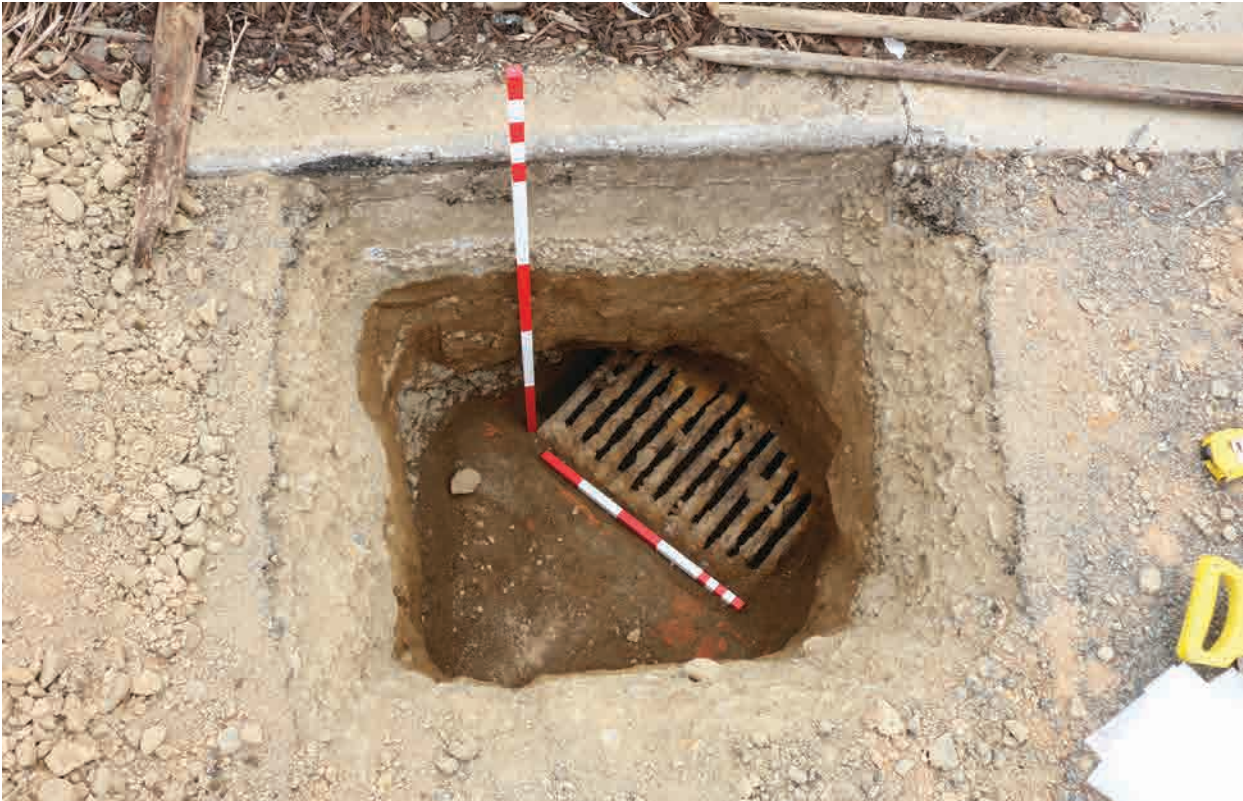
Figure 6. Decommissioned drain outside the Alpha Hotel. Photo scales = 0.5 and 1 m.

Works in the vicinity of the Alpha Hotel were monitored between 27–29 March 2019. A decommissioned drain was encountered in the road reserve along Lyon Road, 700 mm beneath the surface.

The drain consisted of a 540 x 350 mm iron grate consisting of twelve 19 mm square bars bolted to a surrounding frame built into a brick-lined sump. This drain was orientated due north, and not in alignment with the current road (Figure 6). Due to the corroded nature of the grate and the bricks being concreted in, no samples or makers marks were able to be identified, so no indicative date is able to be obtained for the construction of the drain. It is likely that the drain pre-dates the road realignment in the 1930s, where the informal road through the redoubt reserve was formalised, and the reverse curve by the Alpha Hotel was removed (Figure 7).

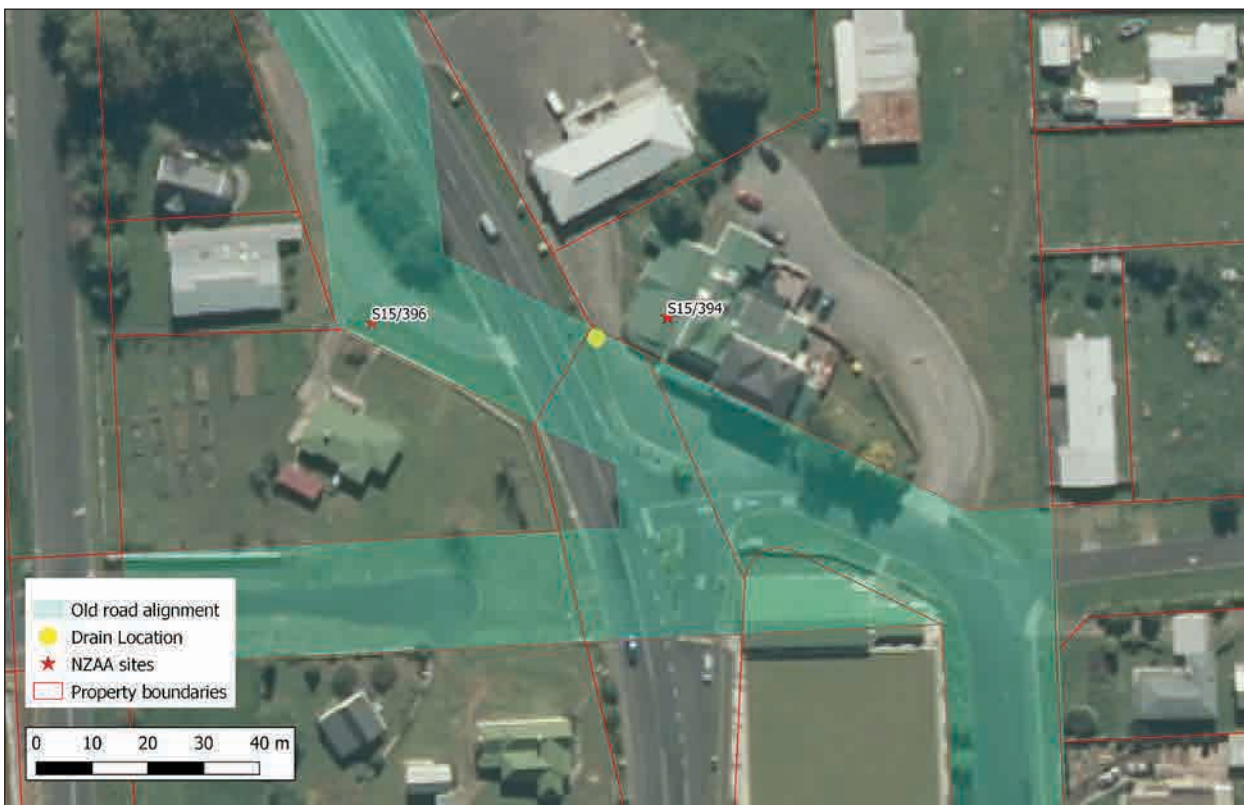
Figure 7. Previous route of the road prior to 1930s realignment.

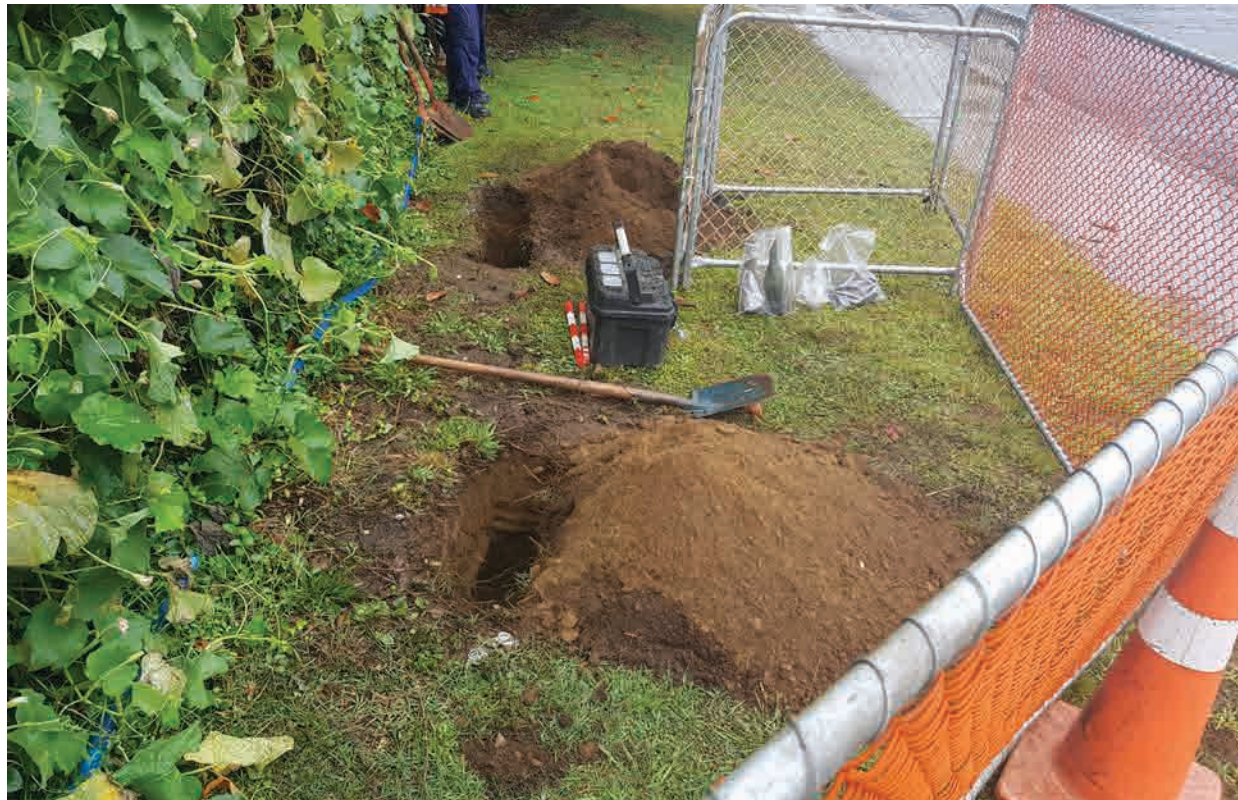
Figure 8. View east of two potholes where Feature 1 was exposed.

A rubbish pit was encountered in two potholes on the corner of Lyon and Leslie Streets on 8 March 2019. It was encountered 150 mm beneath the ground surface below topsoil and consisted of a mix of steel, glass and ceramic artefacts, within a clean fill matrix. The insertion holes were not extended to capture the full extent of the rubbish pit but probing indicated that it measures approximately 3 x 2 m, with a depth of 700 mm. This rubbish pit was subsequently recorded as site S15/782 in the SRS, and the artefacts retained from this rubbish pit are discussed below in the analysis section.

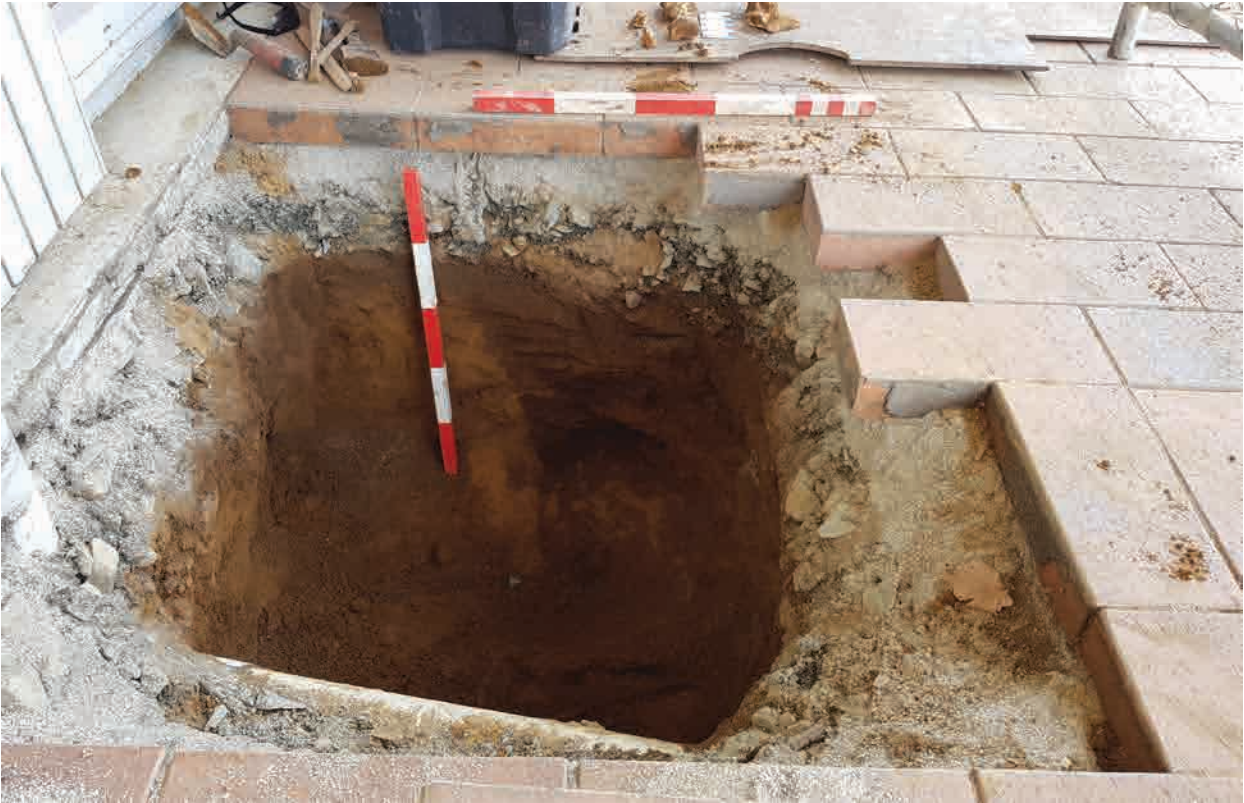
Figure 9. Feature 3 where bone was exposed, with cut of swale to the right of scale. Photo scales = 0.5 m.

Feature 3 represented six cattle bone fragments outside 42 Lyon Street. They were not articulated and appeared to be within an infilled swale. The bones were identified as not being human and were excavated. This portion of the street has been heavily built up and is covered with cobblestones, so it is not possible to identify if any bone or associated artefacts are in the vicinity. Due to the nature of this deposit, it is not possible to determine any estimates on the timing of deposition. This feature has not been recorded in the SRS.

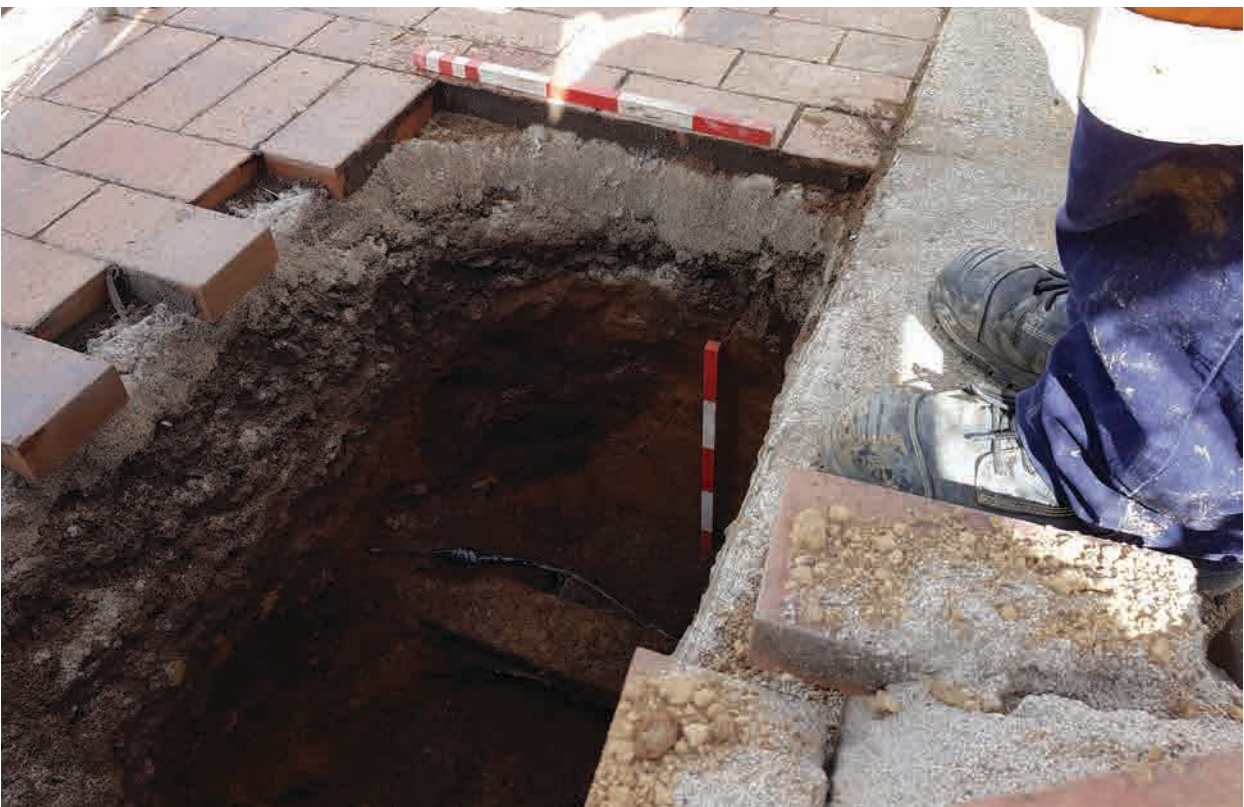
Figure 10. View south of corner of Feature 4 where it was exposed in the pit. Photo scales = 0.5 m.

Feature 4 represented a rubbish pit, located outside 34 Lyon Street, near the Town Hall. The pit was only partially excavated and had an indicative depth of 400 mm, with the other dimensions not able to be identified. The pit was capped with a 100 mm of clean loam, followed by 200 mm layer of basecourse and sand underneath the cobblestone street. The pit contained a dark clean fill with sparse stoneware and glass artefacts. It was subsequently recorded as site S15/783 in the SRS and the artefacts exposed in the pit were retained for further analysis which is described below.

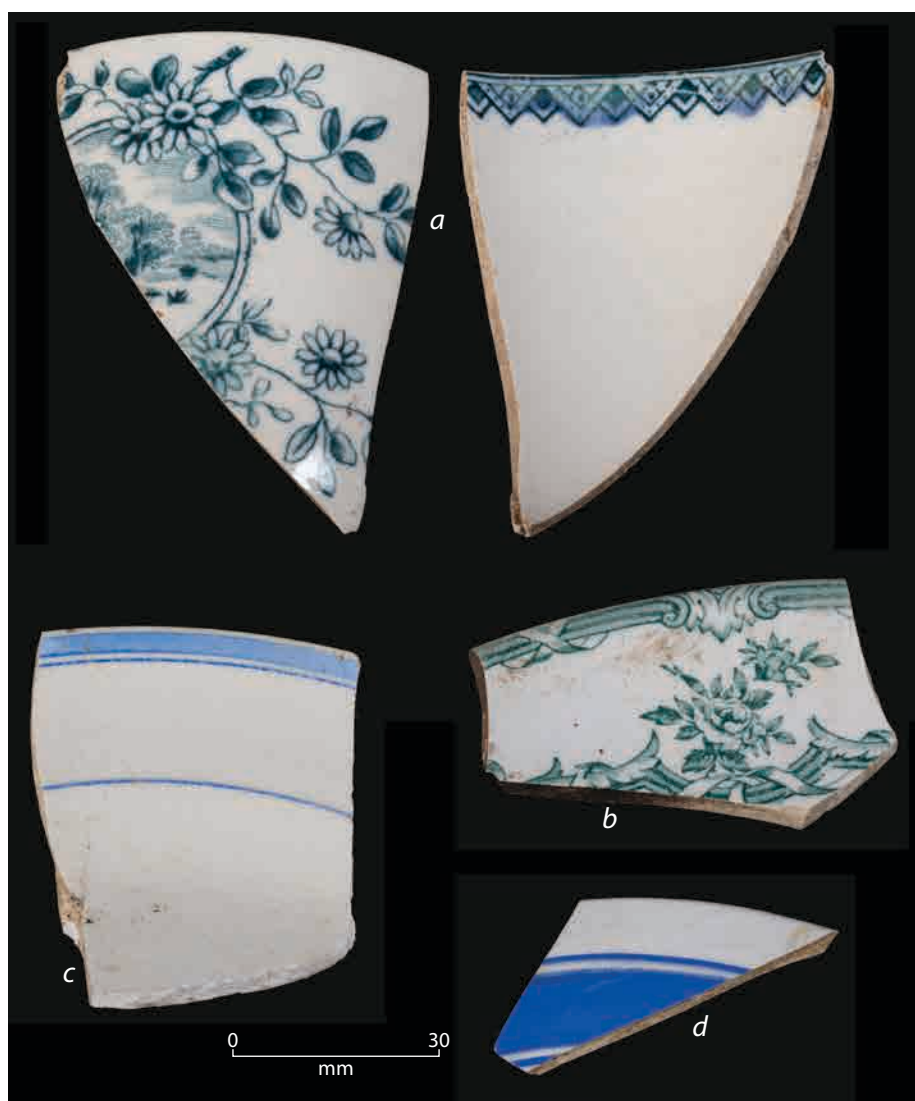
Figure 11. Ceramic artefacts from S15/782: a, b green transferware teacup and saucer; c, blue edgeband plate; d, blue edgeband bowl.

There were 16 artefacts recovered from this feature. Six of these were ceramics, consisting of fragments of a small plate (Figure 10c), a teacup (Figure 10a), a saucer (Figure 10b), a small bowl (Figure 10d) and an ink bottle. The teacup and saucer featured unidentified green transfer patterns, with the plate and small bowl featuring blue edge banding. These patterns are consistent with late 19th century tableware.

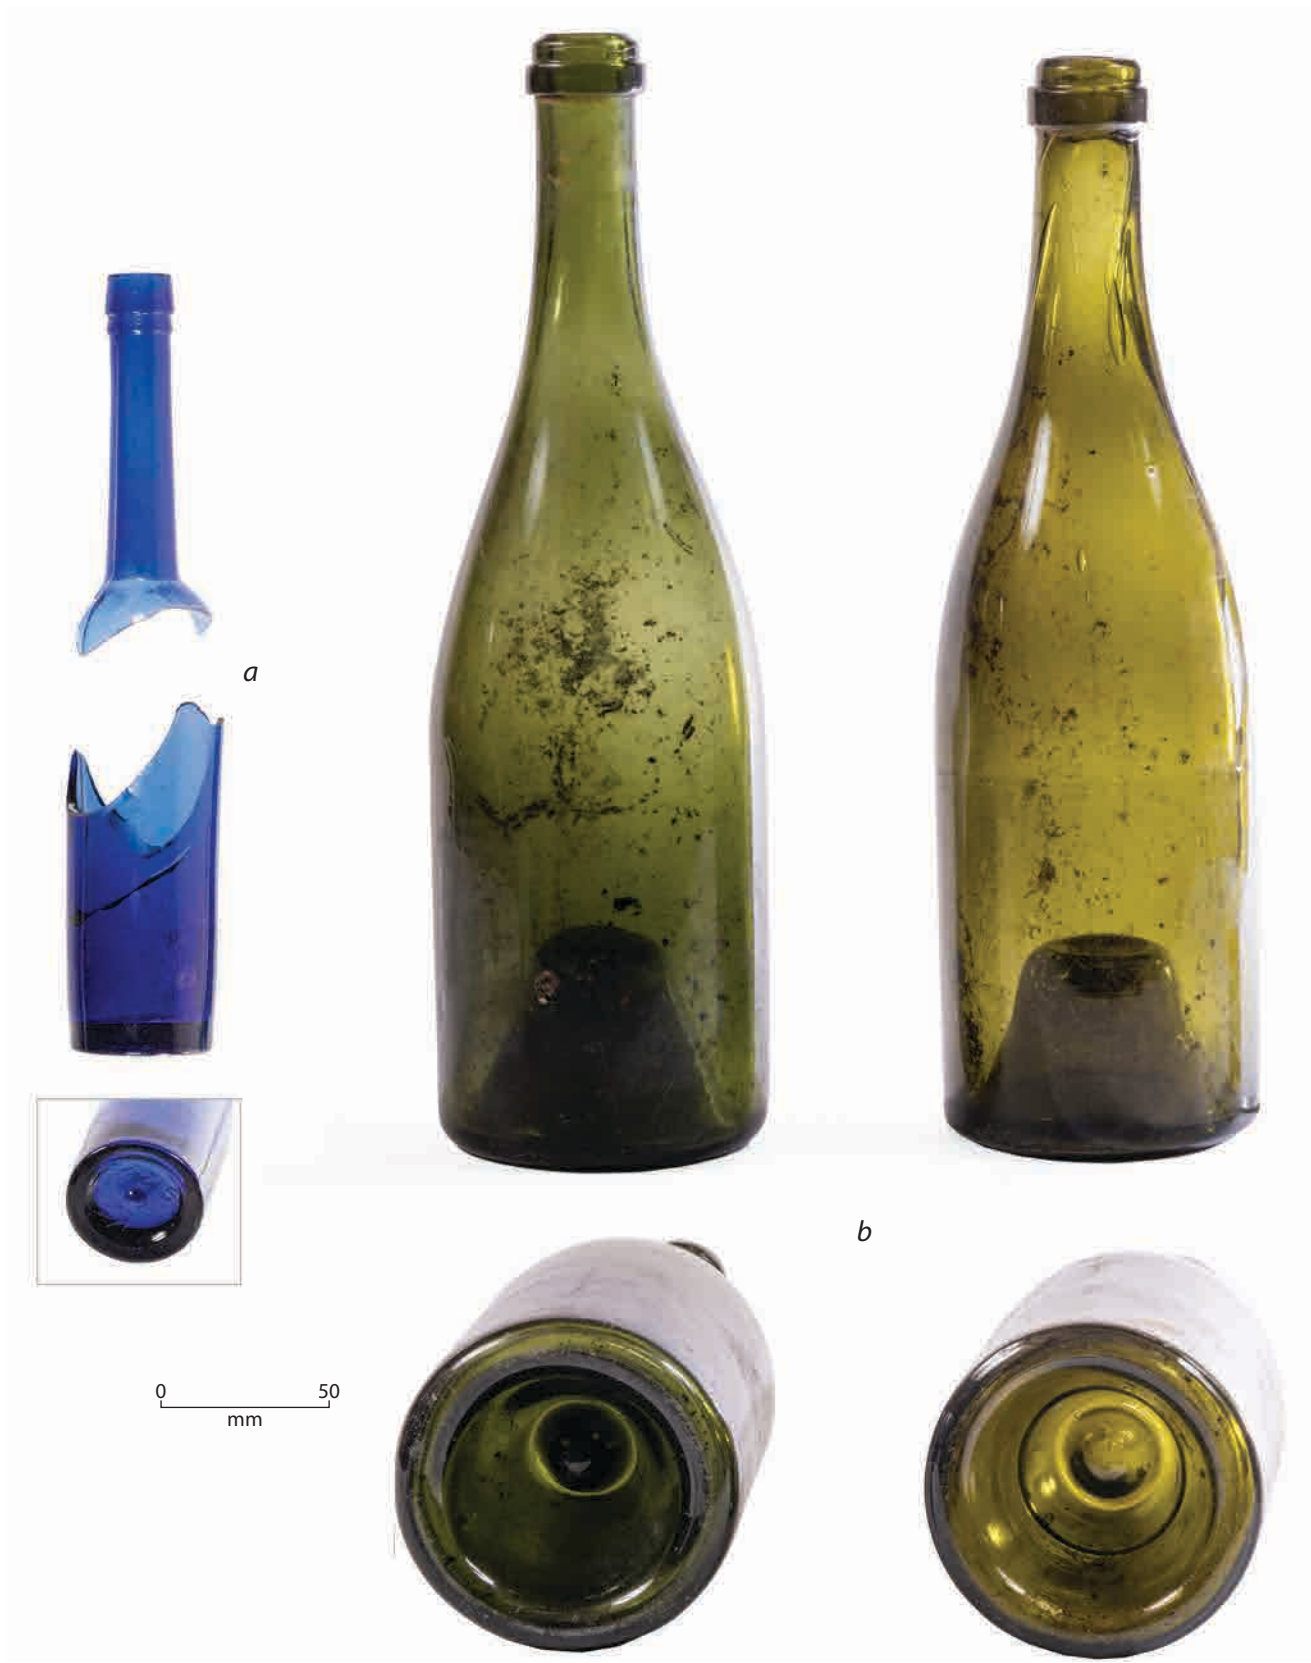
Figure 12. Glass artefacts from S15/782: a, cobalt blue bottle; b, champagne style bottles.

There were six glass artefacts obtained from this feature. This consisted of two cobalt blue bottles (Figure 11a), two champagne bottles (Figure 11b), a vase or bowl fragment (Figure 13a) and a sauce bottle (Figure 13b). The two champagne style bottles were dip moulded with handblown shoulders and necks and hand applied finishes. The two tall long-necked cobalt blue bottles are very similar despite some differences in the finishes and colour of the glass. One of them is basemarked K / 2 / 5127. There are two American manufacturers who used just the letter K followed by numbers, the Kearns Glass Companies and the Knox Glass Bottle Co. The Kearns bottles marked with a K are dated 1860 to 1890 (Lockhart et al 2017). Knox is probably the more likely manufacturer given they are well known for their pharmaceutical bottles with K + number base marks and K / 2 was a common one. They date from 1917 to the 1920s (Lockhart et al. 2017).

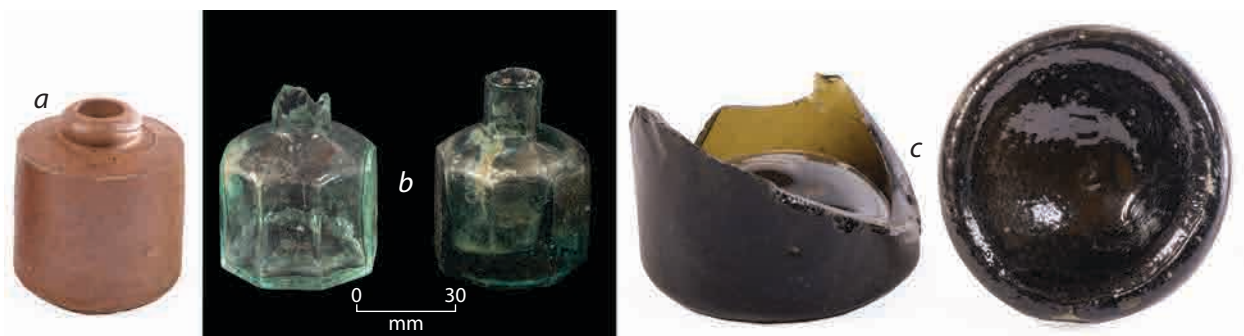
Figure 14. Artefacts from S15/783: a, stoneware ink bottle; b, two octagonal glass ink bottles; c, base of a black beer bottle with "...S & Co" on the kickup.

The ink bottles consisted of one, 'penny ink' style stoneware bottle (Figure 14a), and two octagonal glass bottles (Figure 14b). The round 'penny ink' style of the stoneware type were available throughout the 19th century and into the early 20th century and are common in domestic settings. The octagonal ink bottles feature a 'sheared lip', a crude finishing style common in English utilitarian bottle production from the late 19th century into the early 20th century. Similar style bottles were found by Druskovich (2007) in Kihikihi, which were dated to the early 20th century.

The wine/congnac bottle was made in a two-piece mould, as was the black beer bottle (Figure 14c), although that had a clear seam around the domed base indicating a two-piece cup bottom mould was used. This bottle had a hint of text and then a legible "...S & Co" on the kickup. Black beer bottles are thought to date between the 1850s and 1870s (Tasker 1989).
