# **Matapihi UFB2 build (HNZPT authority 2019/099): final report**

**report to  
Heritage New Zealand Pouhere Taonga  
and  
Ultrafast Fibre**

Date: 21 May 2020

Reference: 18-0841

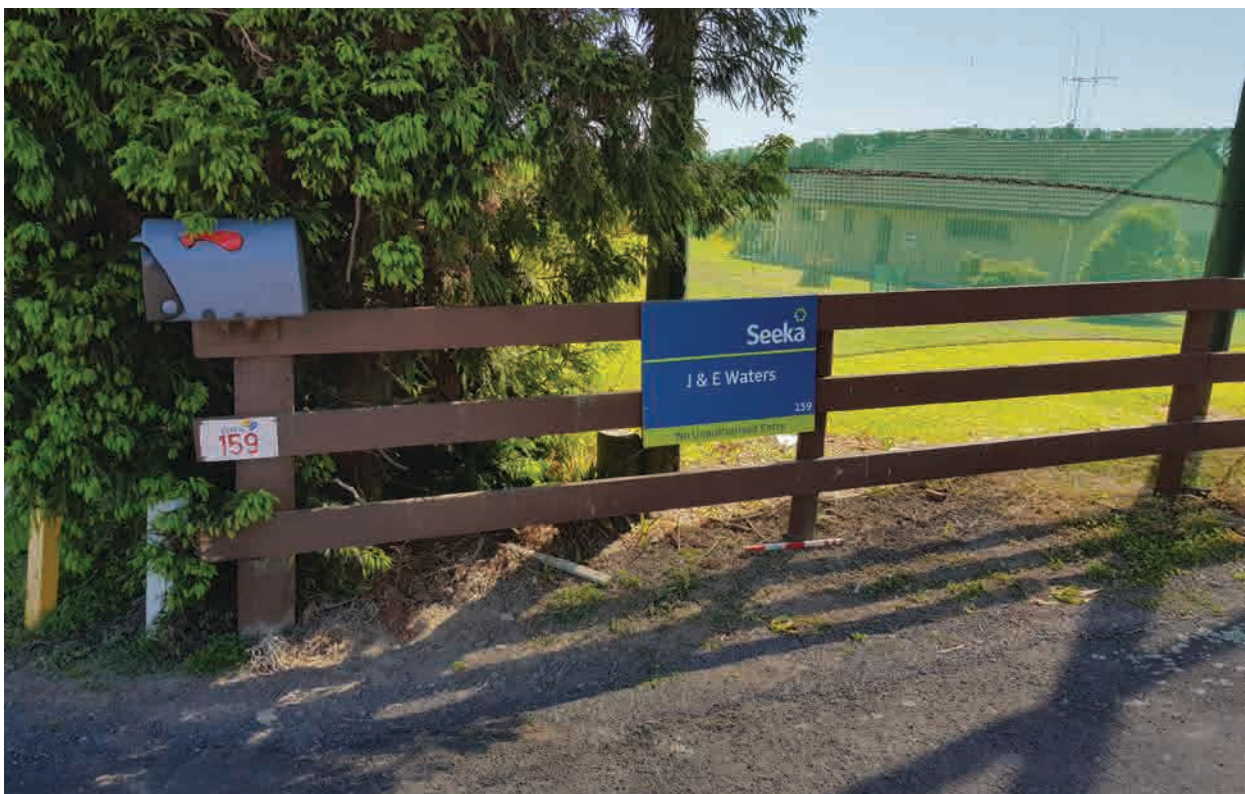
Figure 3. Location of fragmented shell associated with U14/2591. Photo scale = 0.5m.

Works in the vicinity of this site were monitored and the site was tentatively relocated on the driveway of 159 Matapihi Road. There were several pieces of fragmented shell visible near a fence post approximately 5 m from the road reserve. One of the hinges appeared to be from a tuangi (*Austrovenus stutchburyi*), with the rest of the fragments probably also from bivalves. Probing was not possible in the driveway surface, and no sub-surface deposits appear to exist in the road reserve. No material was identified in the insertion hole outside of the property boundary.

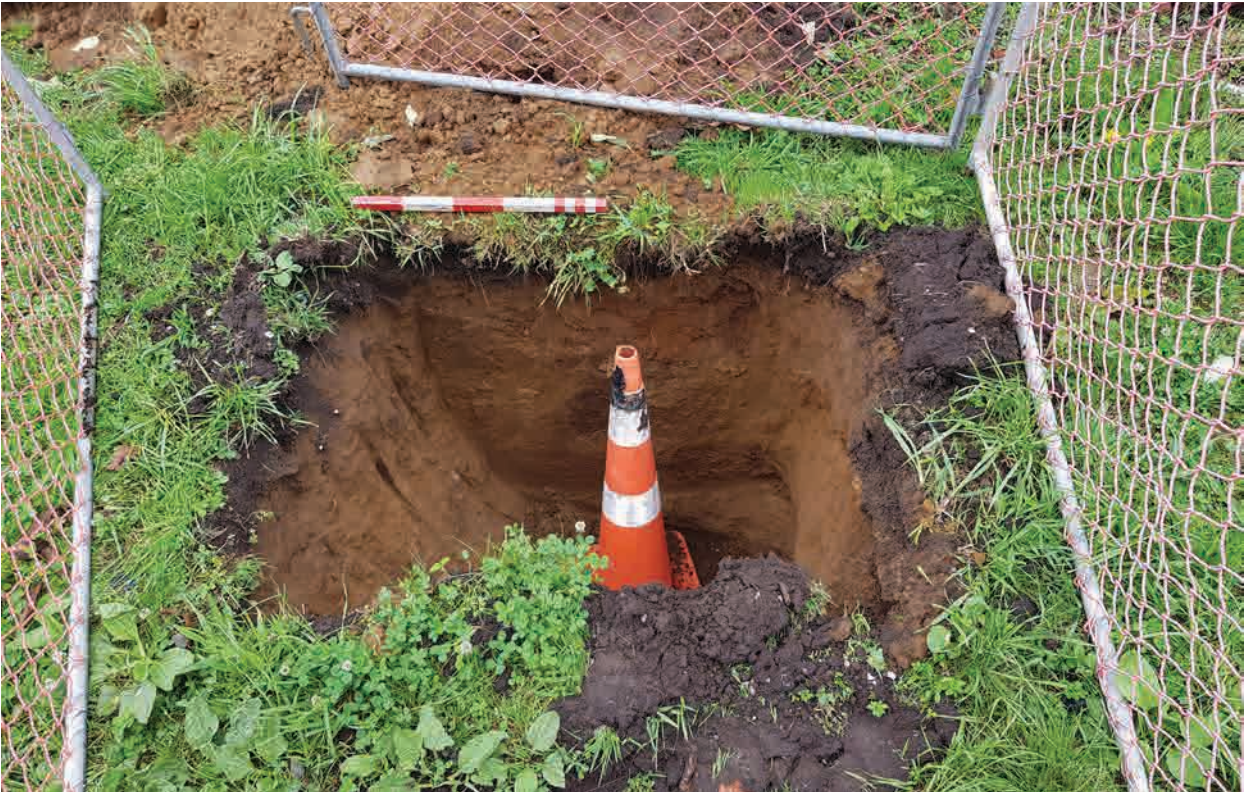
Shell was observed in topsoil, which was uniformly 150 mm deep above a level loam layer. The area appears to have been cut down for road batter and power line installation. The shell was not in situ, and consisted of fragmented and weathered tuangi. As there was no in situ material, no samples were taken. Probing indicated that the redeposited shell extended approximately 1 m either side of the hole.

Figure 4. Redeposited shell of Deposit 1, U14/3677.

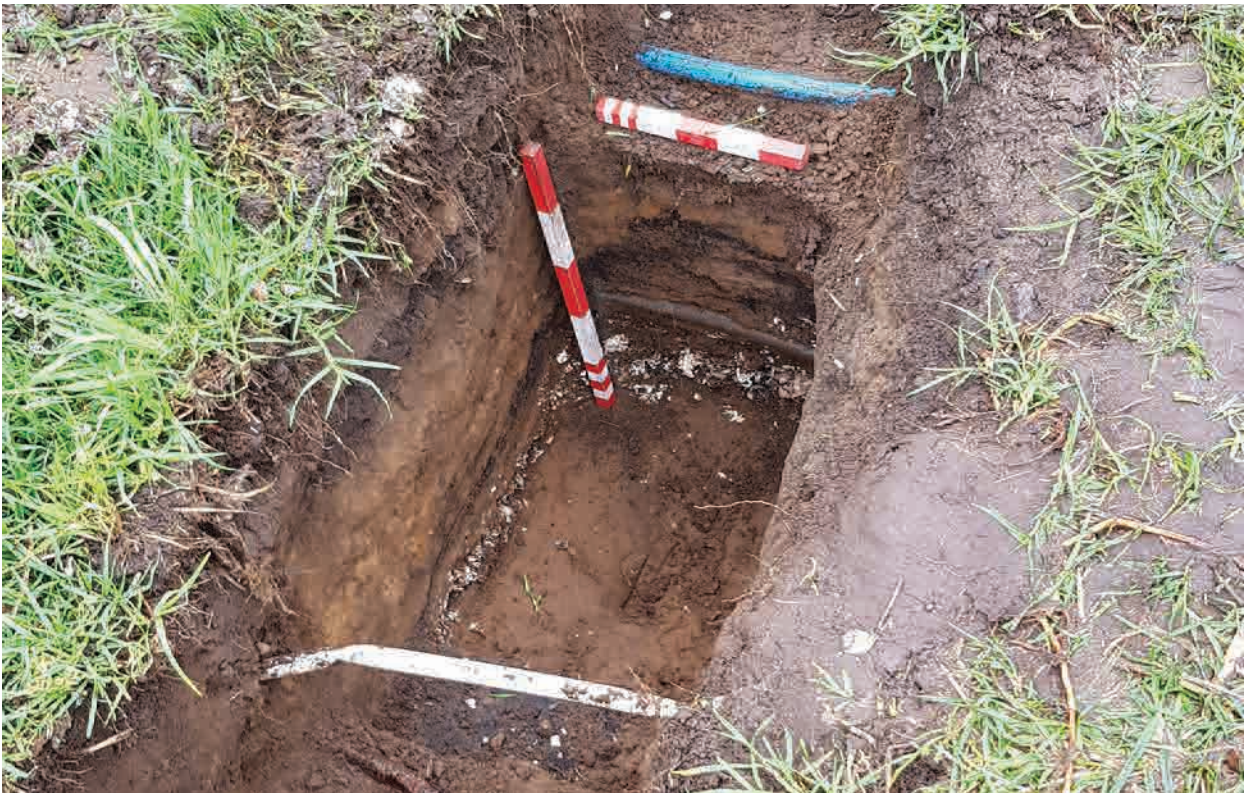
This deposit appears to be a shell lens at the base of a storage pit, which had been heavily modified with two galvanised water pipes, an alkathene water pipe, a telecom conduit and tree roots all within exposed area. On initial inspection prior to sampling, it was noted that the shell was dominated by tuangi with lesser quantities of pipi (*Paphies australis*) and various gastropods. A 10 litre bulk sample of the midden was retained for analysis. The extent of storage pit was unclear, as the 1400 x 420 mm insertion hole did not expose any feature edges, but the base of the pit appeared to be 760 mm beneath surface. The insertion hole was relocated 10 m west of this hole, and no archaeological material was noted.

Figure 5. Shell-lined storage pit, Deposit 2, U14/3677, with modern services above. Photo scale = 0.5 m.

These two midden deposits have been combined as a single site (U14/3677). Although the material associated with Deposit 1 was not in situ and is approximately 30 m from Deposit 2, it is likely that associated features are within the vicinity of these deposits, including in the neighbouring paddocks. An indicative extent for the site has been noted on the NZAA SRS. The drill shot was run intentionally deep (1200mm) through this section to avoid any other related archaeological material that may be present.

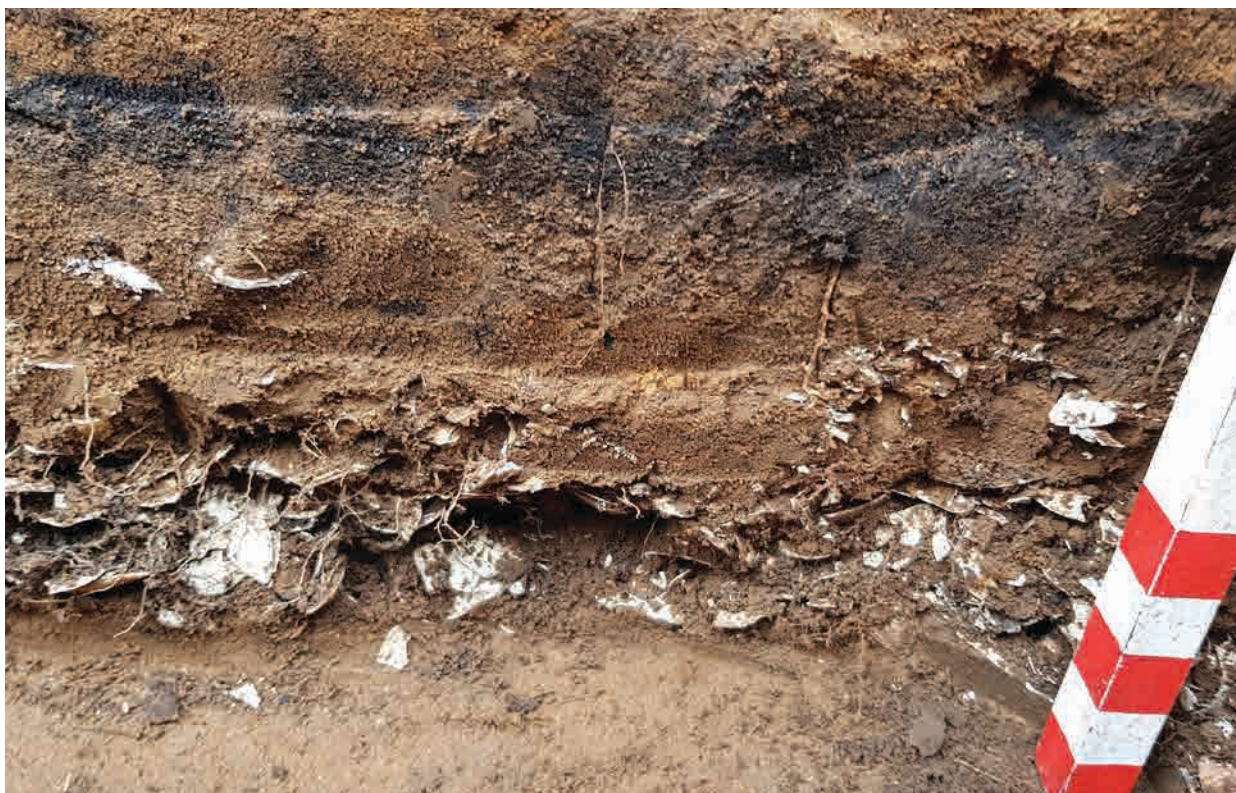
Figure 6. Closer view of shell-lining in base of storage pit, Deposit 2, U14/3677. Photo scale = 0.5 m.
