OLD ST PAUL'S: ARCHAEOLOGICAL MONIORTING

REPORT TO THE NEW ZEALAND HISTORIC PLACES TRUST

OLD ST PAUL'S: ARCHAEOLOGICAL MONITORING

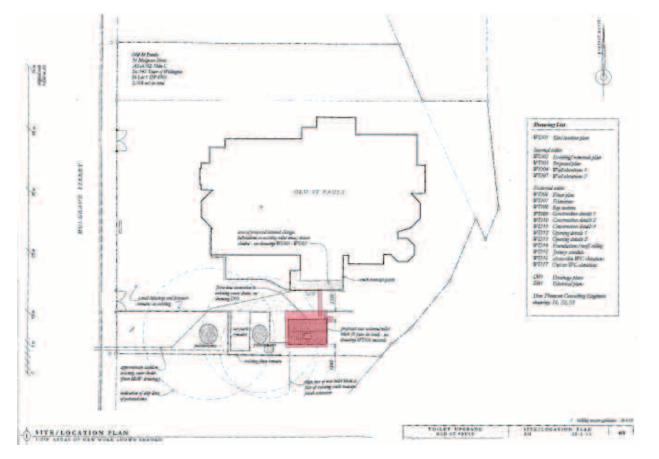
13. Plan showing the location of the toilet block, sump and drain trench.

Excavation in preparation for the construction of the toilet block was monitored by archaeologist Beatrice Hudson, accompanied by Kathryn Hurren from HPT, on 15 June 2011. The area to be monitored included the footprint of the building, approximately 4 x 5 m, a 0.5 m square sump excavated to 1 m depth, and a narrow services trench connecting the toilet block to the existing church building, excavated to 0.7 m. These areas are shown in Figure 13 and Figure 14.

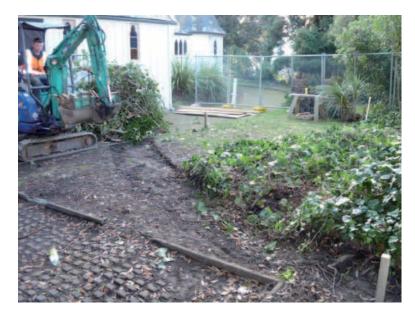
14 (top left). The area to be monitored, prior to topsoil stripping. Wooden stakes in the fore- and background mark the area for the toilet block.

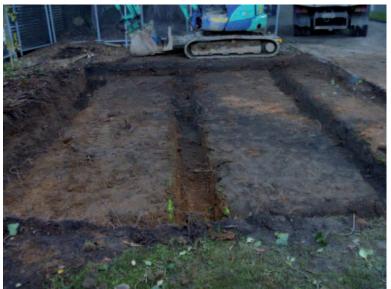
Deeper footing trenches were excavated around the perimeter and across the centre of the toilet block footprint and these did reach the subsoil (Figure 15). The trenches were 300 mm wide and a total of 600 mm deep. They cut through the fill

layer and revealed an old brown topsoil and a yellow-brown subsoil at a depth of 500–600 mm. These trenches showed no evidence archaeological features in the subsoil.

15 (bottom left). The footing trenches excavated into the subsoil.

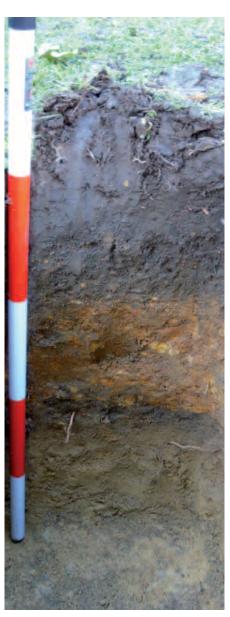
The sump showed the same soil profile of current topsoil on top of imported fill, with old topsoil and natural subsoil beneath that. The sump excavation cut 300 mm into the subsoil and showed it to be clean and undisturbed (Figure 16). Though the subsoil was not gravelly at the top, the sump excavation showed that it became gravelly as it got deeper.

16 (right). Soil profile in the excavation for the sump showing, top to bottom, the topsoil, fill layer, old toposil and natural subsoil.

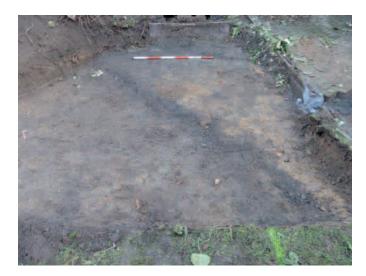
In the northwest corner of the area there was a change in the fill layers. A diagonal line across the area (south west 210°) marked a change from the mixed fill layer to a thinner cap of fill (up to 100 mm thick) that was essentially the same material as the imported fill, but which was denser and less mixed, with larger lumps of soil and clay and lenses of shell and gravel on top of it (Figure 17). It was only in the fill in this area that a few very small historic items were found. These included a very small fragment of stoneware bottle, a fragment of black beer bottle

17. Showing the change in fill in the north west of the area, marked by a dark line.

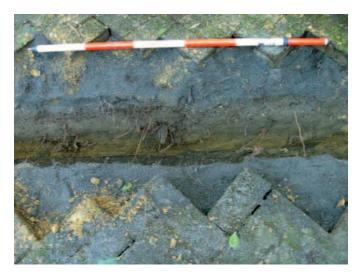
There was one feature of note visible in the profile of the service trench and the profile of the trenches on the west edge of the building footprint. This was a layer of gravel and very fragmented shell up to 100-120 mm thick. It ran diagonally across the area, in line with the dark line visible above in Figure 17. Figure 18 shows a diagram of the area, as extrapolated from where it could be seen in the trench profiles, and Figure 19 shows the shell and gravel layer as it was visible in the profile of the service trench. Immediately above this is the fine gravel base course for the driveway paving. Two small samples were taken of the shell and gravel layer.

The shell and gravel layer was sitting directly on top of the old topsoil and was located underneath the cap of fill in the north west area of the toilet block footprint, and below the paving of the driveway in the service trench. It probably represents a path around the side of the church. It is also visible in Figure 20, the profile of one of the footing trenches, where it ends when it

19. The shell and gravel layer sitting on top of the old topsoil over the natural subsoil.

20. Profile of one of the central footing trenches in the toilet block footprint. The shell and gravel layer can be seen under the thin fill cap in the far left, and it can be seen to end where it meets a darker mixed soil (centre). The deeper fill layer is visible on the right side of the trench profile.

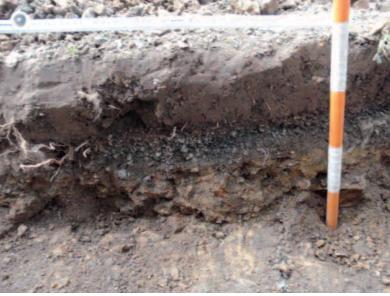
The stratigraphy was fairly consistent, and comprised a shallow topsoil (50 mm) overlaying a fill layer of large angular gravel in a grey-brown clay loam matrix with occasional artefacts (250 mm) which in turn was deposited on the naturally occurring basal layer of yellow-orange-brown clay and rotten rock. Of some interest was an additional layer (50 mm) of fine gravel fill exposed in a 2 m long section of the trench between the grey-brown clay fill and basal layer (Figure 22). This feature began approximately 2 m west of the end of the brick wall and was approximately 2 m long.

21 (left). Northern fence trench.

22 (right). Southern profile of trench showing fine gravel

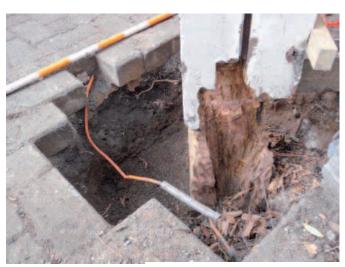
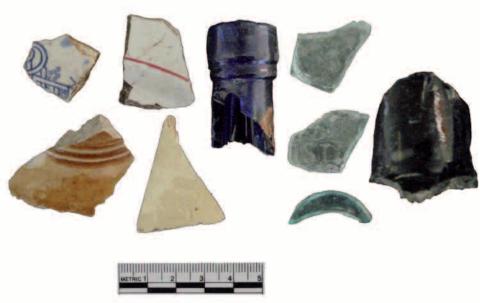
A few artefacts were encountered within the fill layer but, aside from this, no in situ archaeological features were encountered (Table 1, Figure 24).

Also inspected were the excavations around the northern gatepost on the southern Mulgrave Street entrance (Figure 23). Repairs to this post required removal of pavers and a 750 x 750 mm excavation, 300 mm deep to pour a concrete footing. This area had been previously disturbed by the earlier landscaping works which include the garden bed, tree roots, footpath, paved driveway, and the post and rail fence itself. No archaeological features or artefacts were encountered. The depth of fill in this area was 140 mm from below the pavers.

23 (above). Fence post. excavation. 24 (right). Artefacts from the northern fence trench.

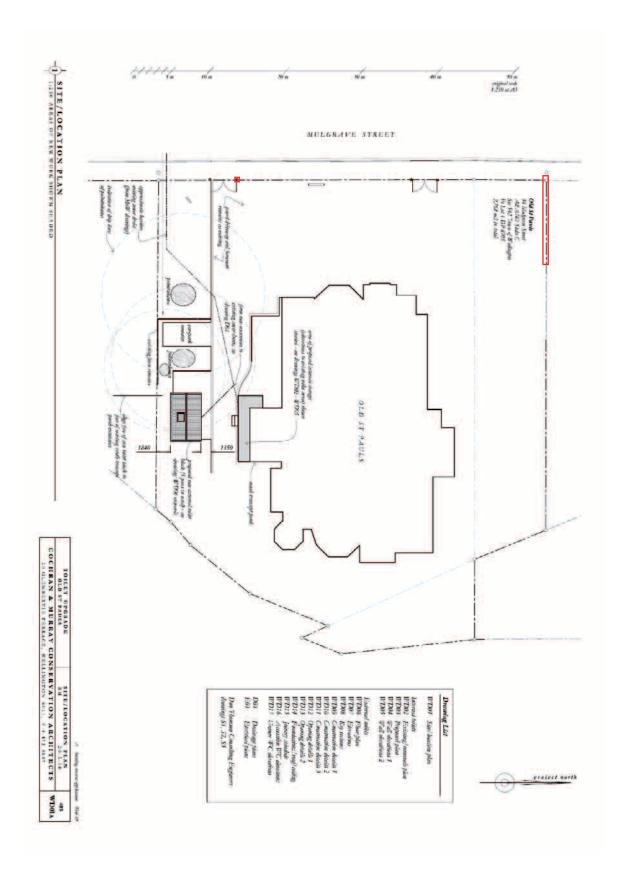
On 5 August 2011 earthworks for the installation of the fence along the western portion of the northern boundary were monitored by Andy Dodd on behalf of CFG Heritage Ltd. An 8.5×0.6 m trench approximately 300 mm deep was excavated from the footpath on Mulgrave Street to the termination of the low brick fence on the northern boundary (Figure 21). Particular attention was paid to the interface between natural and fill layers and brief notes were taken on the stratigraphy exposed in the profile of the trench.

25. Location of monitored earthworks indicated in red. Plan courtesy of Cochran & Murray Conservation Architects.
