Plummers Point UFB2 build (HNZPT authority 2018/663): final report

**report to
Heritage New Zealand Pouhere Taonga
and
Ultrafast Fibre**

Arden Cruickshank and Ella Usher

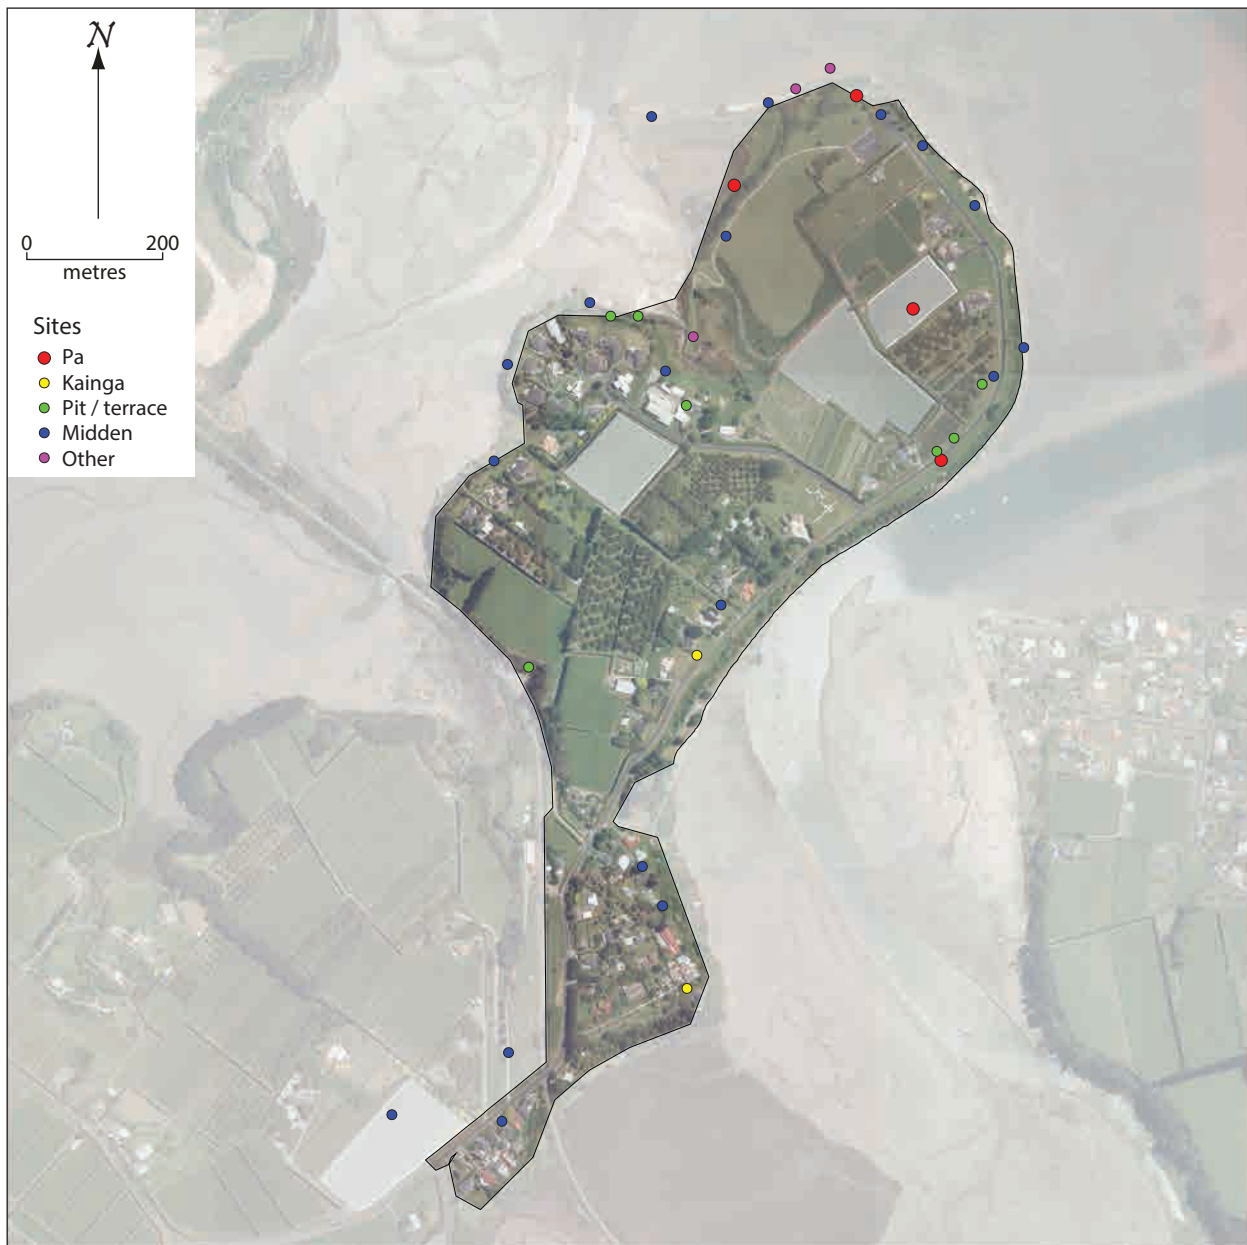
Figure 3. The Plummers Point UFB2 project area, showing recorded archaeological sites by site type.

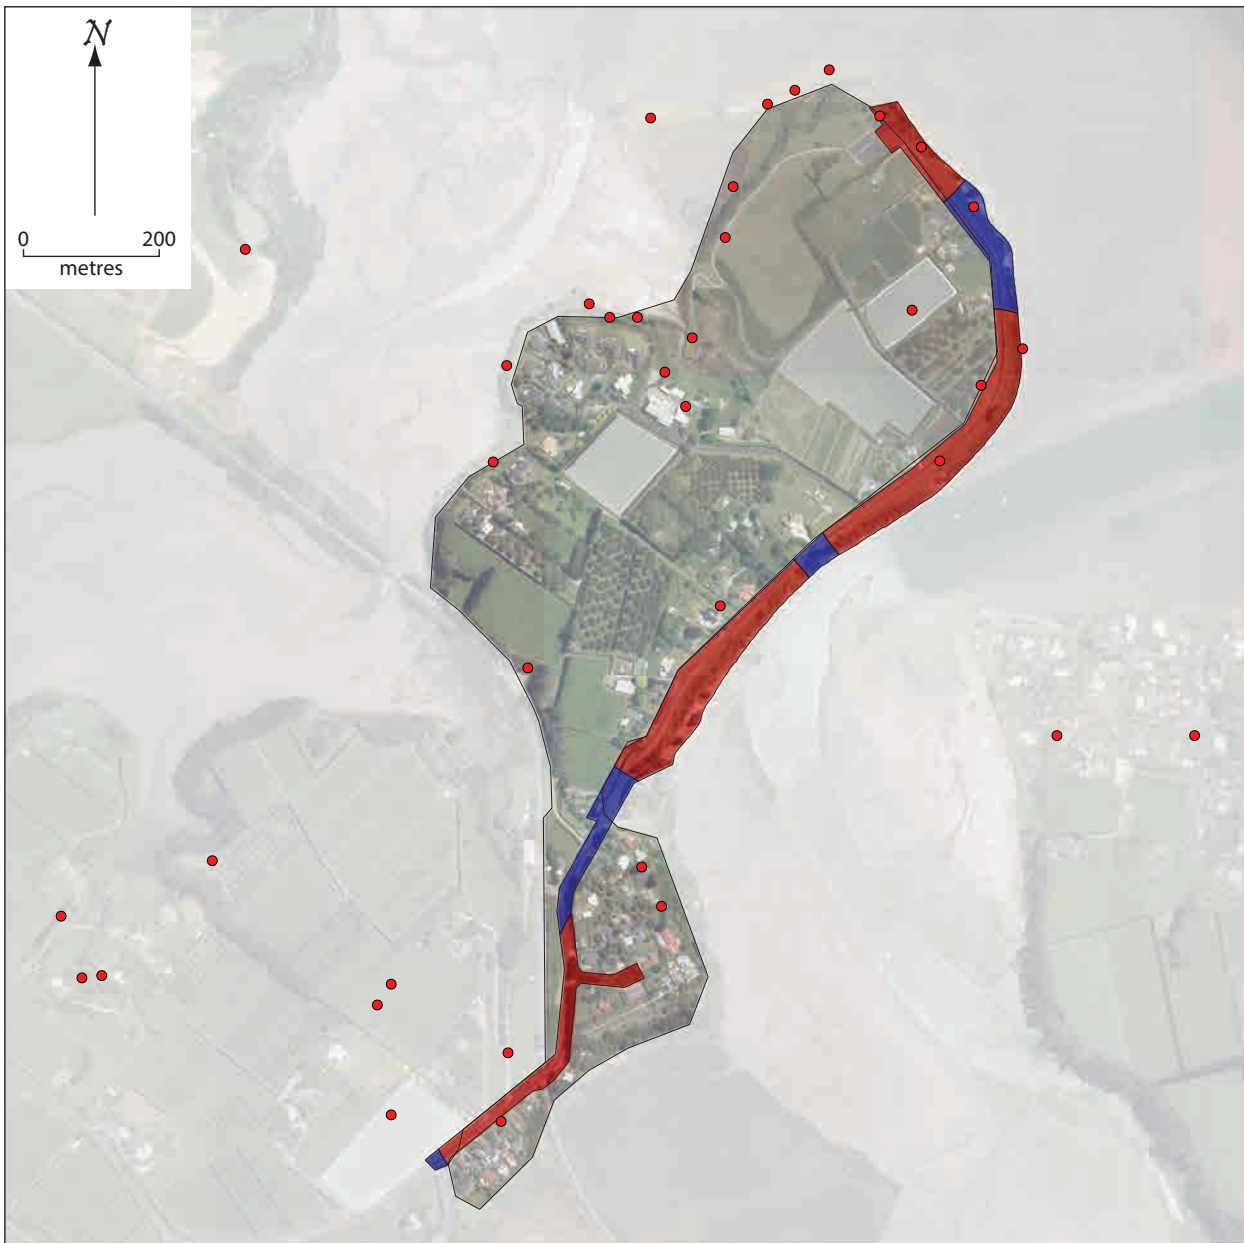
Figure 4. Areas requiring archaeological monitoring (red) and works undertaken utilising the discovery protocol (blue).

Within the earlier archaeological assessment for the Plummers Point UFB2 build (Cruickshank 2018), several areas were highlighted that would require archaeological monitoring during earthworks and the remainder of the build was to operate under a discovery protocol (Figure 4). The earthworks related to the project commenced on 20 July 2018 and were completed in early 2019. The ground disturbance associated with the archaeological sites identified in the project were monitored or inspected prior to drilling to ensure no archaeological features had been affected.

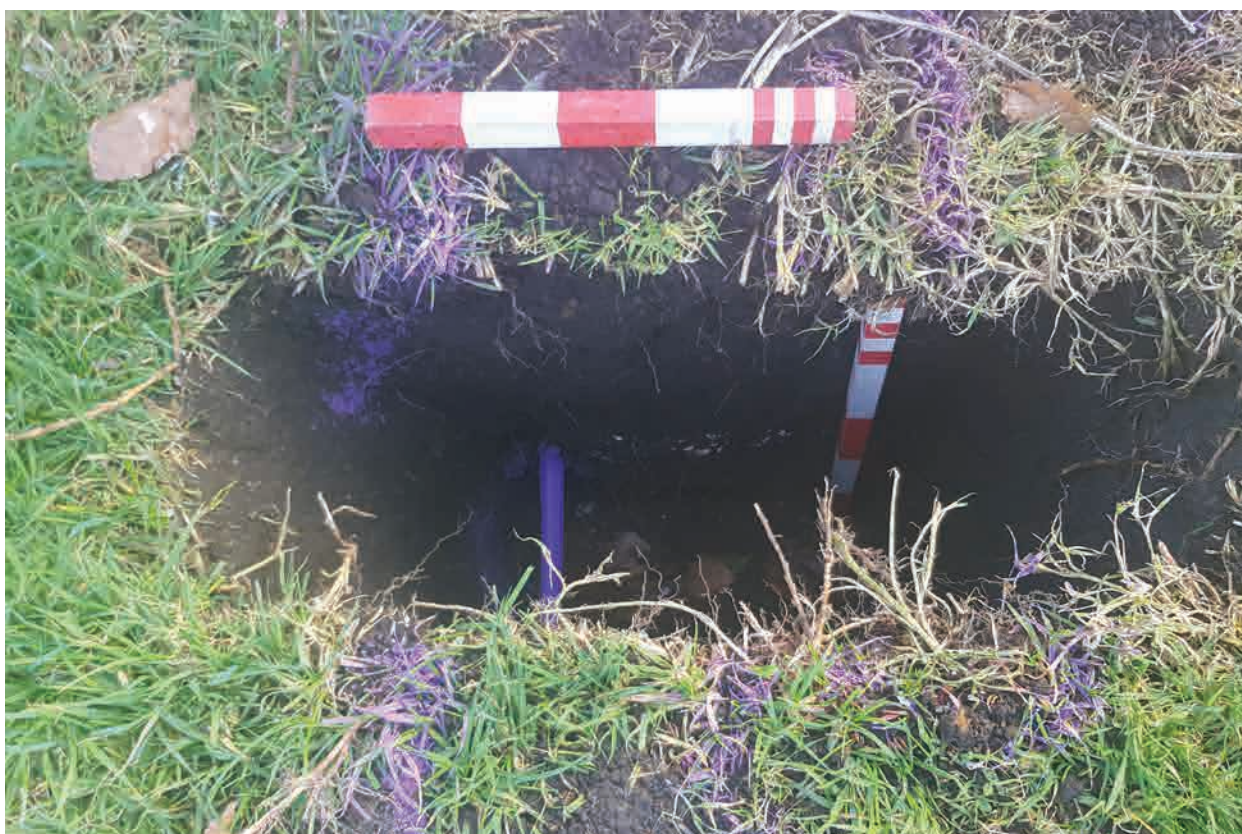
Shell was encountered by drillers making a services pothole on Thursday 19 July outside 299 Plummers Point Road. Works were suspended and the deposit was inspected by Arden Cruickshank on 20 July 2018. The hole was small (220 x 550 x 500 deep) with a midden lens at 350 mm depth (the same depth as the telecom conduit). The midden was 80 mm thick and

mainly fragmented cockle. Probing the surrounding area proved inconclusive and a 250 x 250 mm test pit was dug next to the hole, but it proved to be gravel. A 4 litre bulk sample was taken from the midden deposit, but no more than this could be collected due to the size of the pot-hole. This midden deposit was in the same location as U14/3583, a Maori settlement recorded by Megan Lawrence of WSP Opus in 2018 based on an 1888 survey plan (SO 5222).

Figure 5. Site 1 outside 299 Plummers Point Rd.

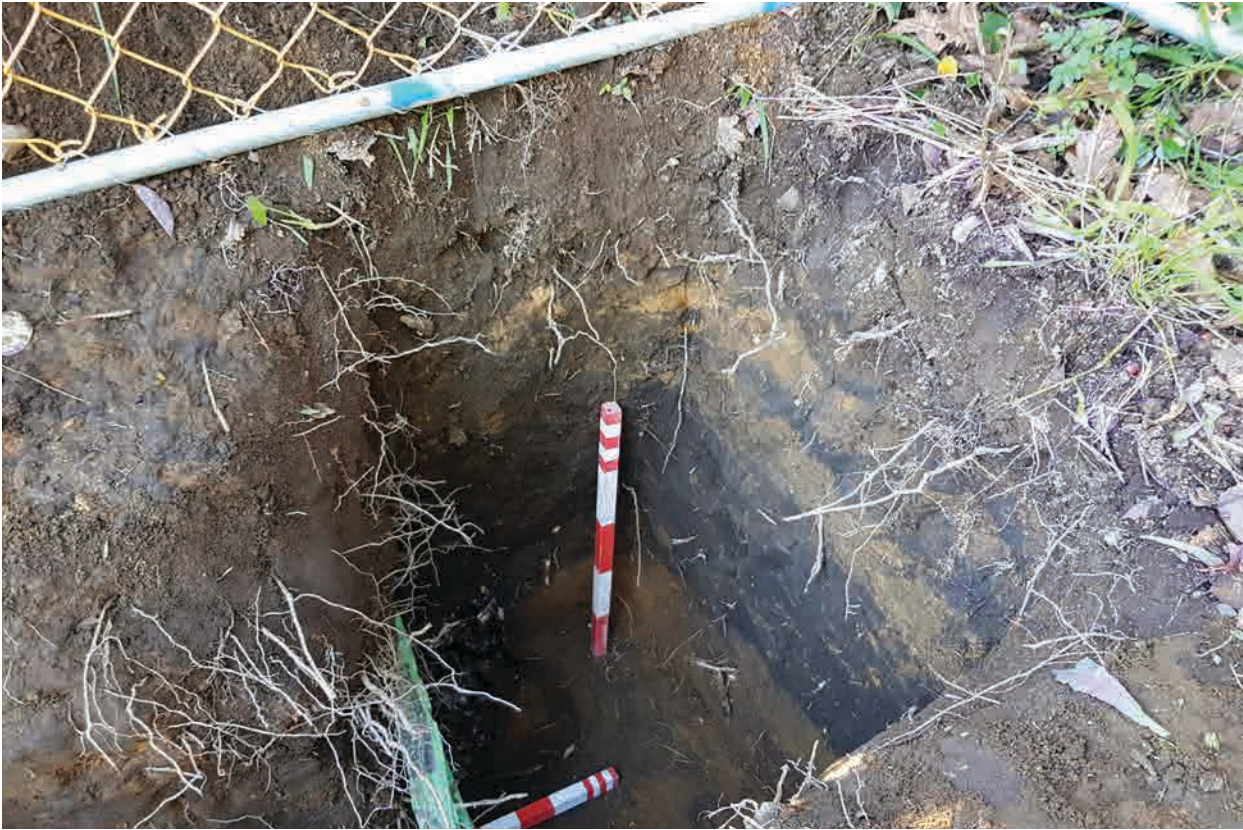
This feature was identified when potholing for services on 23 July outside 244–246 Plummers Point Road. Initially the feature was suspected of being a telecom trench, but once shell was exposed, works were suspended, and the feature was inspected by Arden Cruickshank on 24 July 2018. On closer inspection, it was noted that the deposit was located beneath the telecom trench and had not been impacted by the initial telecom trench. It contained a mix of shell and burned metal sardine cans, glass fragments and a large pig scapula that had been cut with a bandsaw. These probably date to the 20th century, possibly related to the construction of the East Coast Main Trunk in 1927, which is approximately 40 m west of this feature. It began at a depth of 800 mm and was probed to a depth of 550 mm below that. Only 400 x 400 mm of it was exposed in plan, and it is probably bigger than this.

Figure 6. Site 2 outside 244–246 Plummers Point Rd.
