**Supreme Court Development, Wellington
archaeological assessment
and
section 18 archaeological investigation: final report**

**report to
The New Zealand Historic Places Trust,
The Building Intelligence Group
and
The Ministry of Justice**

Date: 24 October 2006

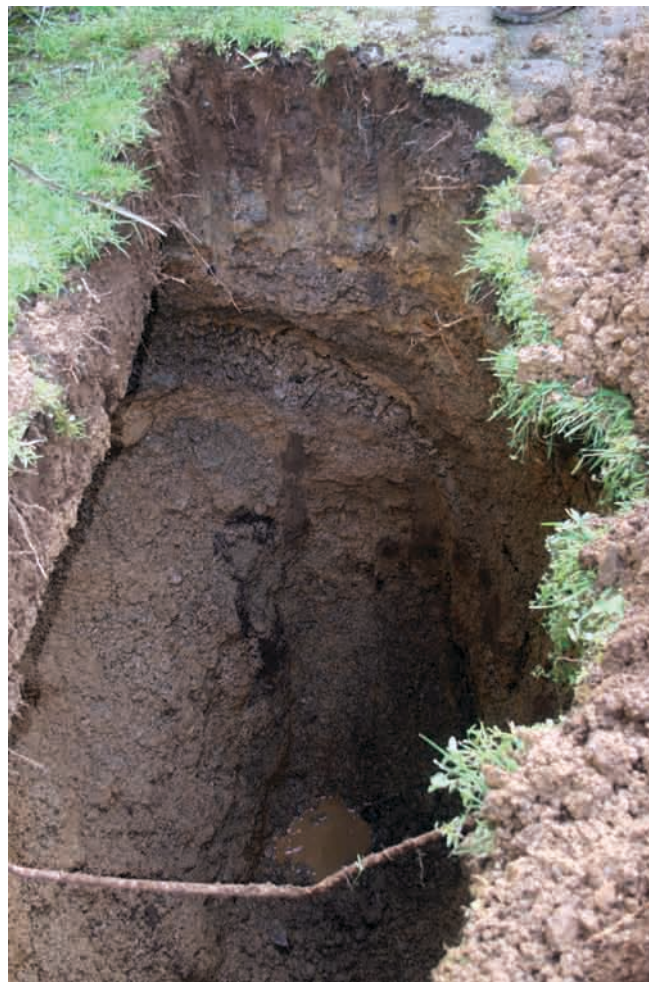
This pit was dug in the courtyard between the Supreme Court building and the 1981 Judges' offices. The purpose of locating the pit here was to look for evidence of outbuildings, particularly latrines, in the shared courtyard of the three main buildings. The pit measured 2250 x 700 mm in plan. Under a layer of topsoil 230 mm deep there was a deep deposit of reclamation fill consisting of clay and crushed metal – this had been taken from the base of Wadestown Hill in the 1870s (Cochran in prep.). This was very loose and unstable and continuously collapsed into the excavation. Excavation continued to the water table at a depth of 2600 mm. Layers were visible in the reclamation fill indicating its deposition by the cart load (Figure 1).

Figure 1. Test Pit 1 showing layers of reclamation fill in the end wall. The reclamation fill beneath the north wall (right) has collapsed away.

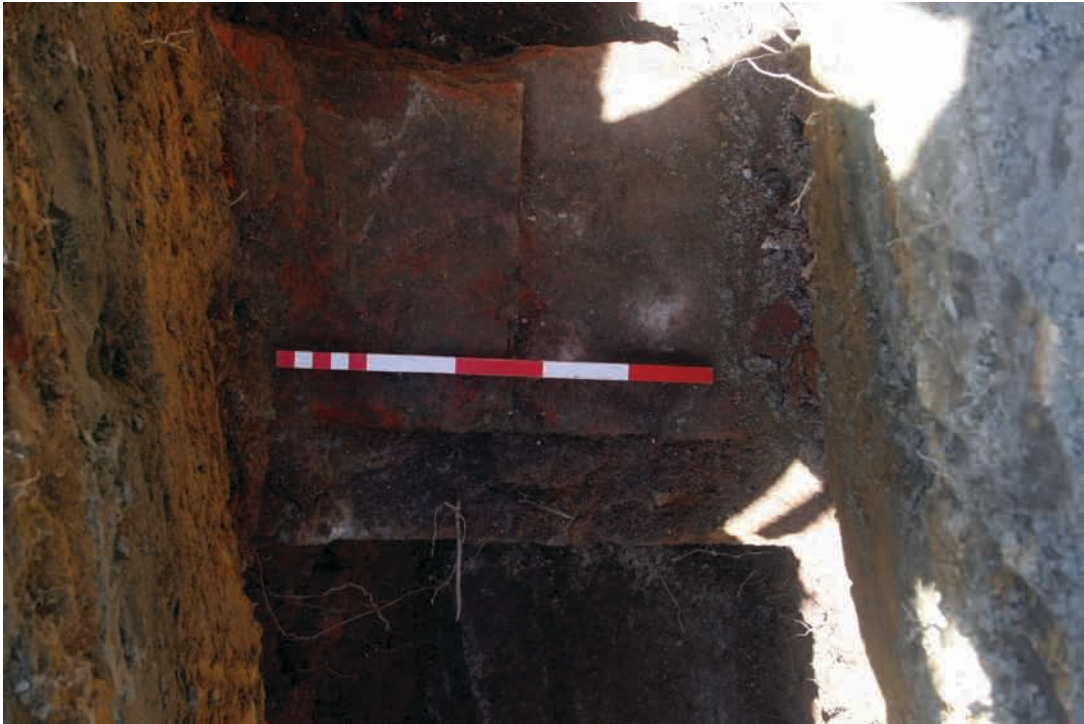
Figure 3. Brick footing/load bearing wall and later mesh-reinforced concrete facing, in the base of Test Pit 2.

Evidence was encountered in Test Pit 2 of alterations to the Magistrates Court – the wire mesh reinforcing indicates that this is perhaps part of the 1951–52 remedial work. The history of the buildings recorded by Chris Cochran indicates that both went through numerous phases of construction and addition before their demolition in 1992 – some evidence of this has been found and more can be expected to survive.

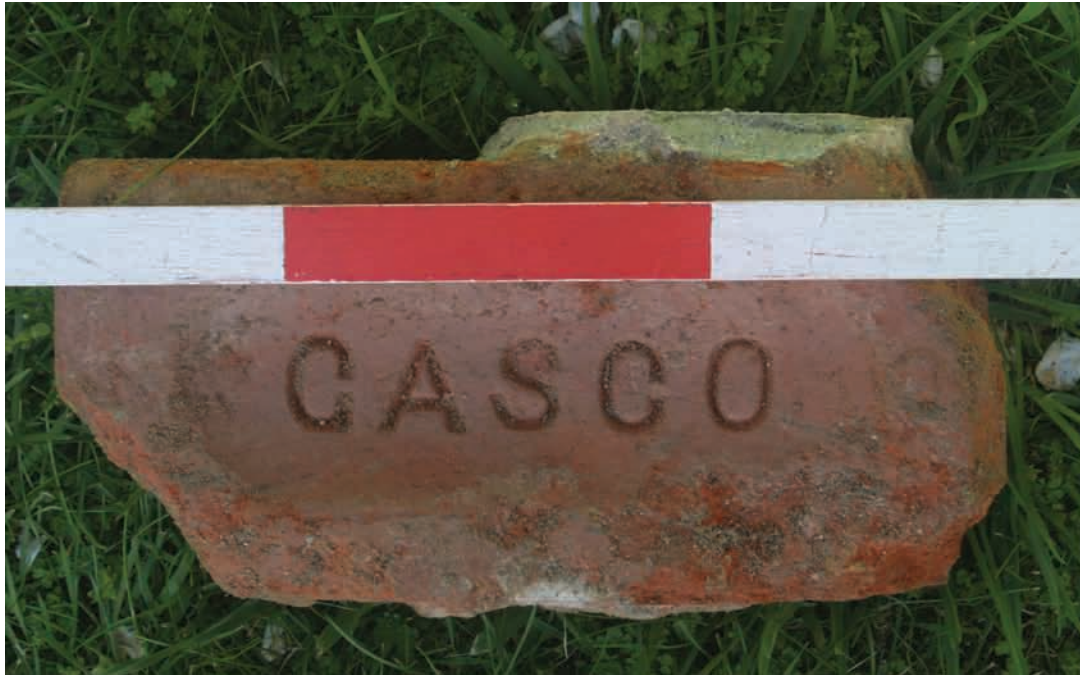
Figure 5. Brick marked "GASCO", scale divisions = 200 mm.

One brick with "GASCO" imprinted in the frog was recovered (Figure 5), the other bricks observed were plain machine-pressed bricks.

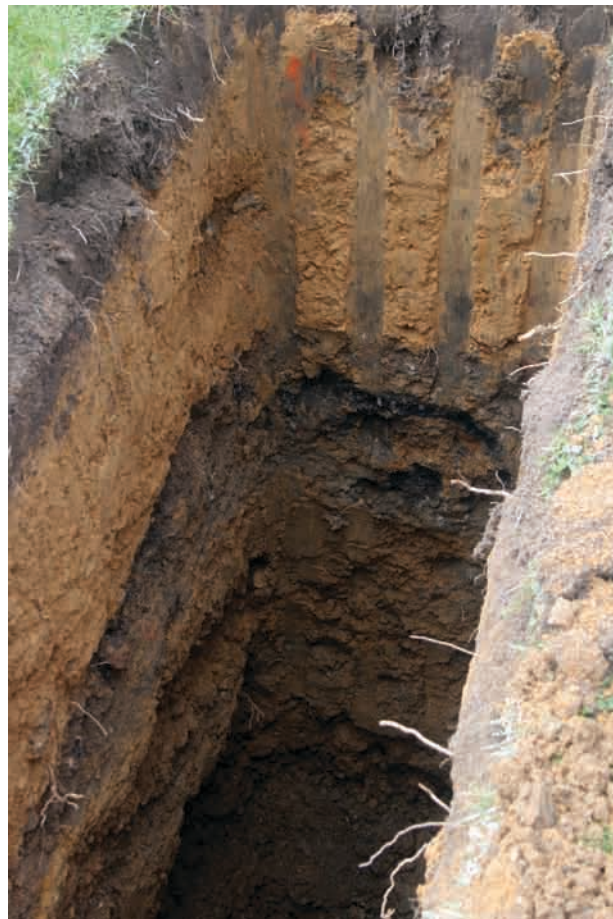
Two small fragments of plain white stoneware were observed in the demolition layer.

Figure 7. Test Pit 3 showing the dark band of demolition rubble.
