THE BUTLER STONEY HOUSE, R10/1125, SILVERDALE

**REPORT TO
THE NEW ZEALAND HISTORIC PLACES TRUST
AND
FOODSTUFFS NEW ZEALAND LTD**

Date: 26 October 2011

Reference: 2011/50

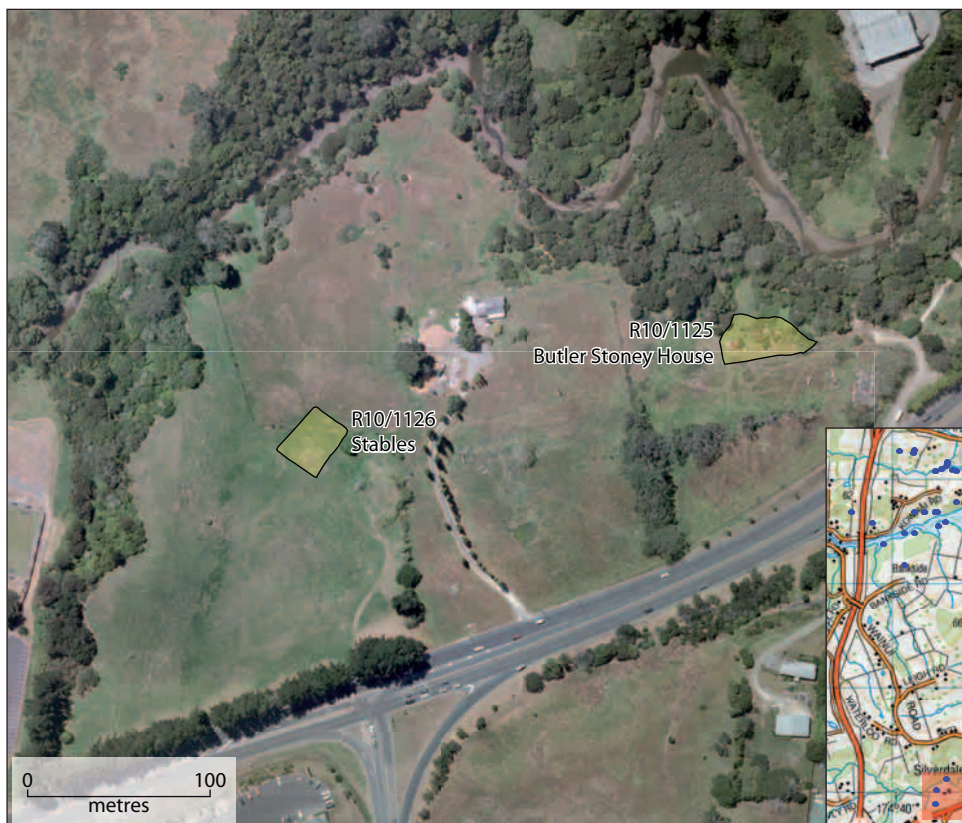
1. Excavated areas of R10/1125, the Butler Stoney House, and R10/1126. The inset (below) shows the location of the main image (red) and archaeological sites recorded in the wider area.

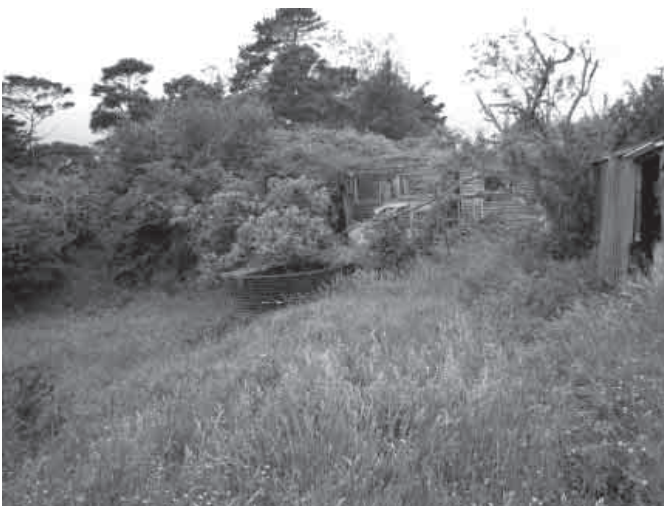
3. View looking east showing the outbuilding (right edge of photo), water tank, and Phase 3 addition (December 2006).

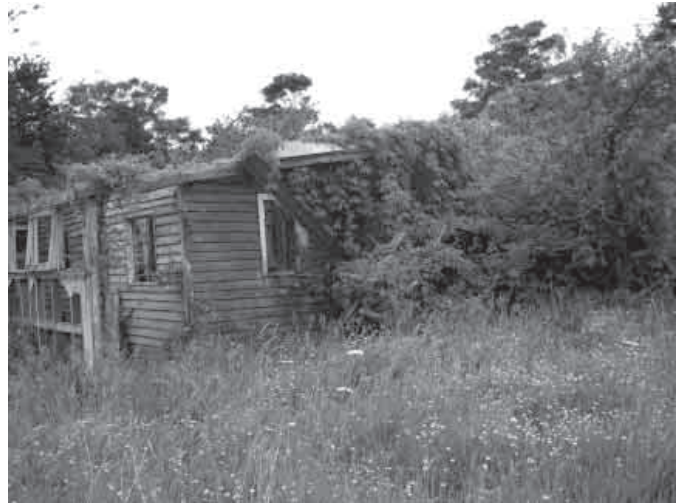
4. View looking roughly north showing details of the house remains (December 2006).

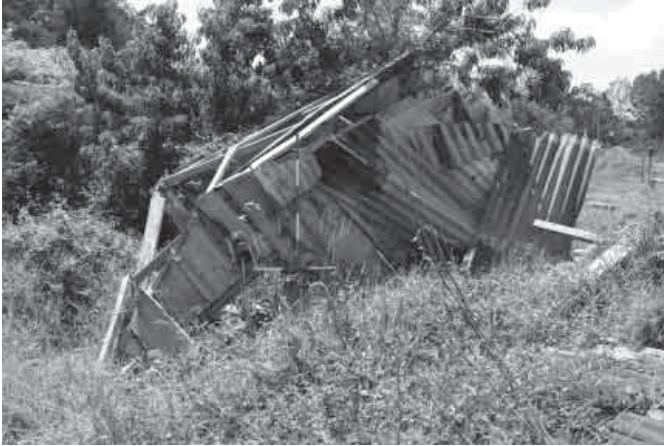
6 (top). The collapsed outbuilding immediately prior to investigation.

To the west of the house site was a partially collapsed board and batten shed. This shed was still standing in 2006 at the time of the assessment by Furey (2006) (Figure 6 and Figure 7). It had a long drop toilet in the north west corner with a plastic seat and modern rubbish was piled up both within and around the structure. Removal of the structure revealed a rough concrete floor in places but no substantial foundations. A thin layer of concrete had been laid over fill to produce a level floor, but below this was more modern rubbish, dating the structure to no earlier than the mid-20th century.

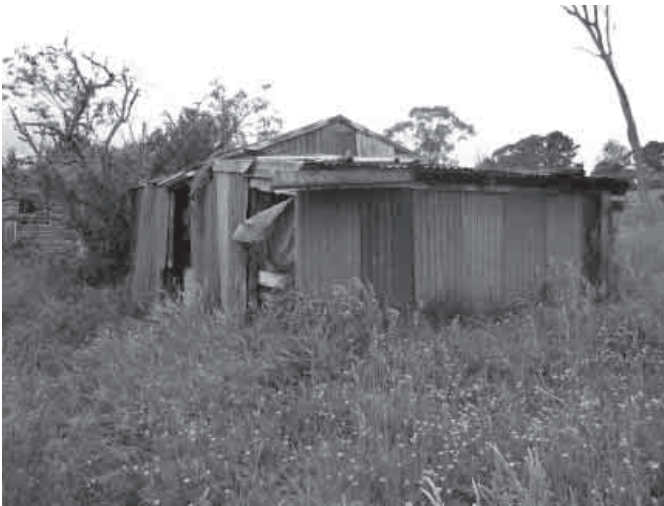
7 (centre). The same building still standing in December 2006.

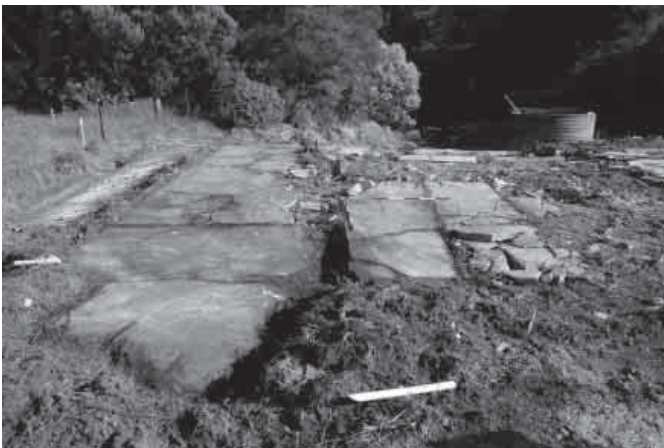
8 (bottom). View of concrete foundations of the outbuilding after the building material has been removed.

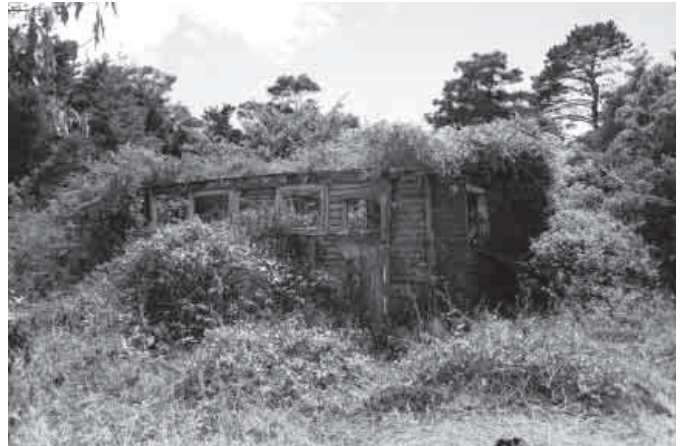
9 (top). The Phase 3 addition prior to rubbish and vegetation removal.

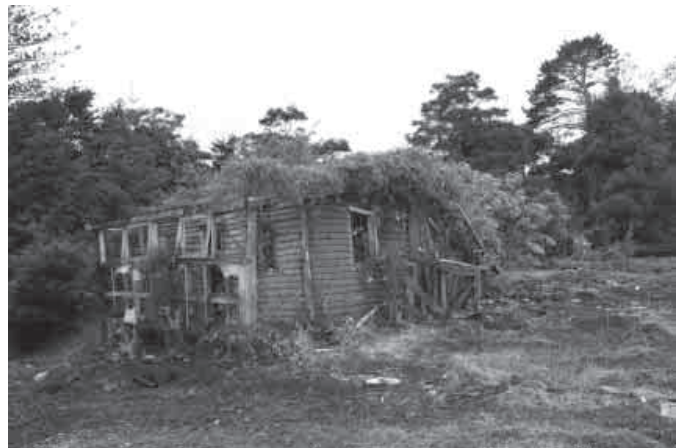
10 (centre). Wider view showing the still standing Phase 3 with rubbish and vegetation removed from around it (note the enclosed verandah on the west side and partially collapsed tank stand on the south side).

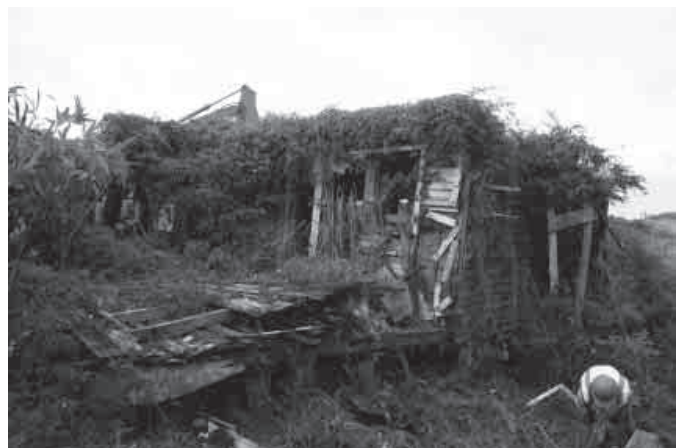
11 (bottom). Reverse view showing the collapsed remains of Phase 2 and partially intact floor still on its piles in relation to Phase 3.

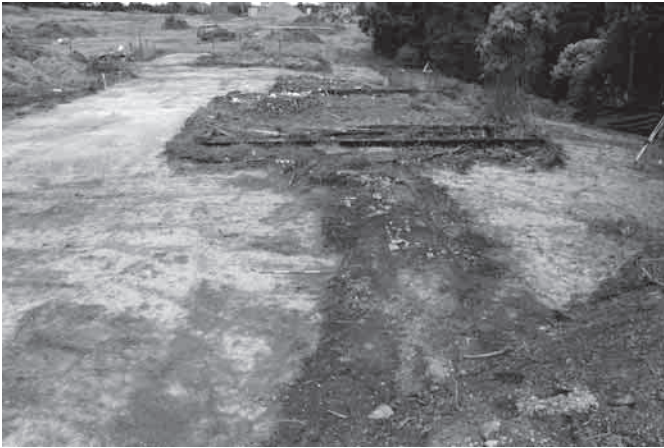
12 (above). View of the site looking west once the standing building material, rubbish and vegetation had been removed (note the concrete path on the east side of the house and the square Phase 1 footprint with a pile of brick rubble marking the fireplace).

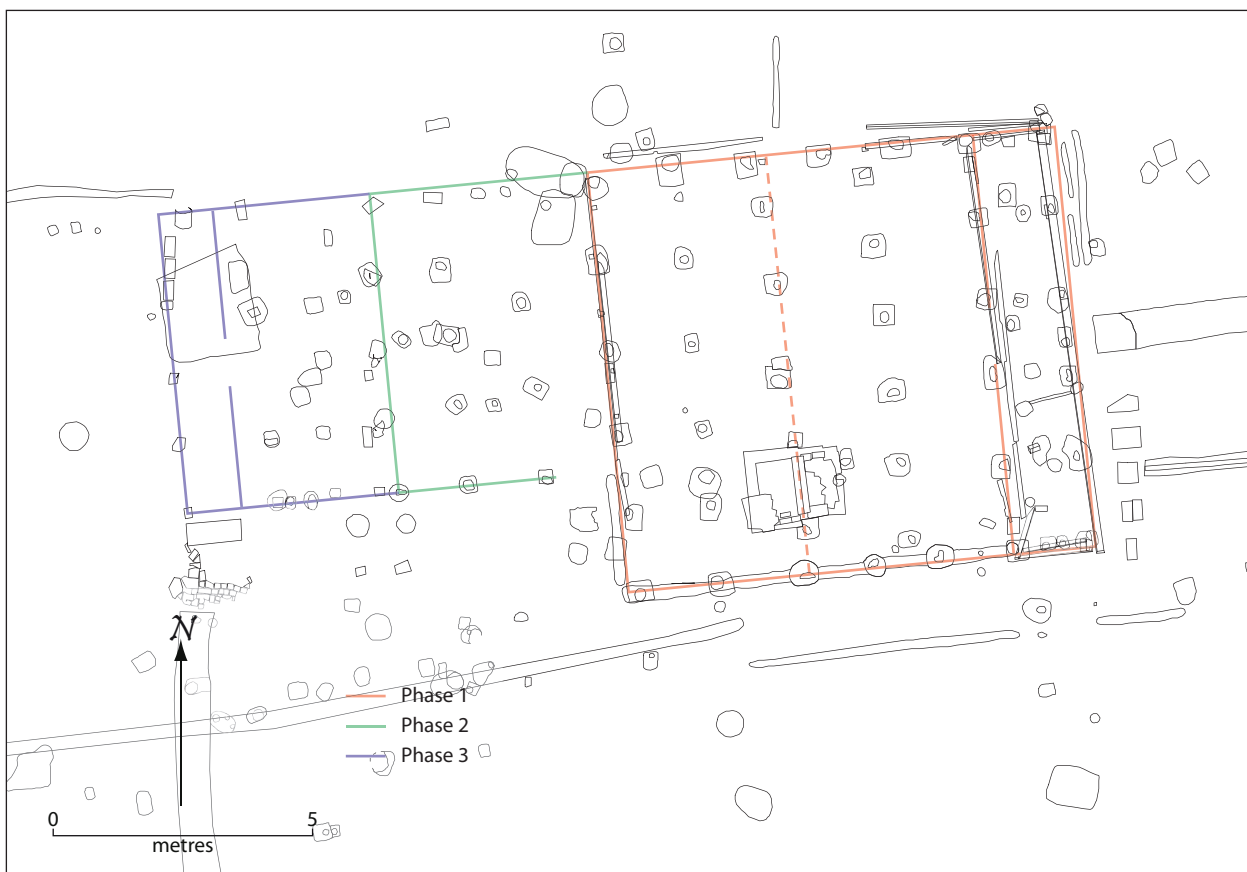
13 (below). Detail of site plan showing phasing of the house and the layout of the underfloor grid.

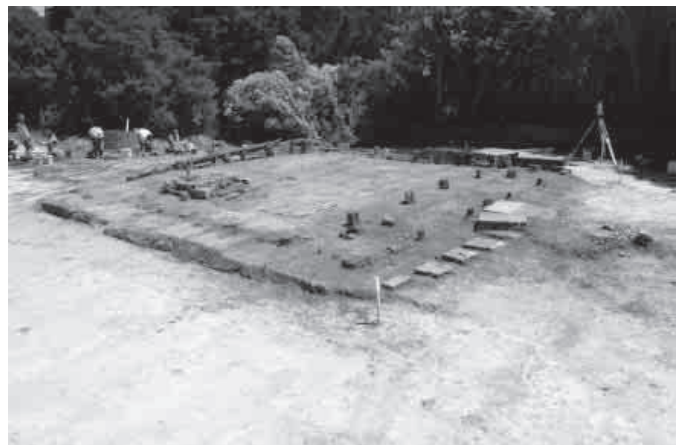
14. The Phase 1 structure after excavation.

The total footprint of the Phase 1 cottage probably measures 8 x 7.5 m with a 1.5 m verandah on the east side. The piles were set in rectangular postholes ranging in depth from 300–400 mm. On the east side of the house the outside row of piles was noticeably smaller and a concrete path was leading to the middle of the east wall suggested that there was a verandah and doorway on this side. In the north east corner the original wooden pile had been replaced by a concrete block and the corner had been further propped up by a piece of 4" x 2" timber set on edge, resting on flat boards. In the south east corner bricks had been inserted beside the wooden pile to provide extra support. Other piles had also been added at various times and a post sample from Feature 98 in the verandah section of the building was identified as probably being from a eucalyptus species. Along the south side of the house the postholes for the piles had been dug into a shallow footing trench (Feature 38). Around the outside of the house, and especially where Phase 2 joins on, of some of the split piles had been replaced by square sawn piles, probably when the Phase 2 addition was constructed.

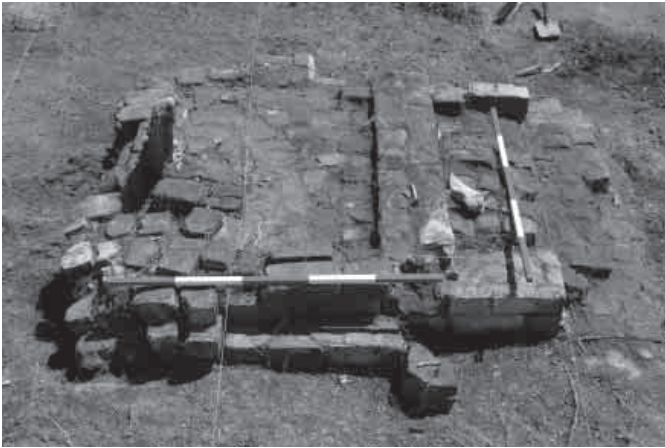
15 (top). The fireplace base in the Phase 1 cottage after loose rubble has been removed.

The fireplace base was constructed of both mortared and unmortared bricks. A test trench dug along the west side of the fireplace showed that the foundations were not cut down to the natural clay but were set within the same mixed clayey soil that was present across the footprint of the Phase 1 cottage. Only the sub-floor portions of the foundations were preserved so it is not possible to say exactly what type of fireplaces may have been installed in the two rooms. On the kitchen side the fireplace base was packed with broken half-bricks suggesting that it was only intended as a support for a stove or range, while in the living room the construction was neater and probably had an open hearth. The fireplace base was not deconstructed or investigated in any detail beyond cleaning off the loose rubble.

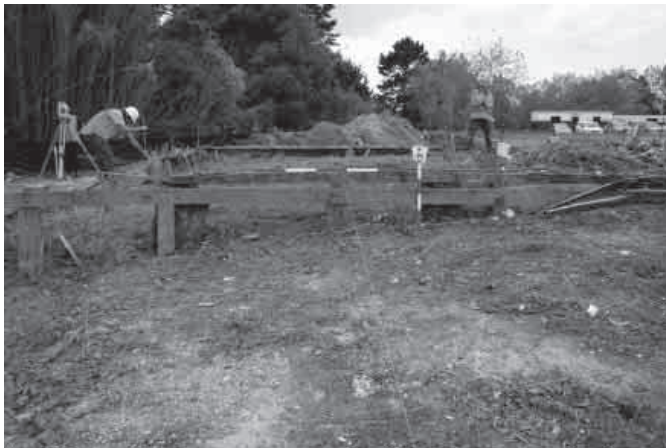
16 (centre). View looking east showing the change in height between the baseplate of the Phase 2 addition and the Phase 1 structure (note the sawn Phase 2 piles as opposed to the earlier split Phase 1 piles).

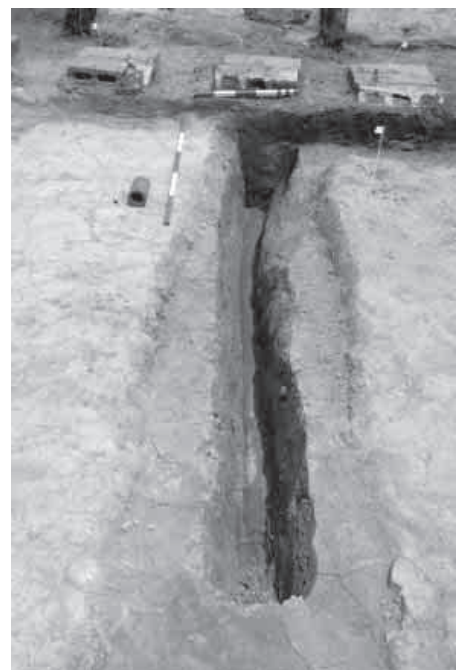
18. Feature 175, the field tile drain running under the house, with the eastern section of the drain exposed.

On the east side of the house the main features were a concrete path leading up to the middle of the east wall and a field tile drain running to the west, continuing under the house. The concrete path measured 750 mm wide and had a concrete step at the base of the east wall. The concrete was clearly not of any great age and is most likely a replacement for an earlier dirt or gravel path leading to the main door of the house. There was no indication elsewhere around the Phase 1 house of an entranceway. Features 53–57 were concrete blocks or pavers used as steps for an informal path leading along the side of the house to the doorway from the south east corner of the house. Several postholes were present on this side, but none indicated a fence or other structures.

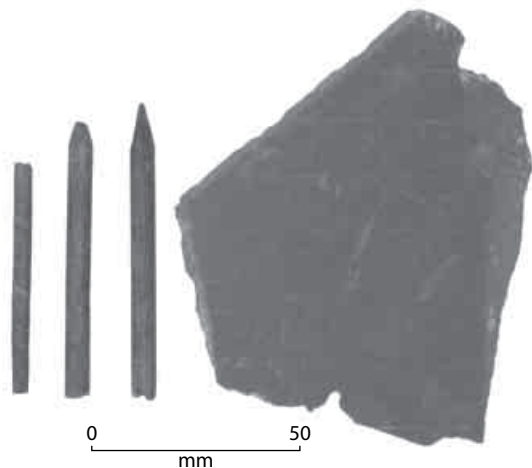
24. Slate pencils and writing slate fragment.

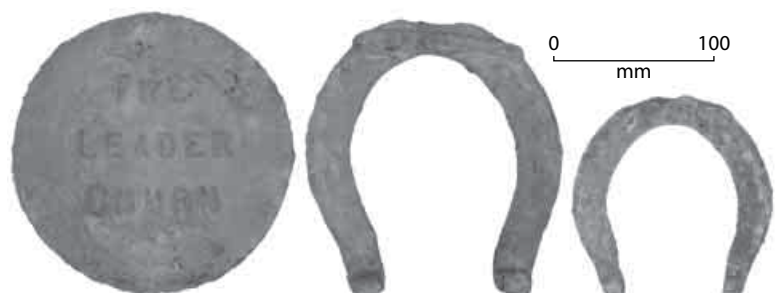
26. Butter churn counter-weight and horseshoes.

Items that give an insight into the semi-rural domestic life of the occupants are a counter-weight from the base of a small butter churn and horseshoes. The butter churn counter-weight found in square I 17 (Phase 1) is 170 mm in diameter and is embossed 'THE/LEADER/CHURN' and most likely dates to the early 20 century. A "Leader" brand butter churn was marketed in New Zealand by the Nelson firm Wilkins and Field Hardware Company Limited and
