Urenui UFB2 Build (HNZPTA authority 2020/746): final report

report to
Heritage New Zealand Pouhere Taonga
and
Chorus

Date: 9 March 2021

Reference: 19-1083

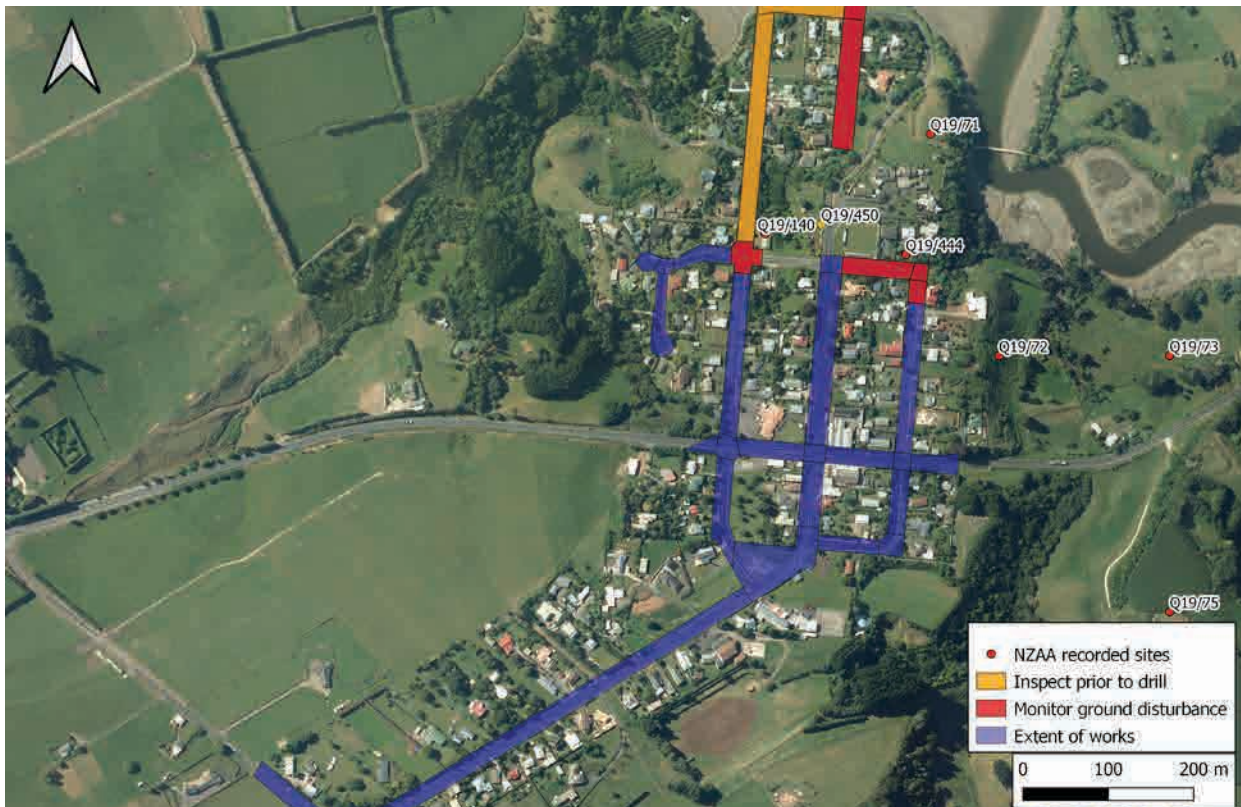
Figure 3. Areas monitored or inspected during build.

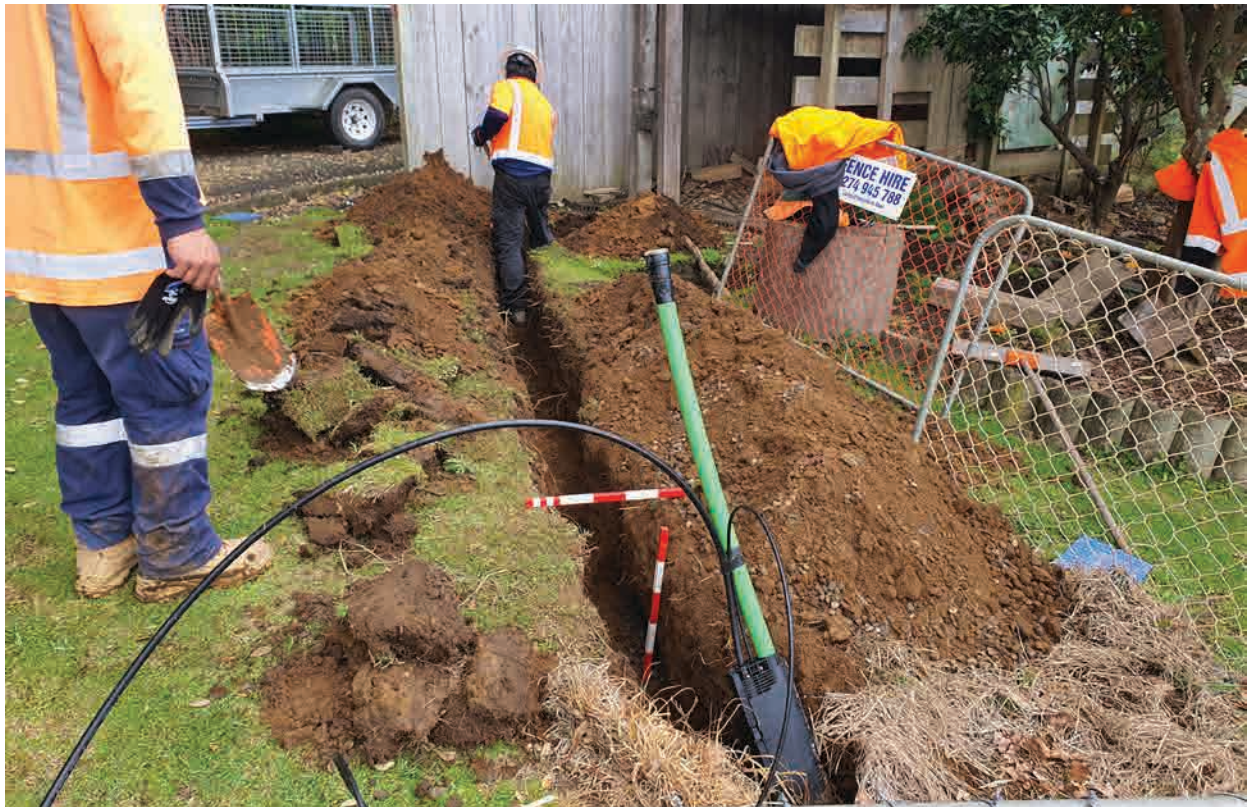
There were two trenches excavated in this street to join the drill shots to meet power poles, the first outside number 47, and the second outside number 51. The first trench was in an area that had previously been disturbed to a depth of approximately 400 mm, with mid-to-late 20th century rubbish including, fibrolite, brown beer bottle glass and part of an old D-Cell battery. There was also a deposit of drainage material in the form of water rolled pebbles where the watermain intersected the trench.

Figure 4. View south of trench outside 47 Ngakoti Street.

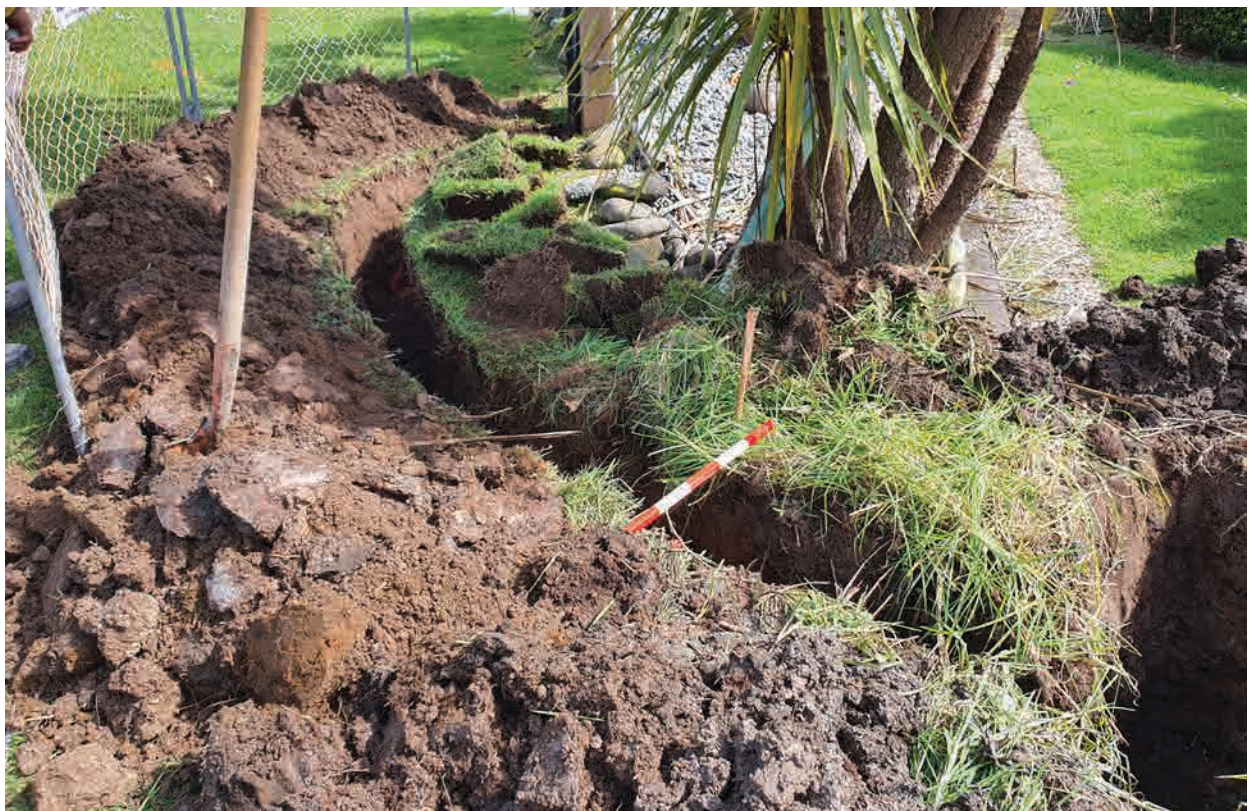
The soil in the second trench was a mix of topsoil and gley, with rootlets and organic material within it. This area appears to be naturally flat and is likely a drained former wetland.

Figure 5. View west of trench outside 51 Ngakoti Street.

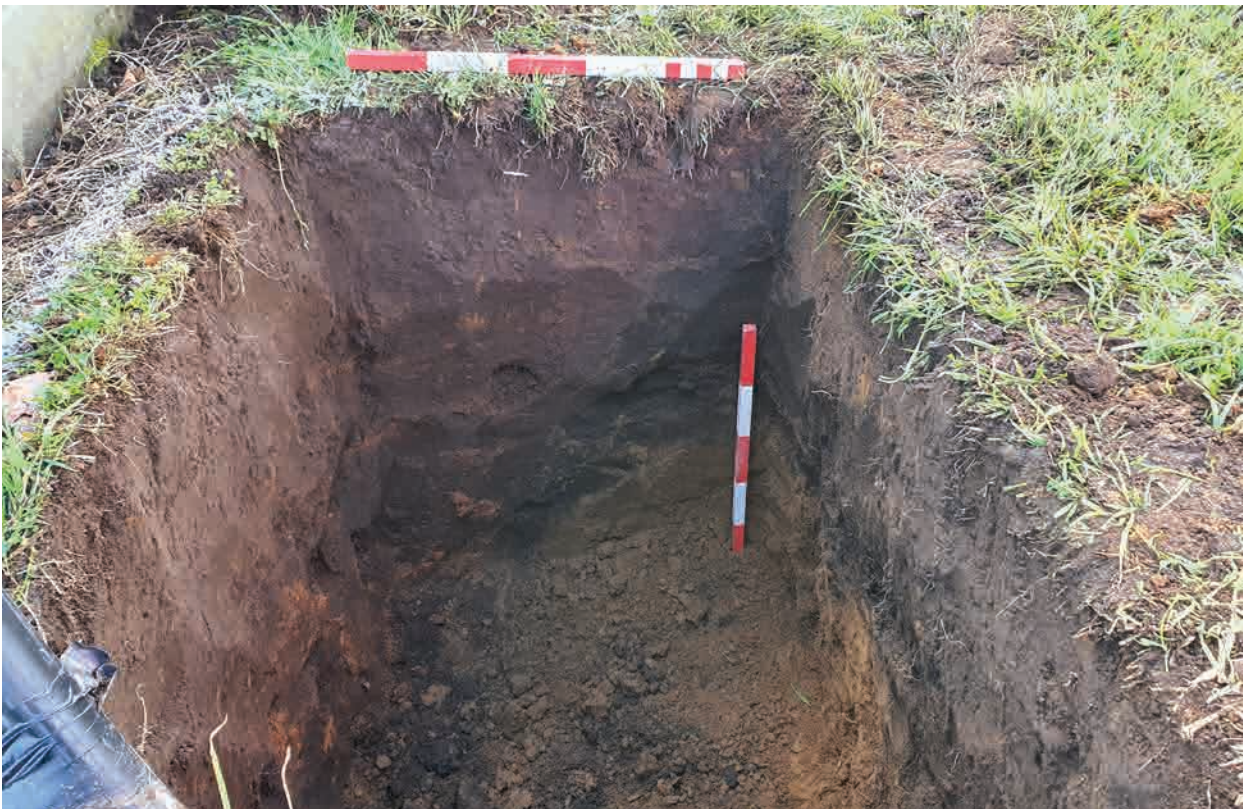
An insertion hole was dug on the corner of Ritimona and Ngakoti Streets which had a deep mixed topsoil layer 600 mm deep at the southern end, with the natural surface sloping down northwards. The hole was abandoned at 900 mm and sterile soils were not reached in the northern side.

Within this mixed topsoil layer some undiagnostic ceramic fragments were found. It is likely that this area was subject to fill activities prior to the formation of Ritimona Street and Bowling Club and is probably associated with the drainage and road identified by McCurdy at Q19/450.

Figure 6. View east of insertion hole at corner of Ritimona and Ngakoti streets showing likely original slope of hill prior to fill event. Photo scale = 0.5 m.

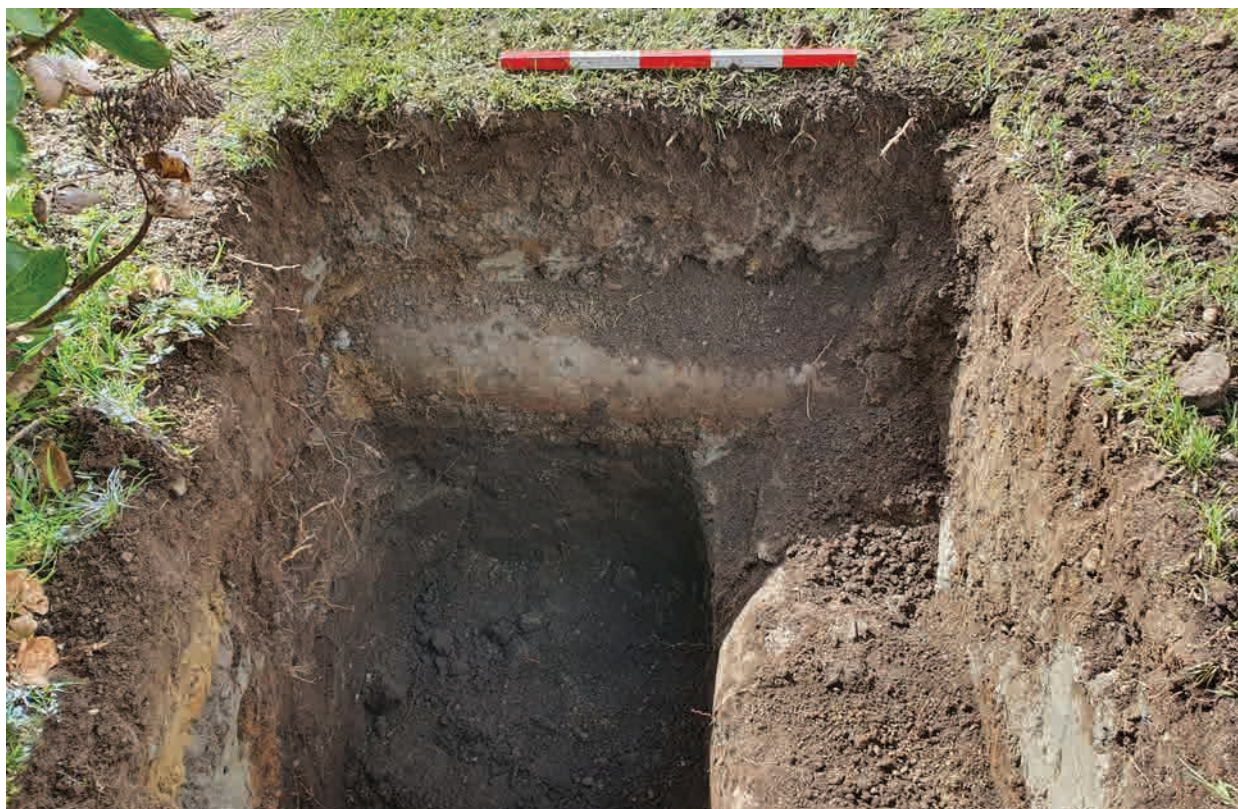
Outside 2 Ritimona Street the soil profile was a mix of grey clay, concrete, some 20th century rubbish and water rolled stones. There was a 300 mm concrete/ACM pipe exposed within a trench, which appears to be the stormwater main which discharges into the Urenui River. Beneath the pipe was similar mixed topsoil that was observed in the insertion hole on the corner of Ritimona and Ngakoti Streets indicating that there has been significant fill imported to build up the surface. The remainder of the potholes outside number 2 Ritimona Street had similar 20th century fill, likely associated with service installation and building up the road surface.

Figure 7. View east of insertion hole outside 2 Ritimona Street showing 300 mm stormwater pipe.

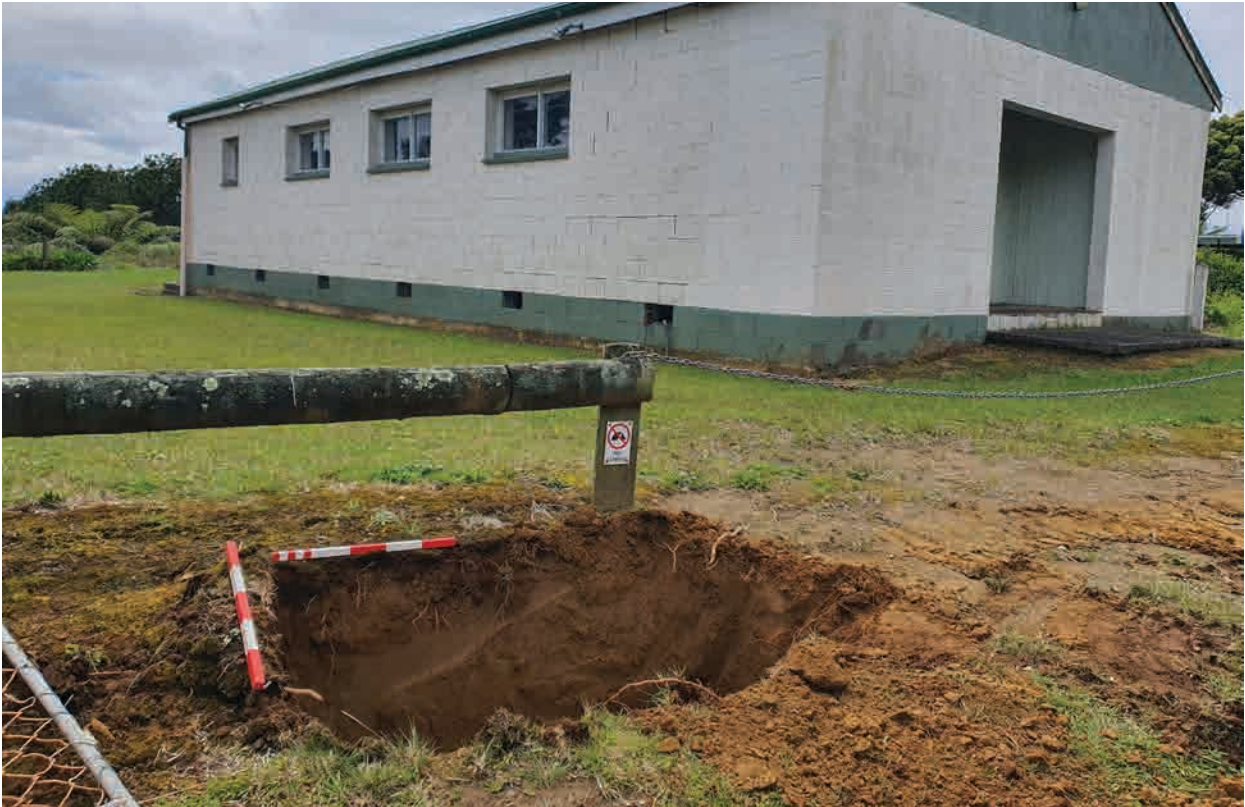
Figure 8. Additional holes dug outside 2 Ritimona Street.

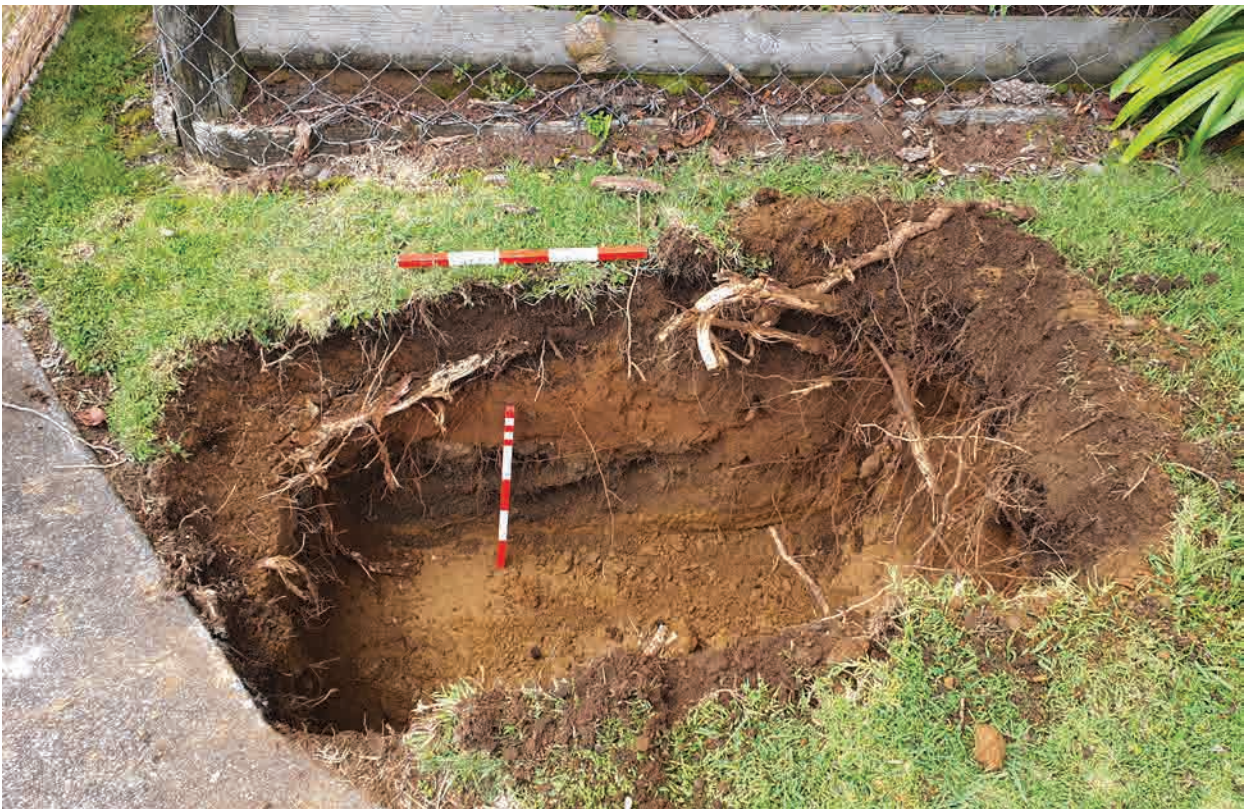
Figure 9. View of hole outside Scout Den showing lack of topsoil compared to description in the site record.

The first hole was directly outside the Scout Den, in the vicinity of Q19/140. The original site record mentions that there was 18 inches of topsoil across the site, but less than 10 mm of topsoil was observed in this hole indicating there has been extensive cut not only within the lot where Q19/140 was located but in the road reserve also.
